**LOTS 202 & 203 WANDENA ROAD
AND
LOTS 204 & 205 GREAT NORTHERN HIGHWAY
CHITTERING**

**ENVIRONMENTAL ASSESSMENT
AND MANAGEMENT STRATEGY**

**Focus Demolition Pty Ltd
and
Mr David Weightman Smith**

Draft Report No. J19018a
18 May 2021

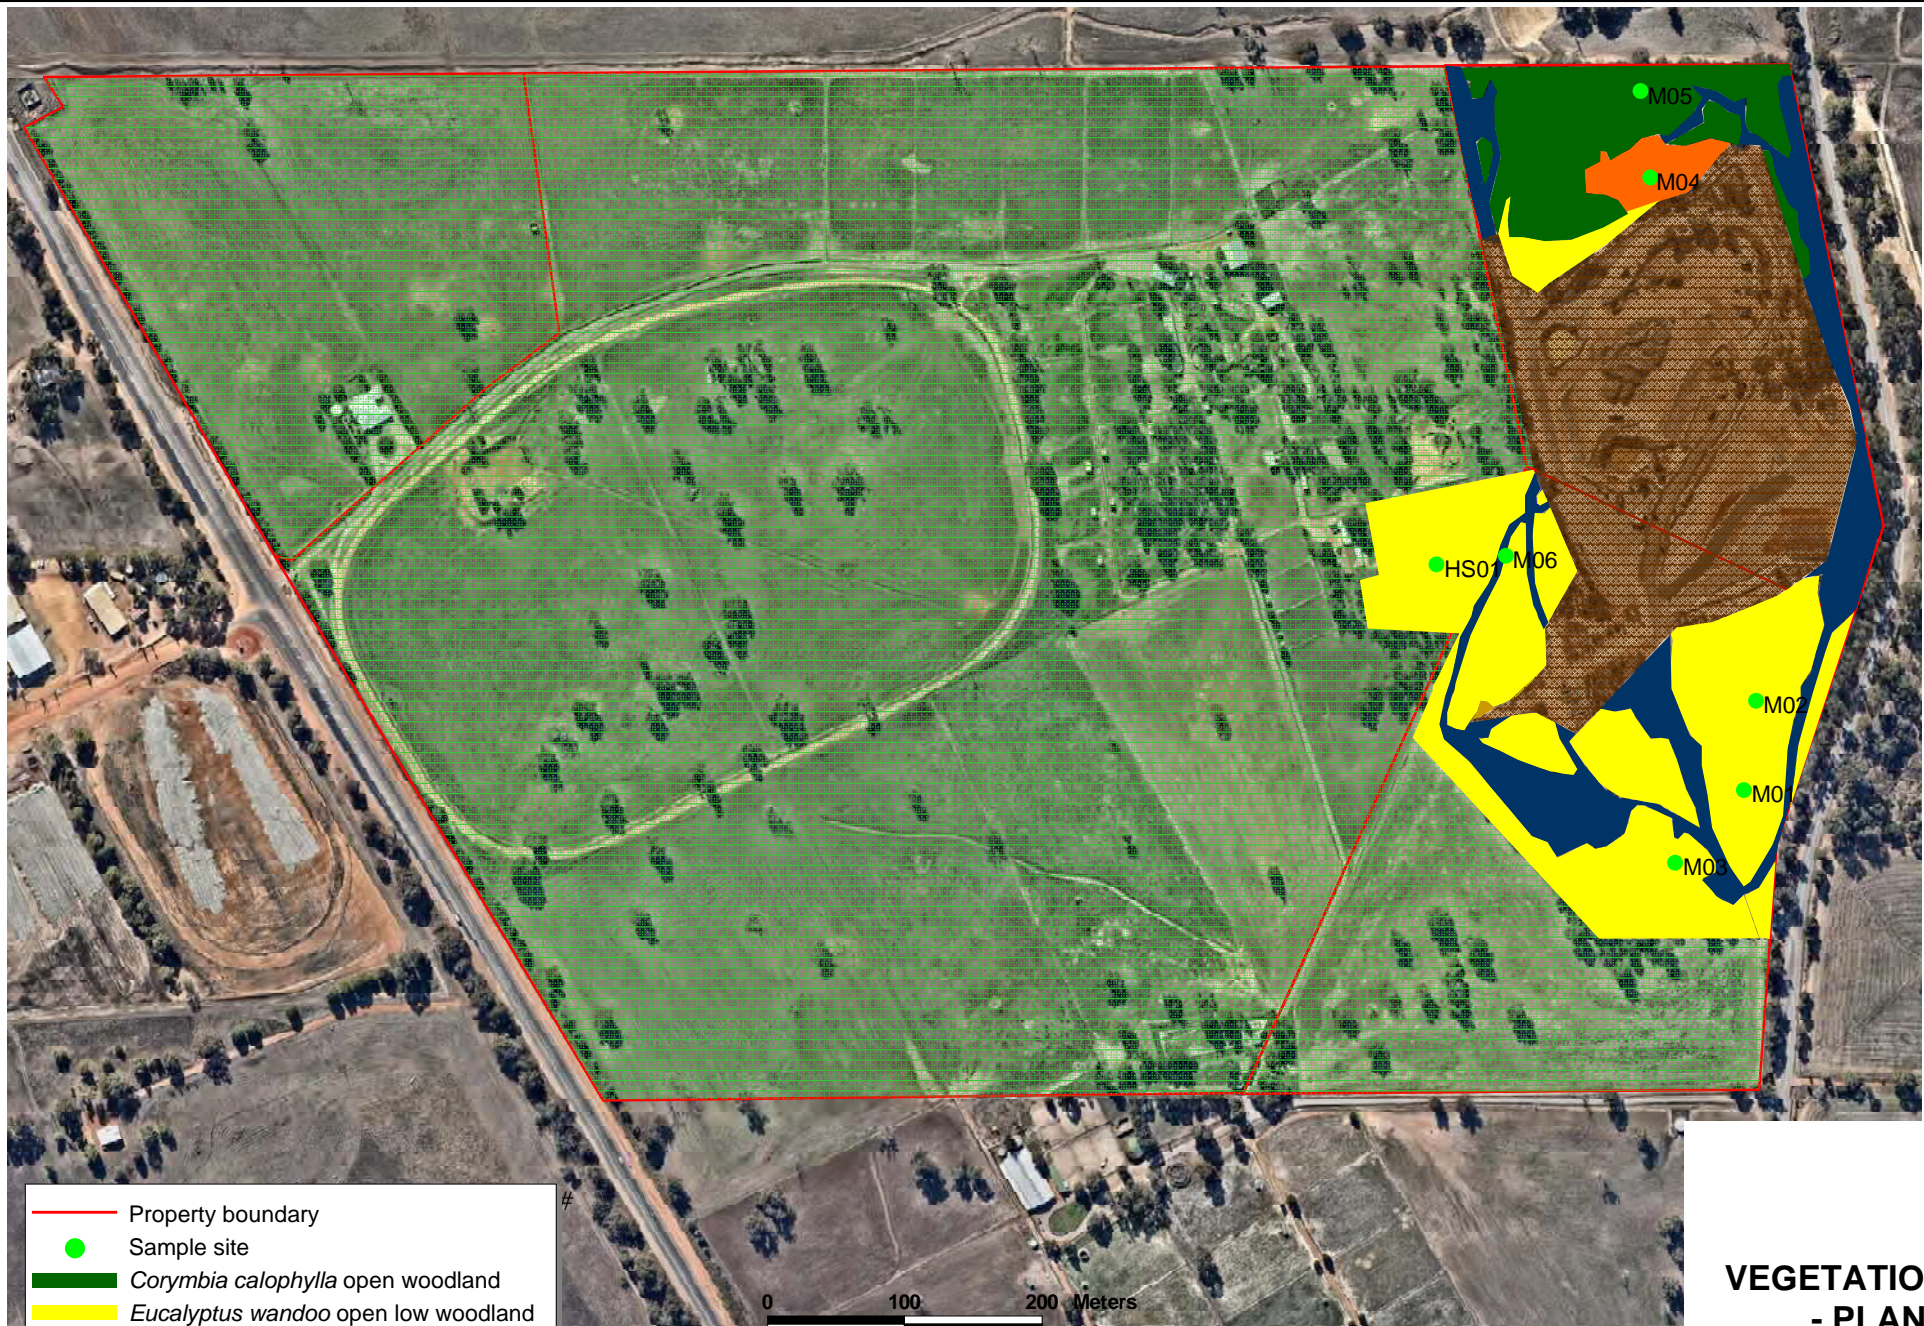
Figure 8

- Property boundary
- Sample site
- Corymbia calophylla* open woodland
- Eucalyptus wandoo* open low woodland
- Rehabilitation
- Tracks and clearings
- Infrastructure
- Pasture and Paddocks

**VEGETATION MAPPING
- PLANT ECOLOGY**

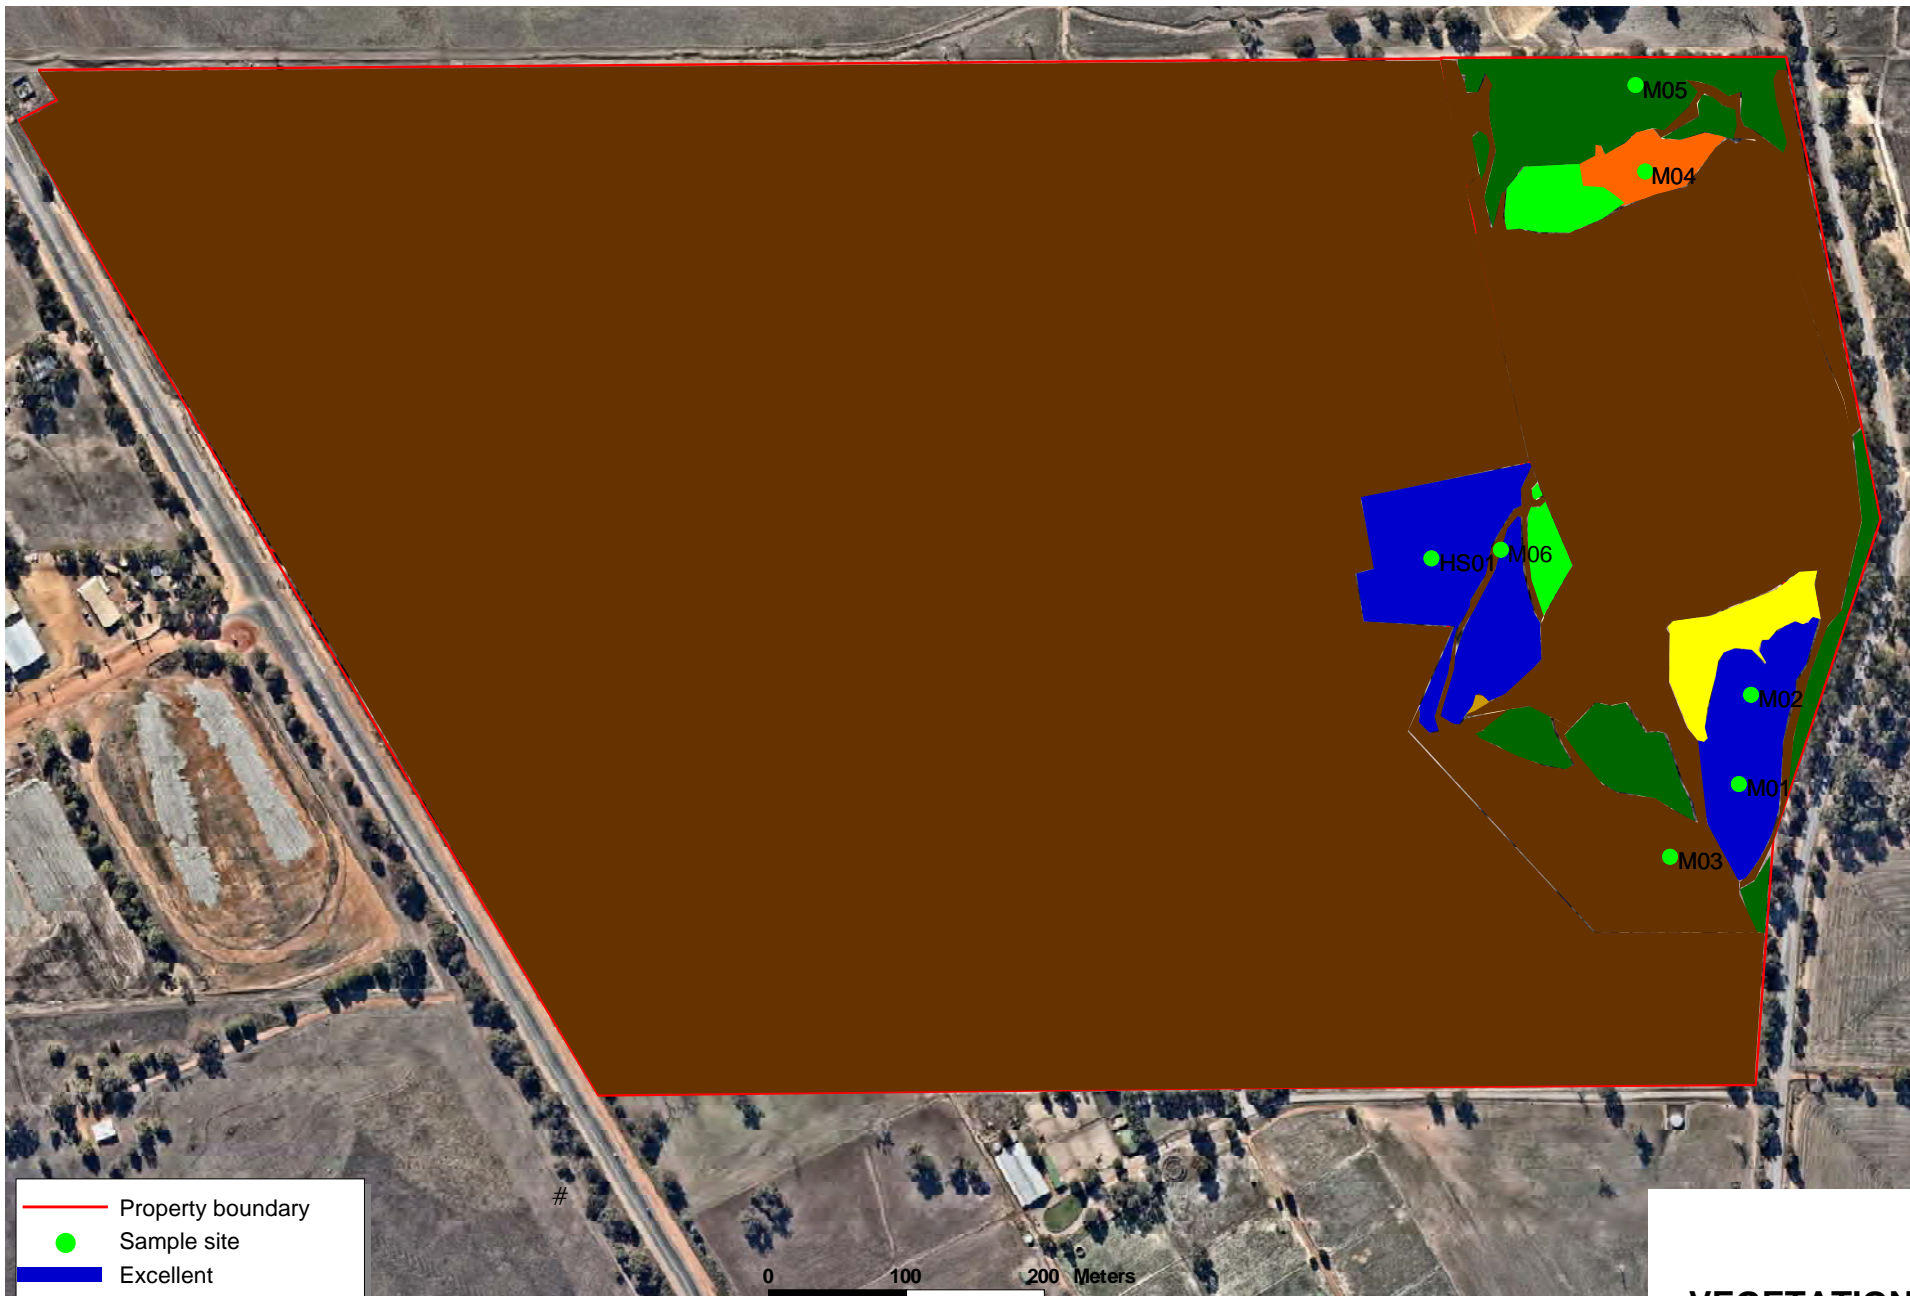
- Property boundary
- Sample site
- Excellent
- Very Good
- Good
- Degraded
- Completely Degraded
- Rehabilitation

VEGETATION CONDITION

The native vegetation ranges in condition from Completely Degraded to Excellent. The highest quality vegetation is located in the north of Lot 203, the east of Lot 205 and the north of Lot 202, in patches of 1.3ha or less. Figure 9 shows the vegetation condition.

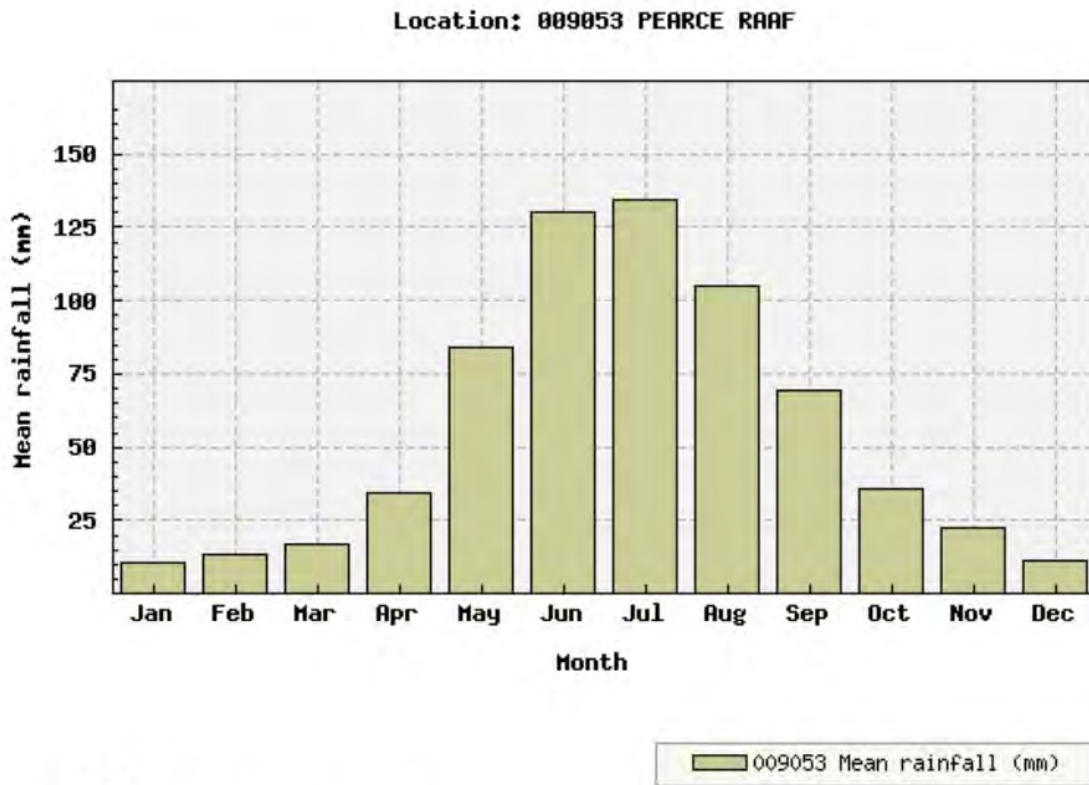
Figure 4 Pearce RAAF Mean Rainfall

Figure 4 shows a rainfall occurrence chart for Pearce RAAF. Table 2.1 shows rainfall intensity, frequency and duration for Muchea.

Muchea, like the rest of the greater Perth region, has a strongly seasonal rainfall, with most of the annual rain falling between May and September in association with winter cold fronts. Occasional heavy falls may occur from summer thunderstorms. The long-term average annual rainfall for Pearce RAAF Base (located 6.5km south of the site) is 679.7mm, of which 77% falls between the months of May and September.

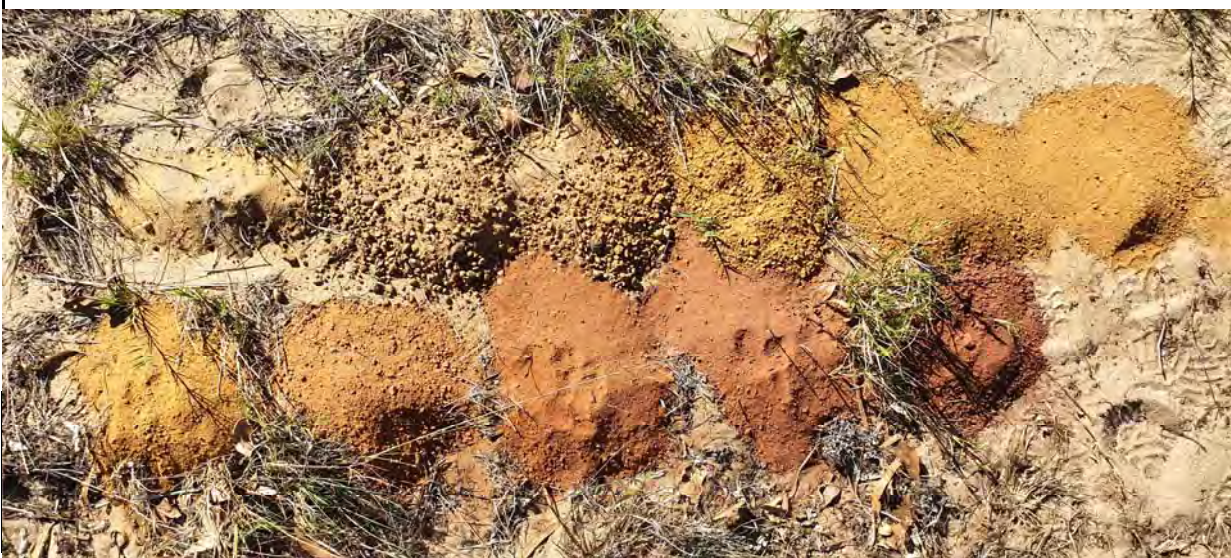
PROJECT NUMBER:	J19018
SITE ID:	WB1
EASTING:	405843
NORTHING:	6503819
METHOD:	Auger rig
TOTAL DEPTH (mbgl):	5.5
REFUSAL (Y/N):	N
DATE:	24/03/2020
DEPTH TO WATER (mbgl)	None encountered

SOIL PROFILE		SAMPLE DATA	
DEPTH (m)	SOIL DESCRIPTION	SAMPLE ID	INTERVAL (m)
0	Pale yellow-brown sand		
0.5 - 1.5	Brown gravelly sand		
2	Orange pebbly silt		
2.5 - 3	Orange pebbly sandy silt		
3.5	Orange clayey silt		
4	Red-orange clayey silt		
4.5 - 5	Red silty clay		
5.5	Red gravelly clay

Drilling by BES at four sites on Lots 204 and 205 in March 2020 showed a pebbly silty sand to pebbly silty clay profile in the top 5.5m, which corresponds to the GSWA description for the Guildford Formation. Previous drilling by Bowman & Associates Pty Ltd (2016) at four sites on Lots 202 and 203 found a silty clay profile with ironstone commonly occurring at between 5m and 18m, which corresponds generally with the GSWA descriptions for Leederville Formation and colluvium.

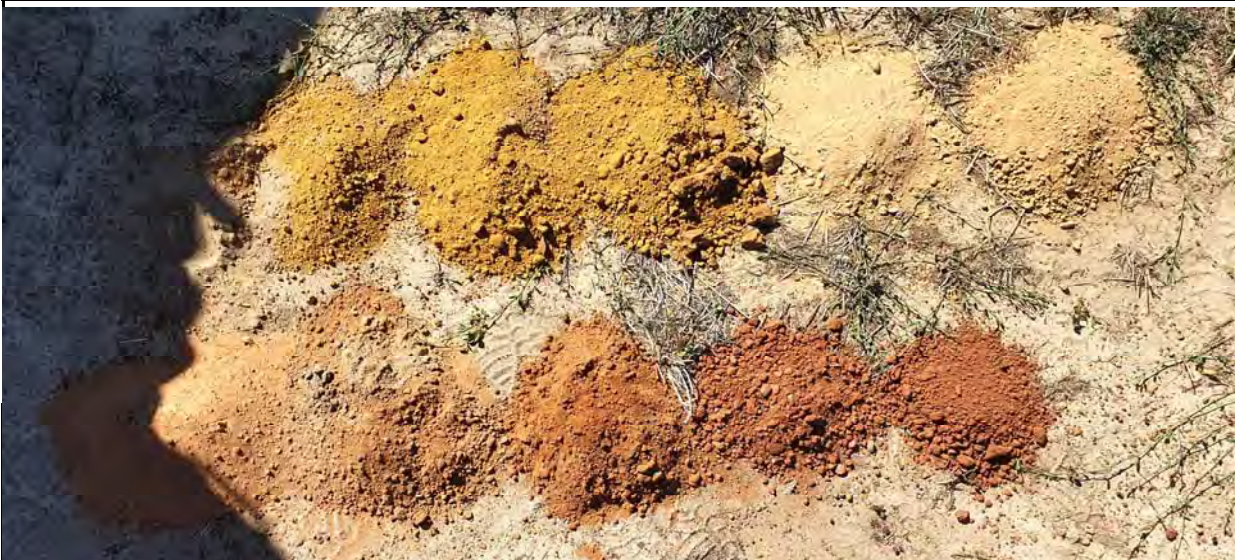
PROJECT NUMBER:	J19018
SITE ID:	WB2
EASTING:	406206
NORTHING:	6504189
METHOD:	Auger rig
TOTAL DEPTH (mbgl):	5.5
REFUSAL (Y/N):	N
DATE:	24/03/2020
DEPTH TO WATER (mbgl)	None encountered

SOIL PROFILE		SAMPLE DATA	
DEPTH (m)	SOIL DESCRIPTION	SAMPLE ID	INTERVAL (m)
0	Pale yellow-brown pebbly silty sand		
0.5 - 2	Orange-brown gravelly sandy silt.		
2.2	Hard red/grey mottled clay		
2.5 - 3	Pale brown pebbly sandy silt		
3.5	Pink clayey silt		
4-4.5	Orange-brown pebbly clayey silt		
5-5.5	Red gravelly silty clay, hard

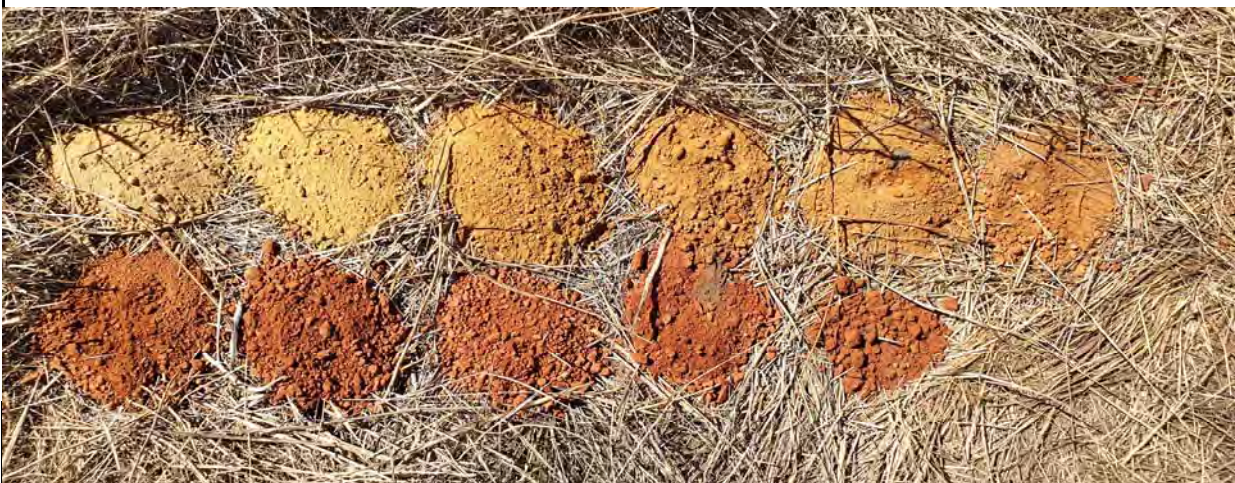
PROJECT NUMBER:	J19018
SITE ID:	WB3
EASTING:	406365
NORTHING:	6503799
METHOD:	Auger rig
TOTAL DEPTH (mbgl):	5.5
REFUSAL (Y/N):	N
DATE:	24/03/2020
DEPTH TO WATER (mbgl)	None encountered

SOIL PROFILE		SAMPLE DATA	
DEPTH (m)	SOIL DESCRIPTION	SAMPLE ID	INTERVAL (m)
0 - 0.5	Pale yellow-brown pebbly silty sand		
1	Yellow pebbly sandy silt		
1.5	Orange-brown pebbly silt		
2 - 2.5	Orange pebbly silt		
3	Red-brown pebbly silt		
3.5	Reddish pebbly silt		
4	Red-brown pebbly silty clay		
4.5 - 5	Red pebbly silty clay		
5.5	Red silty clay

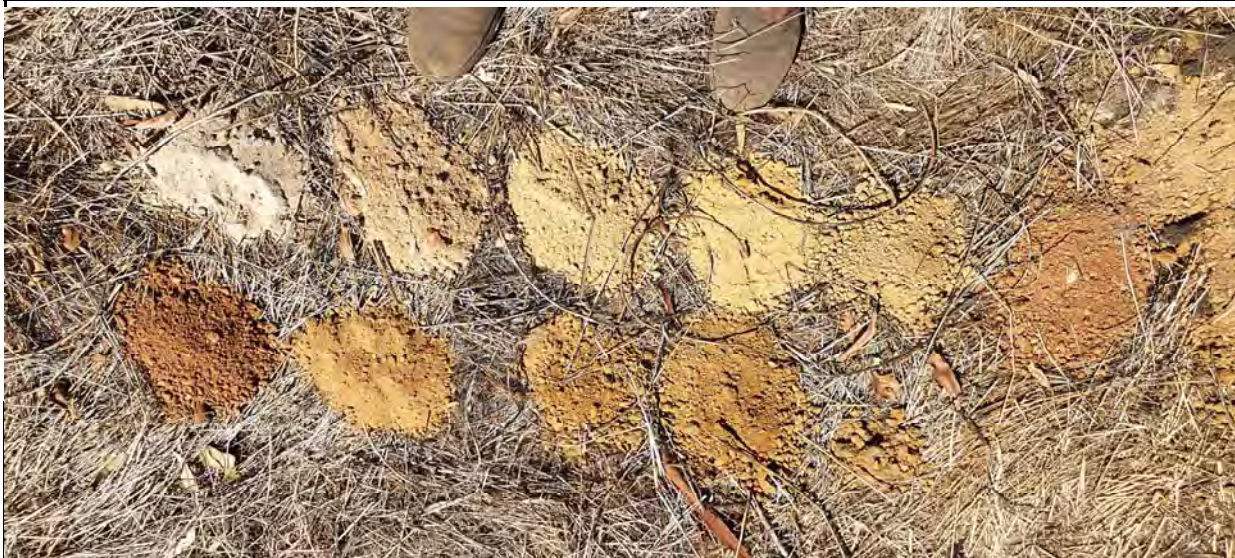
PROJECT NUMBER:	J19018
SITE ID:	WB4
EASTING:	406393
NORTHING:	6503460
METHOD:	Auger rig
TOTAL DEPTH (mbgl):	5.5
REFUSAL (Y/N):	N
DATE:	24/03/2020
DEPTH TO WATER (mbgl)	None encountered

SOIL PROFILE		SAMPLE DATA	
DEPTH (m)	SOIL DESCRIPTION	SAMPLE ID	INTERVAL (m)
0 - 0.5	Grey-brown silty sand		
1 - 2	Yellow-brown pebbly silty sand		
2.5	Yellow-brown pebbly silt		
3 - 3.5	Red-brown pebbly silt		
4	Yellow-brown pebbly silty sand		
4.5 - 5	Yellow-brown pebbly clayey silt		
5.5	Brown/grey mottled silty clay

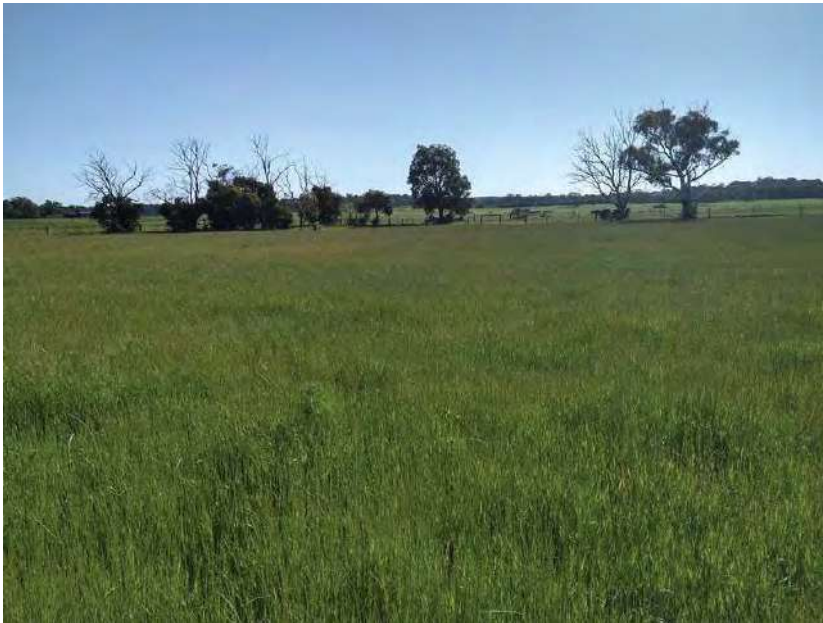
Figure 1: Typical site conditions in western part of the site.

At the time of the investigation, the eastern part of the was operating as a horse stud and the eastern part of the site was a partially backfilled quarry. The western part of the site was mostly covered in grassy paddocks with scattered mature trees. The surface across the eastern part of the site is generally gravelly and vegetation consists of scattered shrubs and trees. Figures 1 and 2 below show typical site conditions at the time of the investigation.

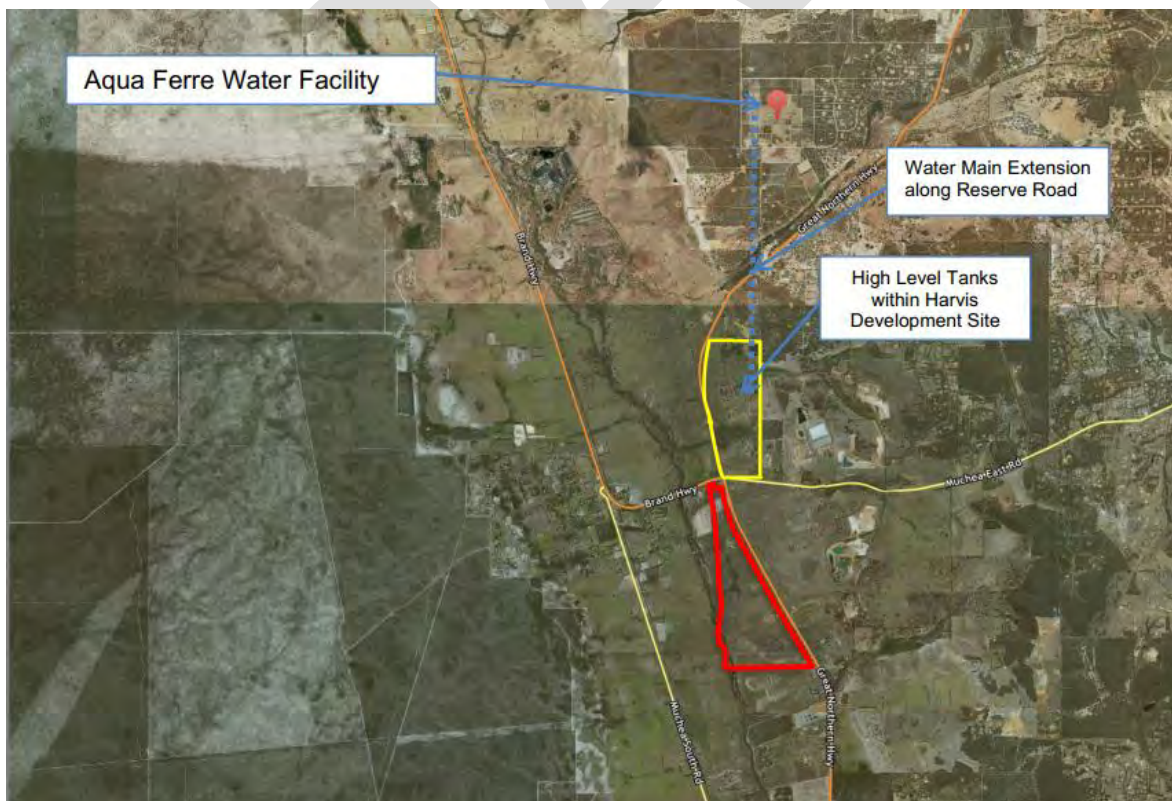
Figure 2 Development boundaries

Figure 2 below broadly shows the Precinct 3 development (outlined in red) to the south of Harvis' proposed MEN (Phase 1) development (outlined in yellow) and Aqua Ferre's proposed water facility to the north.

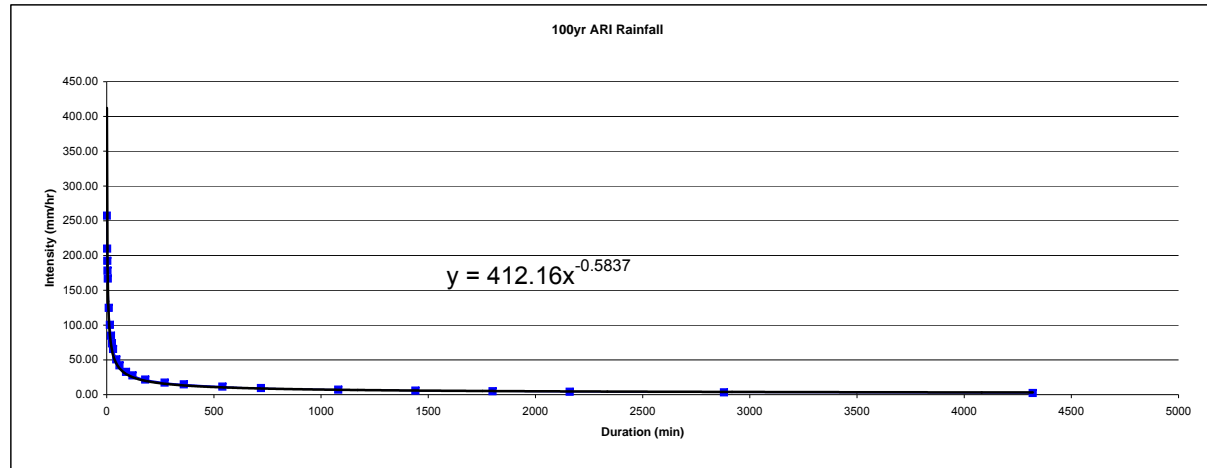
COMBINED 100 YEAR ARI FLOWS

Segment	Contributing Segments	Contributing Lots	Segment Cum Peak Flow (L/s)	Lots Cum Peak Flow (L/s)	Total Cum Peak Flow (L/s)	Long Slope	Height in Channel (m) (Fang)	Height Over Weir (m)
A1	A1,C1	2,3	72.39	252.05	324.44	0.0054	0.48	0.21
A2	A2-A5	1,6,13-18,23N,24N	218.75	1217.97	1436.72	0.0202	0.70	0.33
A3	A3-A5	13-18,23N,24N	159.30	922.52	1081.82	0.0021	0.75	0.47
A4	A4,A5	14-18,23N,24N	86.73	778.75	865.48	0.0221	0.55	0.21
A5	A5	18,24N	35.69	221.18	256.86	0.0522	0.25	0.09
B1	B1	7-10	85.90	503.29	589.19	0.0063	0.61	0.24
B2	B1,B2	7-10	137.05	503.29	640.34	0.0204	0.49	0.18
C1	C1	4	28.70	273.48	302.18	0.0033	0.52	0.20
D1	D1	19-22,23S,31	104.36	775.07	879.43	0.0122	0.63	0.25
D2	D1-D7	11,12,19-22,23S,24S,25-32,47-52	538.79	3508.57	4047.36	0.0223	0.80	0.50
D3	D3-D7	24S,25-30,47-52	307.86	1991.56	2299.42	0.0091	1.02	0.47
D4	D4,D5	49-52	117.50	601.98	719.47	0.0631	0.39	0.14
D5	D5	51,52	39.17	296.98	336.14	0.0321	0.32	0.13
