**TALLANGATTA FARM
LOTS 50 AND 1456 GREAT NORTHERN HIGHWAY, MUCHEA**

**ENVIRONMENTAL ASSESSMENT
AND MANAGEMENT STRATEGY**

Draft Report No. J20008a
11 March 2021

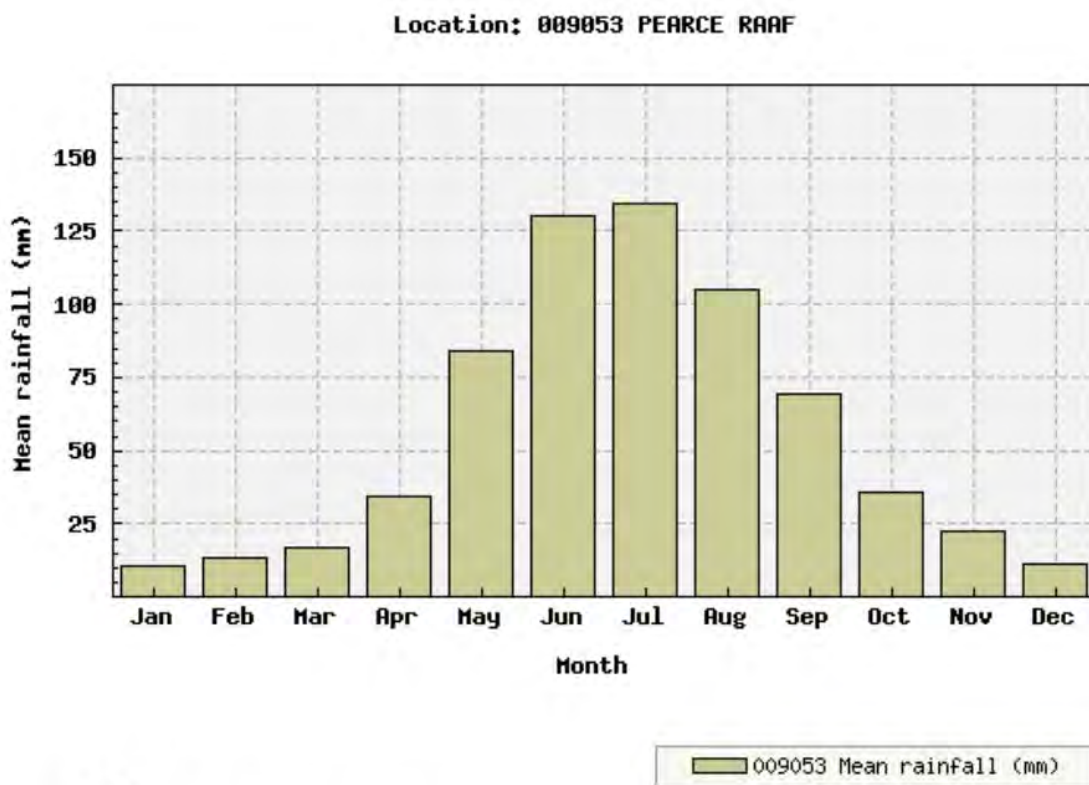
Figure 4 Pearce RAAF Mean Rainfall

Figure 4 shows a rainfall occurrence chart for Pearce RAAF.

Muchea, like the rest of the greater Perth region, has a strongly seasonal rainfall, with most of the annual rain falling between May and September in association with winter cold fronts. Occasional heavy falls may occur from summer thunderstorms. The long-term average annual rainfall for Pearce RAAF Base (located 6.5km south of the site) is 679.7mm, of which 77% falls between the months of May and September.

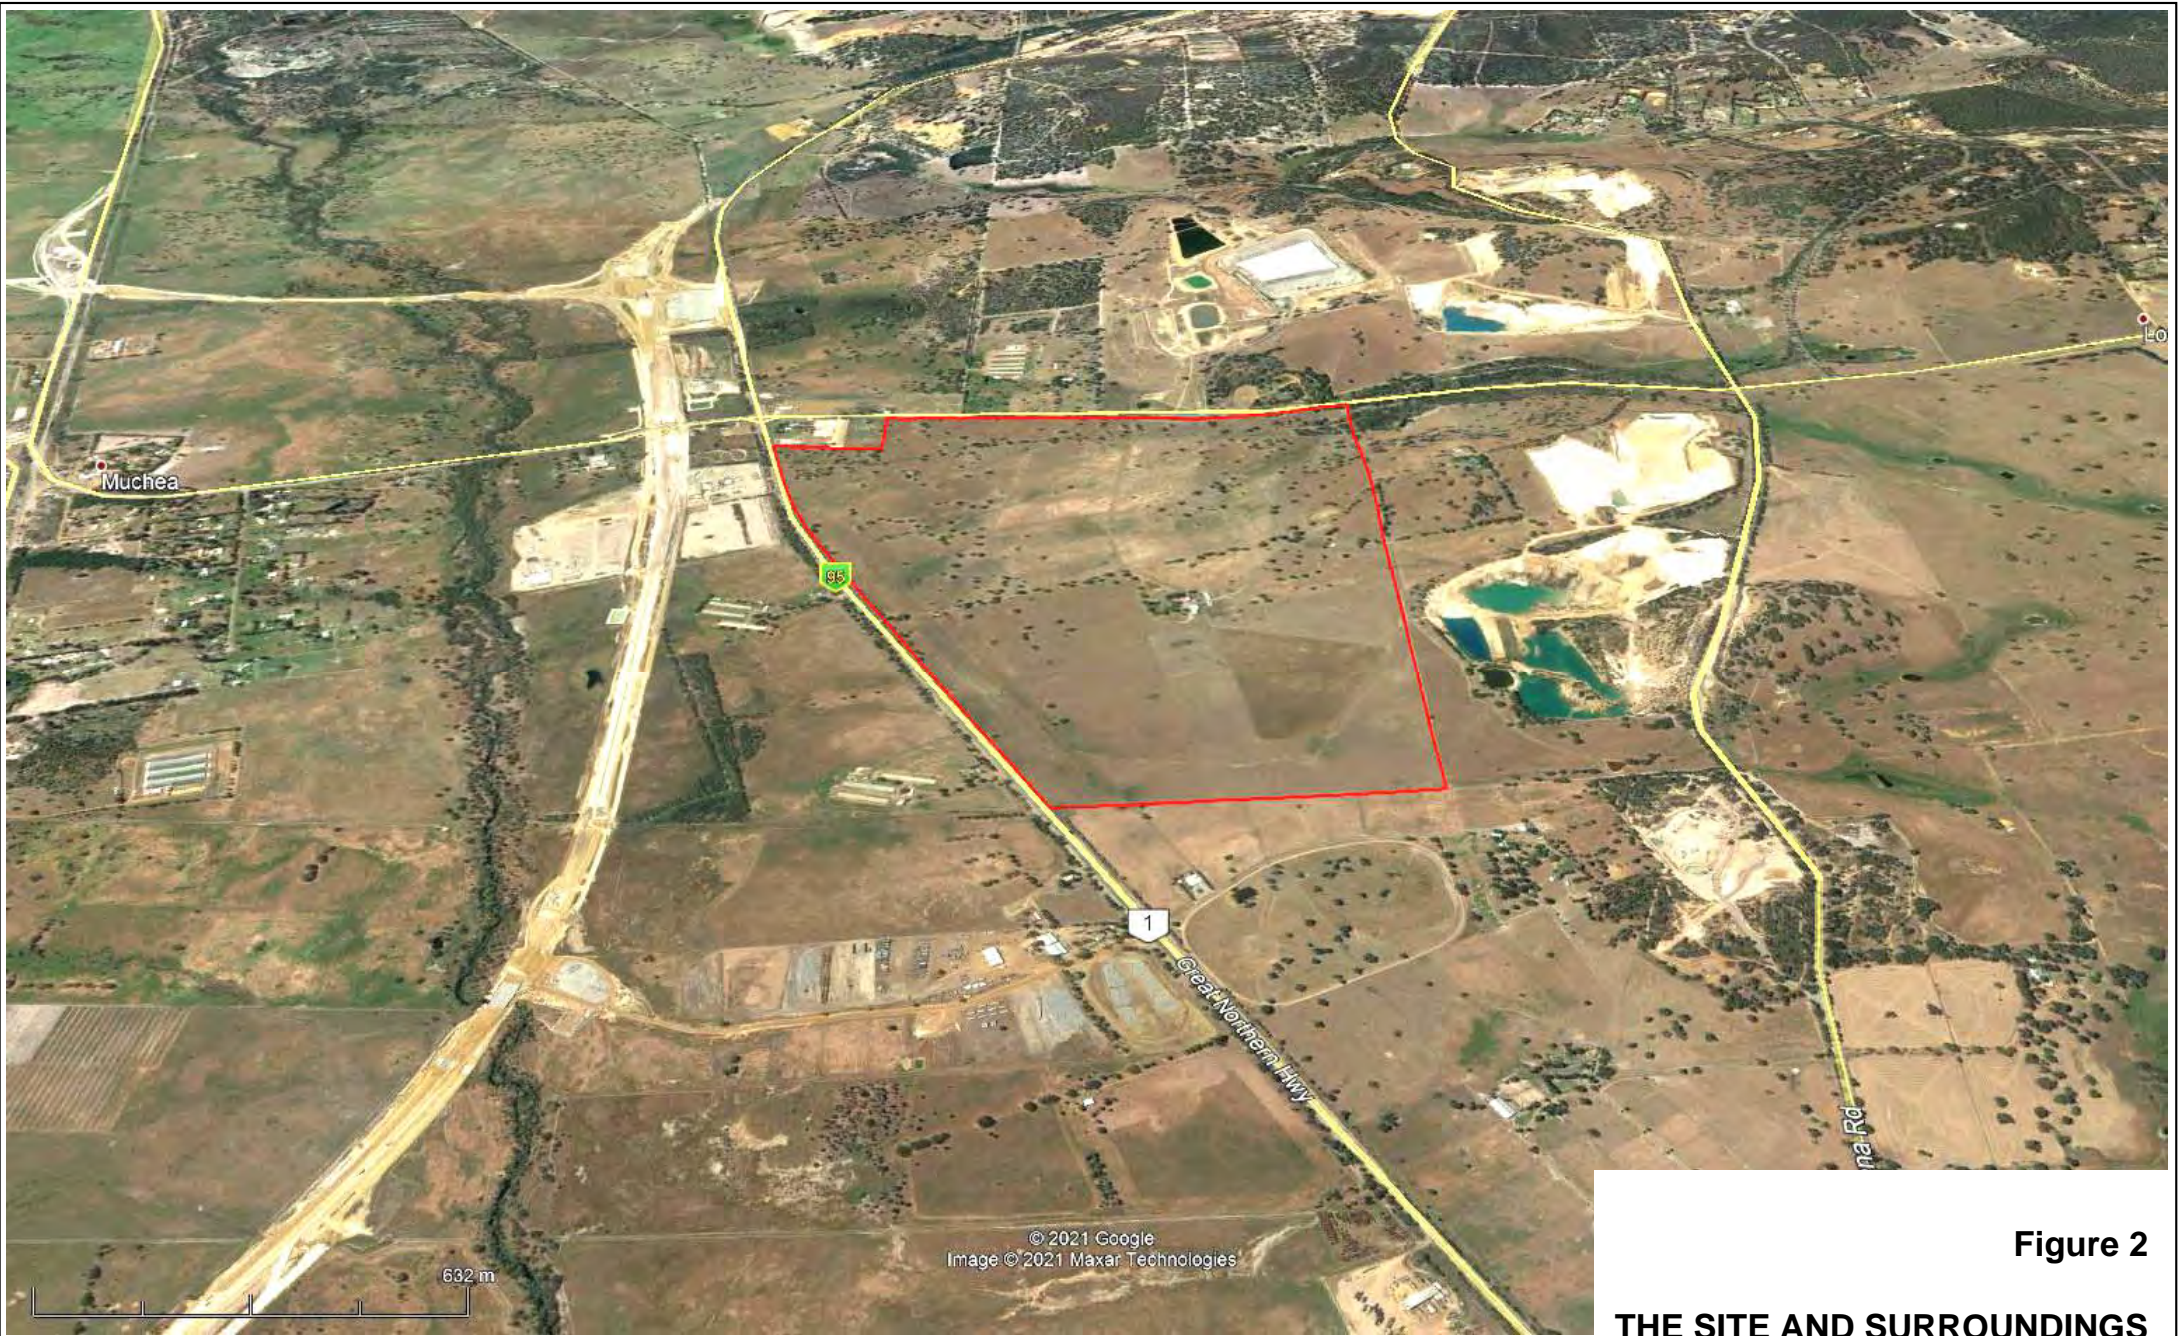
THE SITE AND SURROUNDINGS

The total area of Tallangatta is 213 hectares. Figure 2 shows the boundaries of the site. Figure 3 shows a preliminary conceptual plan of subdivision.

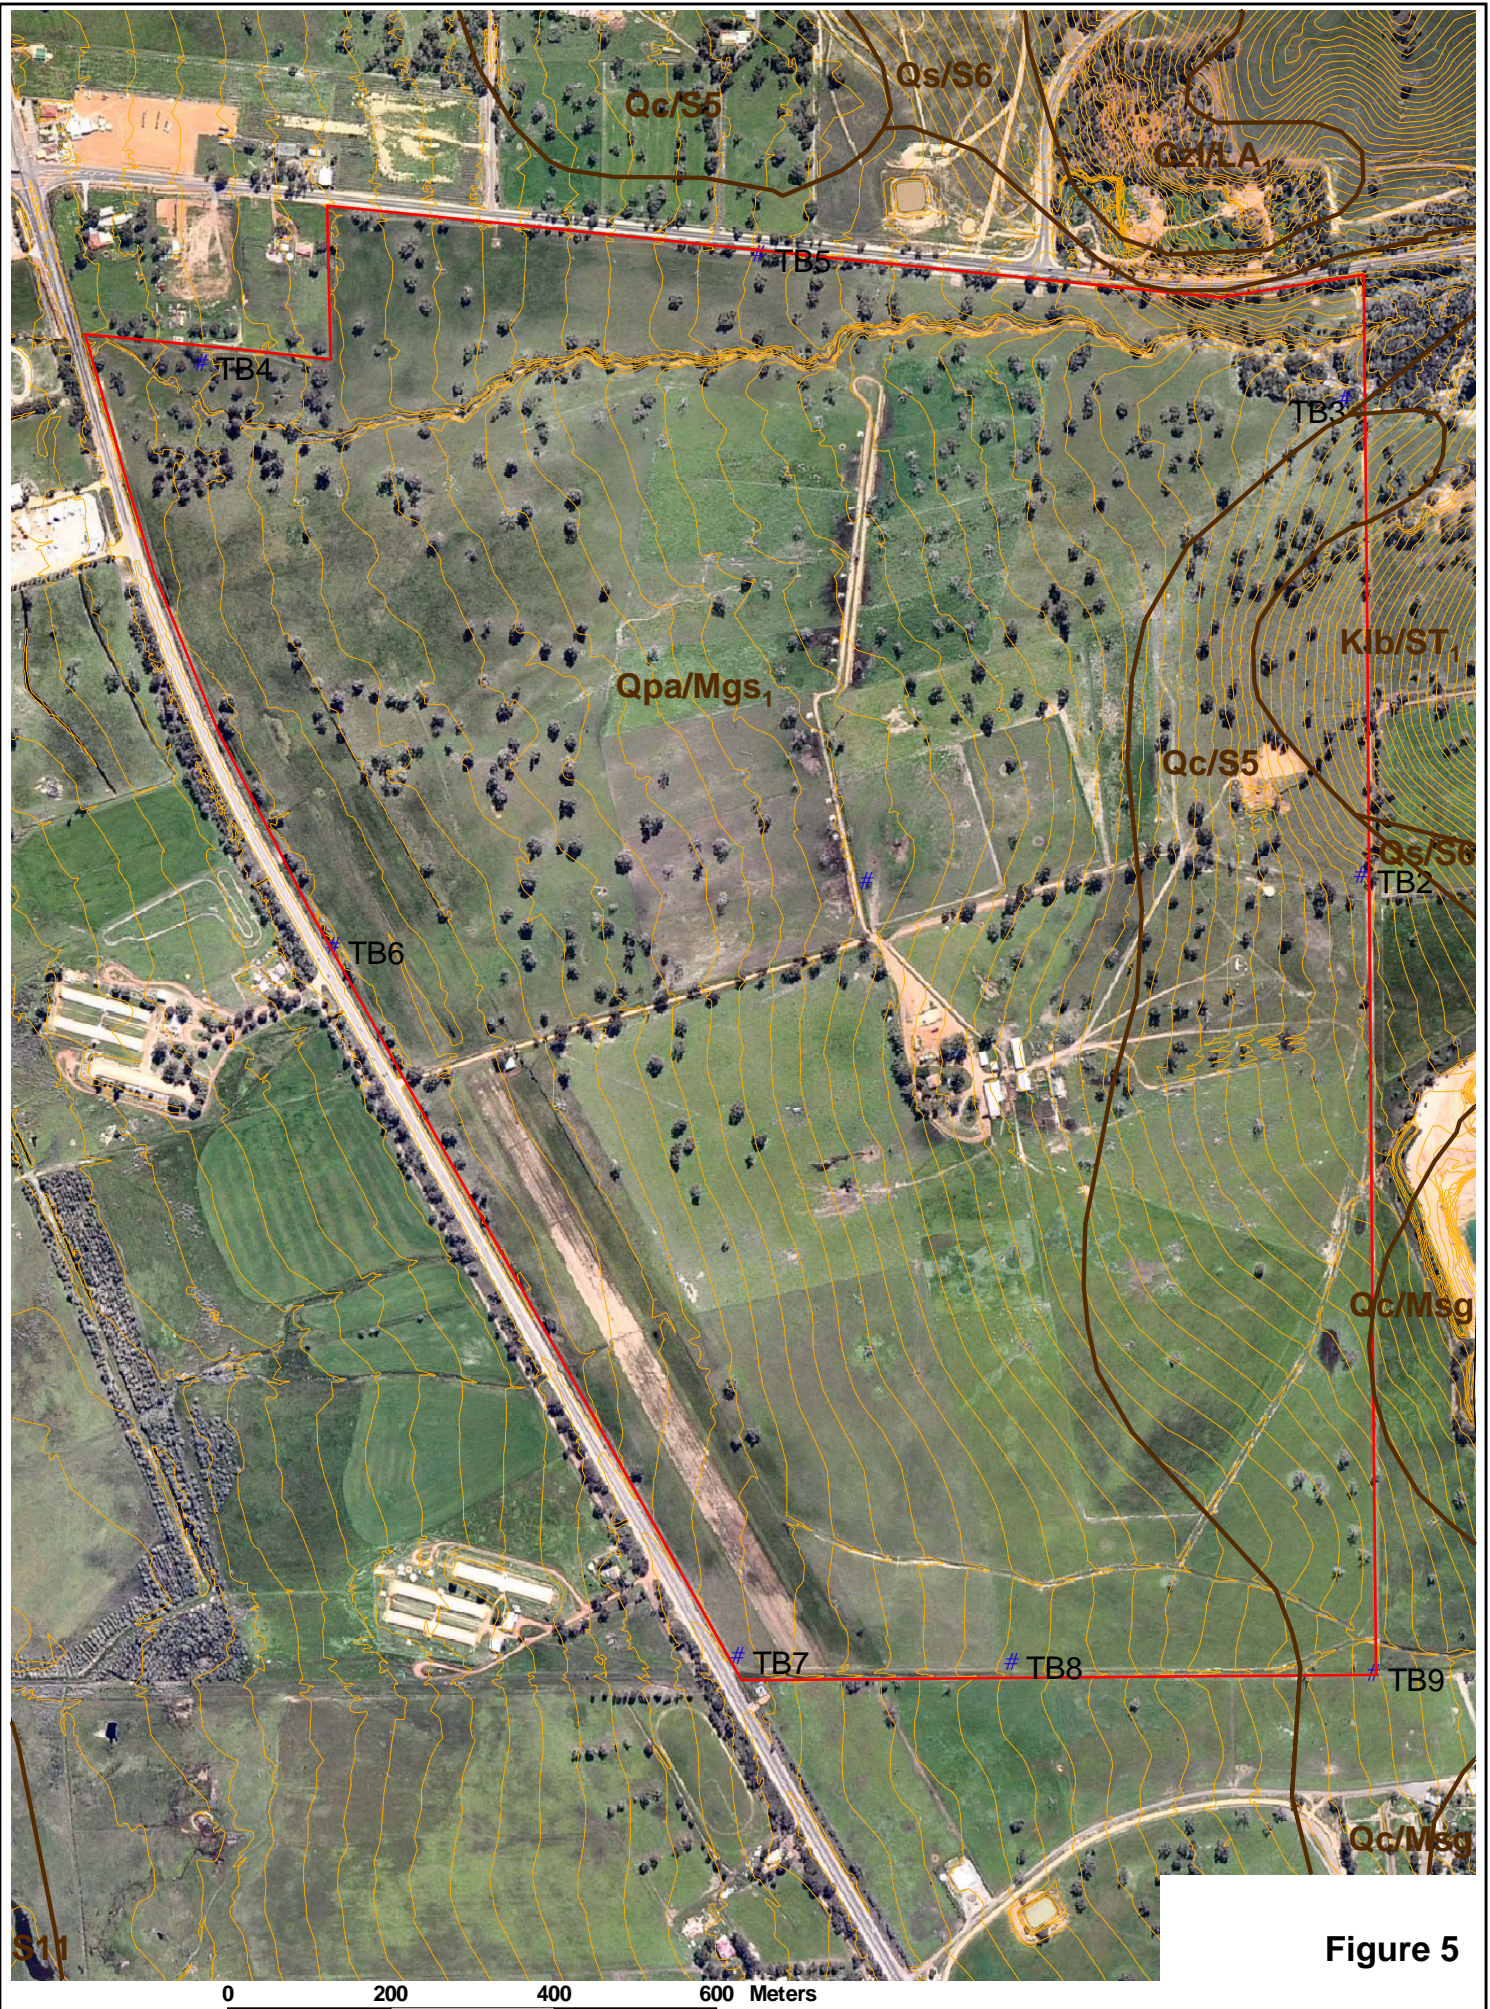
Figure 5

PHYSIOGRAPHY

Most of Tallangatta is mapped by the GSWA (Gozzard, 1982) as Guildford Formation (Qpa), with soils consisting of pebbly silt (Mgs₁). This unit is described as having generally low permeability and shallow groundwater, with a low to moderate capability for effluent and drainage disposal. The foundation stability may vary, with differential settling possible in clayey areas. Sand pads are generally necessary for foundations.

The eastern part of the property is mapped as Colluvium (Qc), with soils of medium to coarse grained brown sand (S₅) and sandy silt (Msg). The S₅ soil type has high permeability and generally high capability for drainage and effluent disposal. The Msg type has low permeability and consequently low suitability for effluent disposal. Both soil types provide good foundations when compacted.

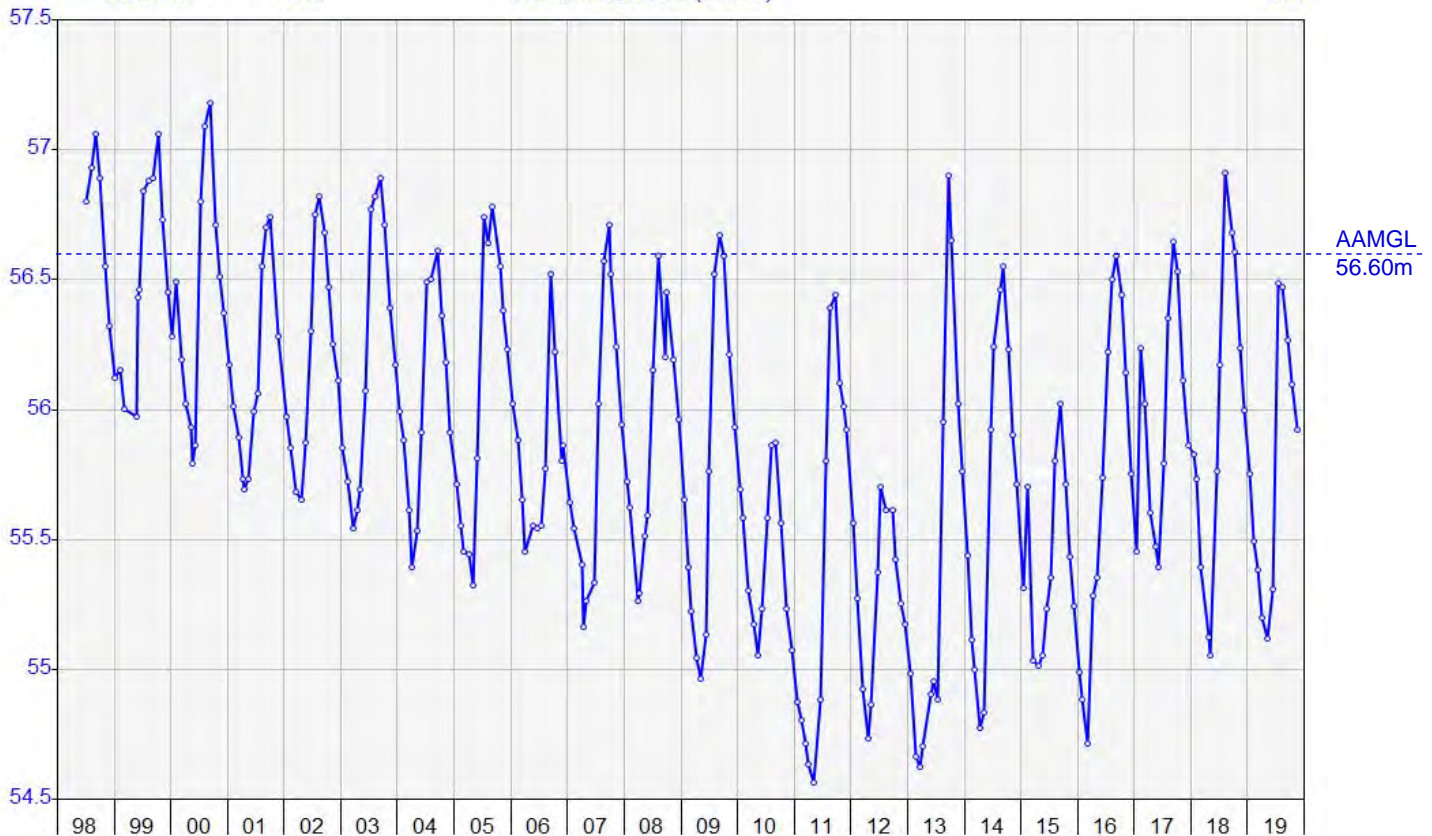
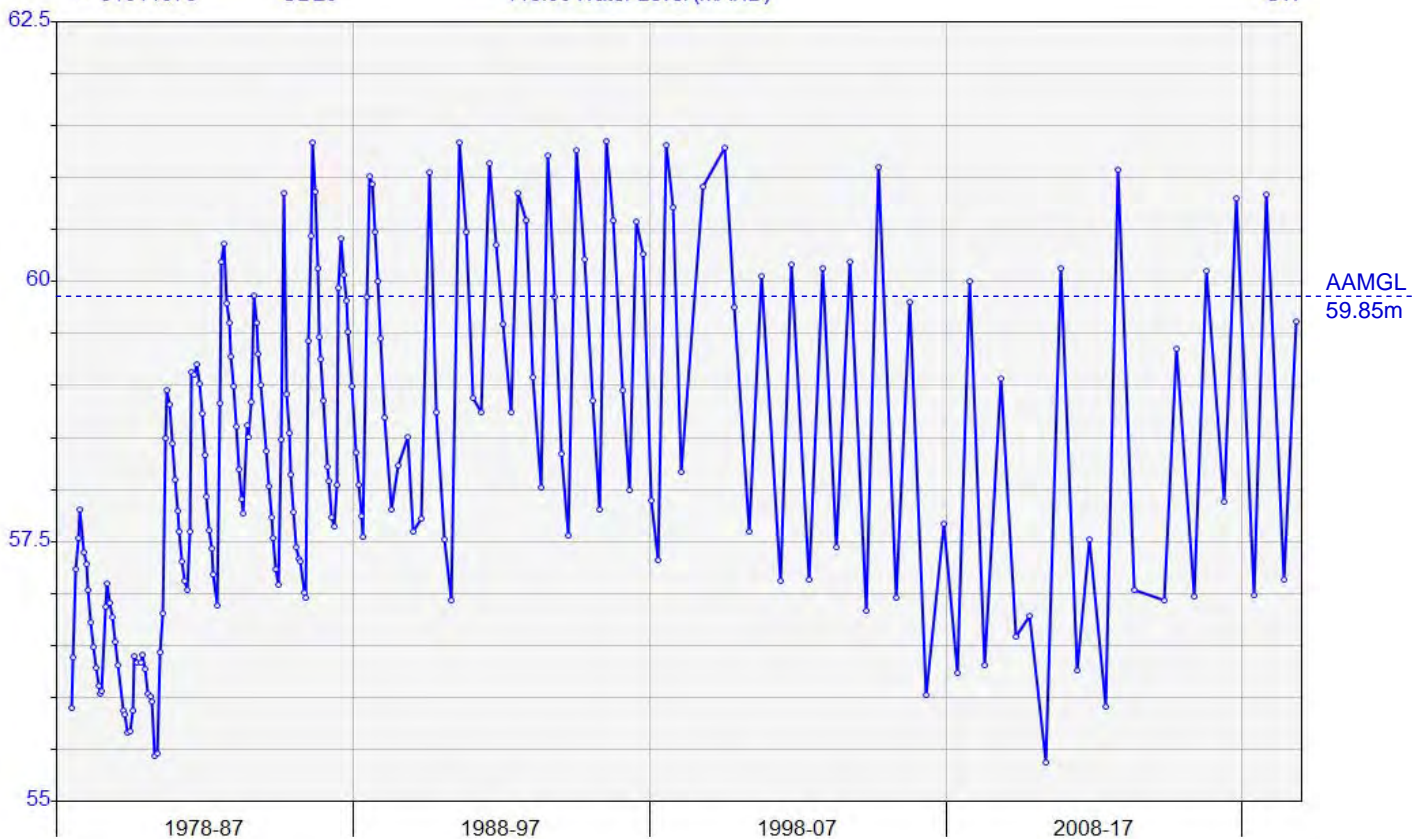
Figure 7

DWER BORE
HYDROGRAPHS

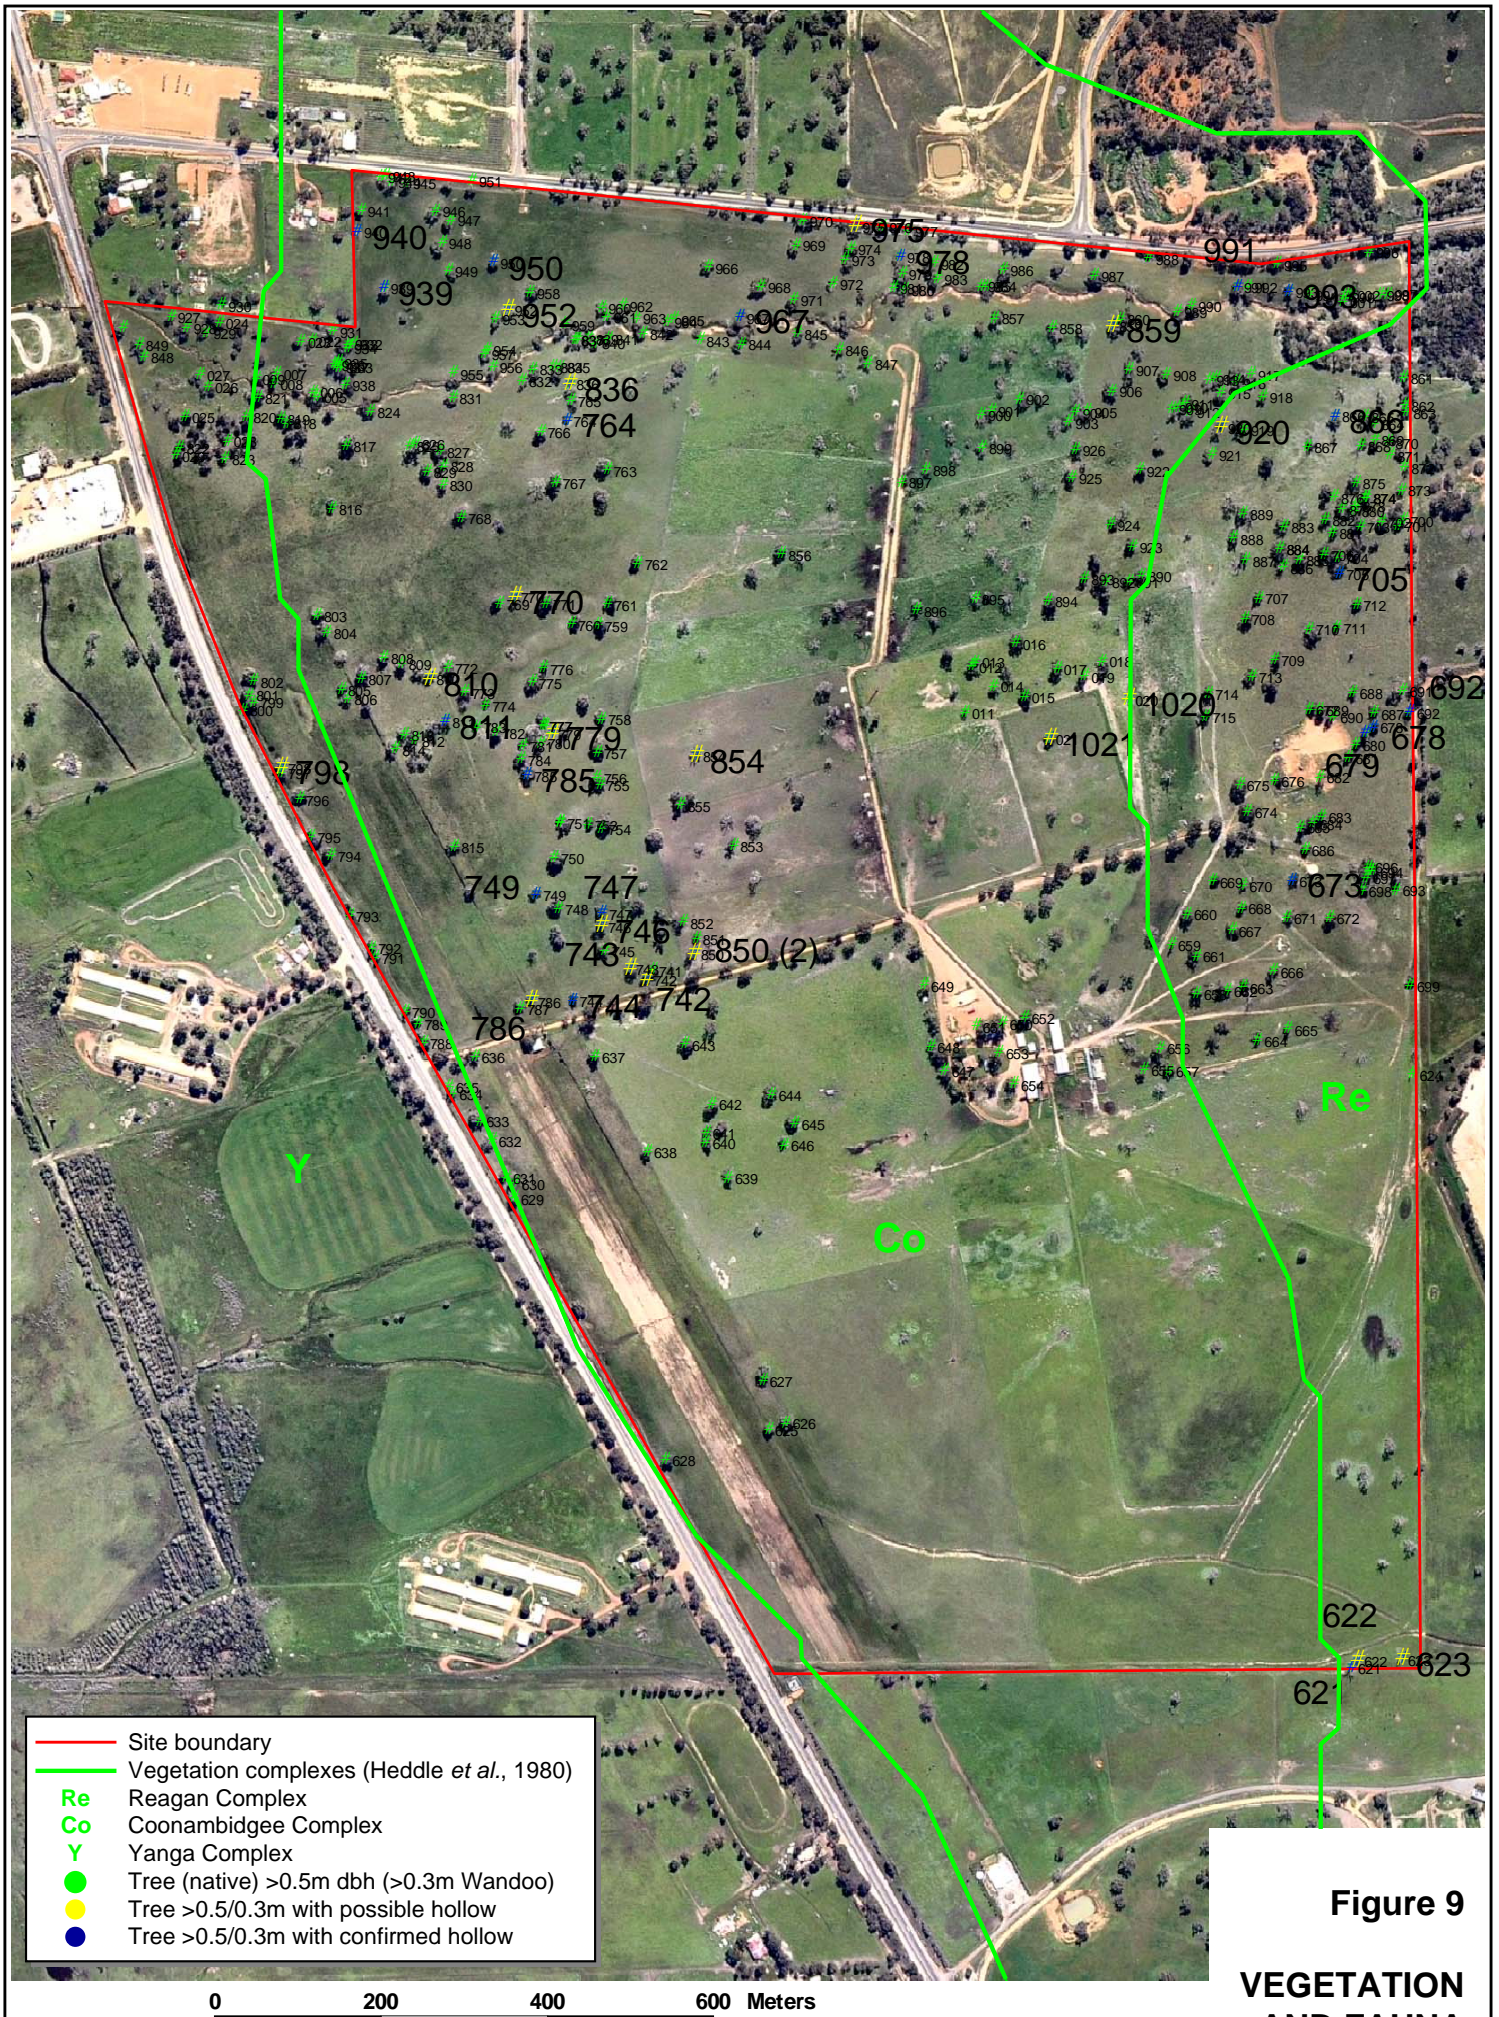
Figure 9

VEGETATION AND FAUNA
