# Environmental Assessment Report

## Chandala Battery Energy Storage System

### Accenture Australia Pty Ltd

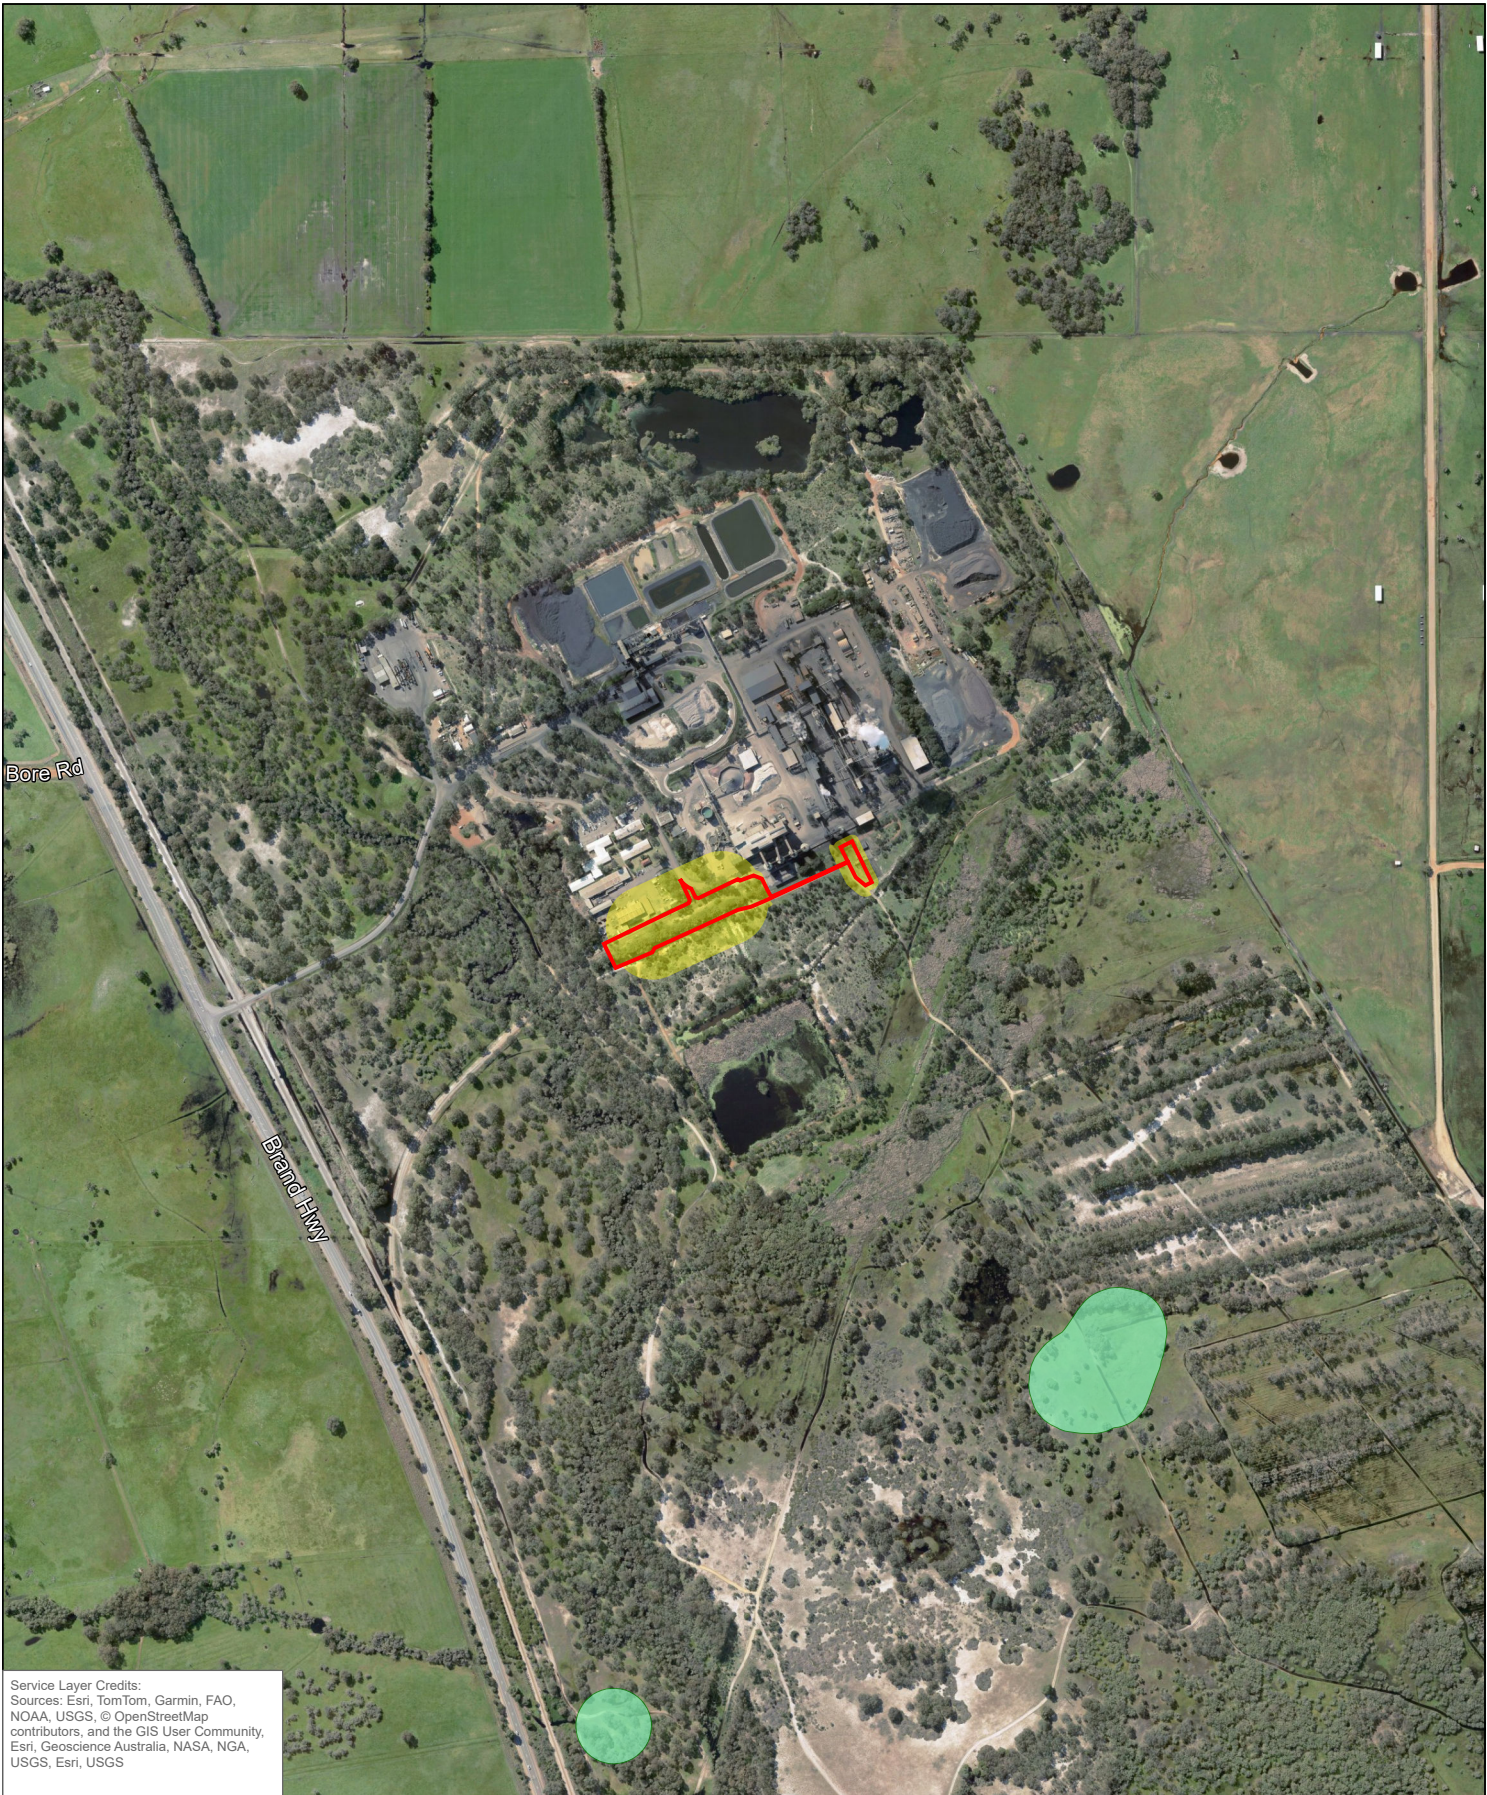
**Figure 2 - Site Concept Plan**  
Lot 1261 (No. 722) Old Gingin Road, Muchea

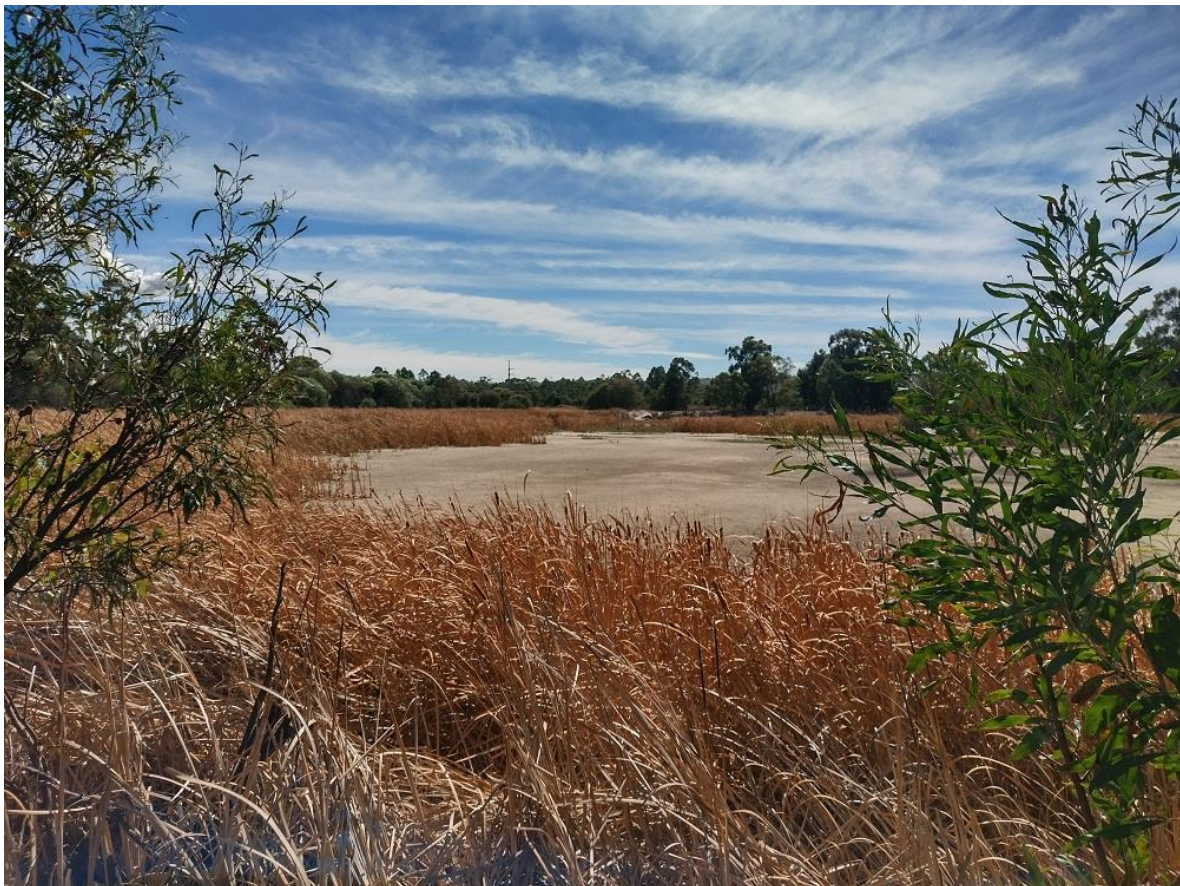
*Plate 14 Stormwater Pond 1 with extensive beds of Bulrush Typha sp. Photo credit: M. Bamford.*

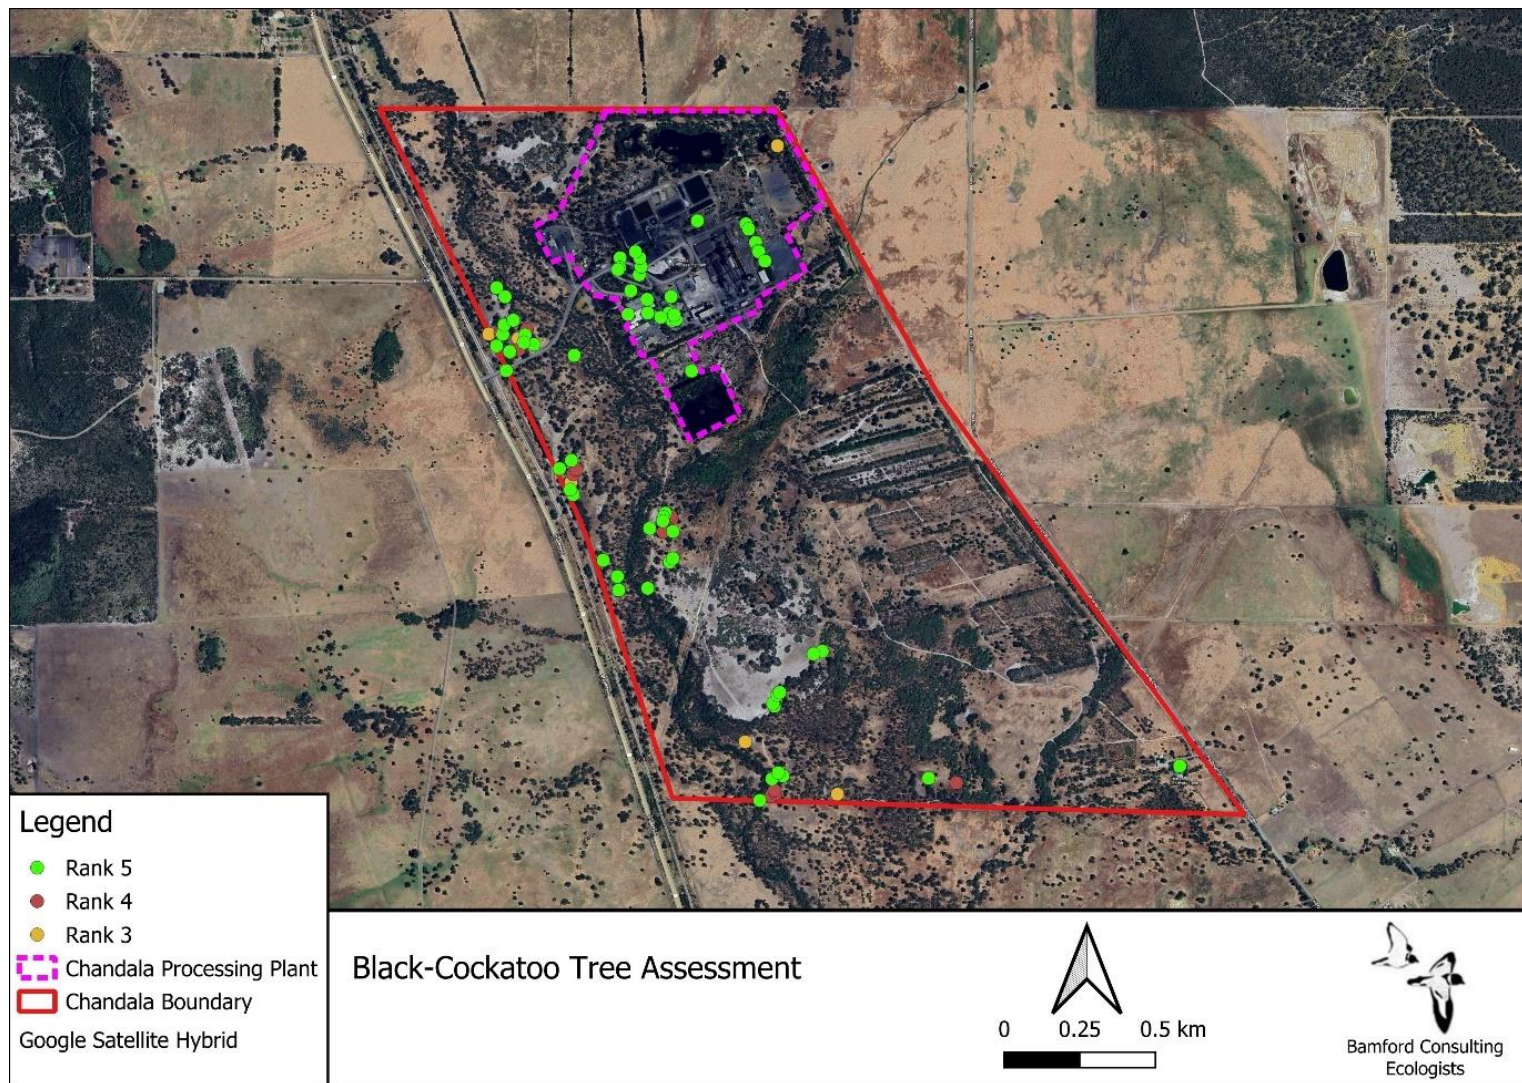
Figure 4 Black-cockatoo tree assessment. Trees recorded within survey area with DBH > 500mm and ranked according to BCE Black-Cockatoo scoring system in Table 1.

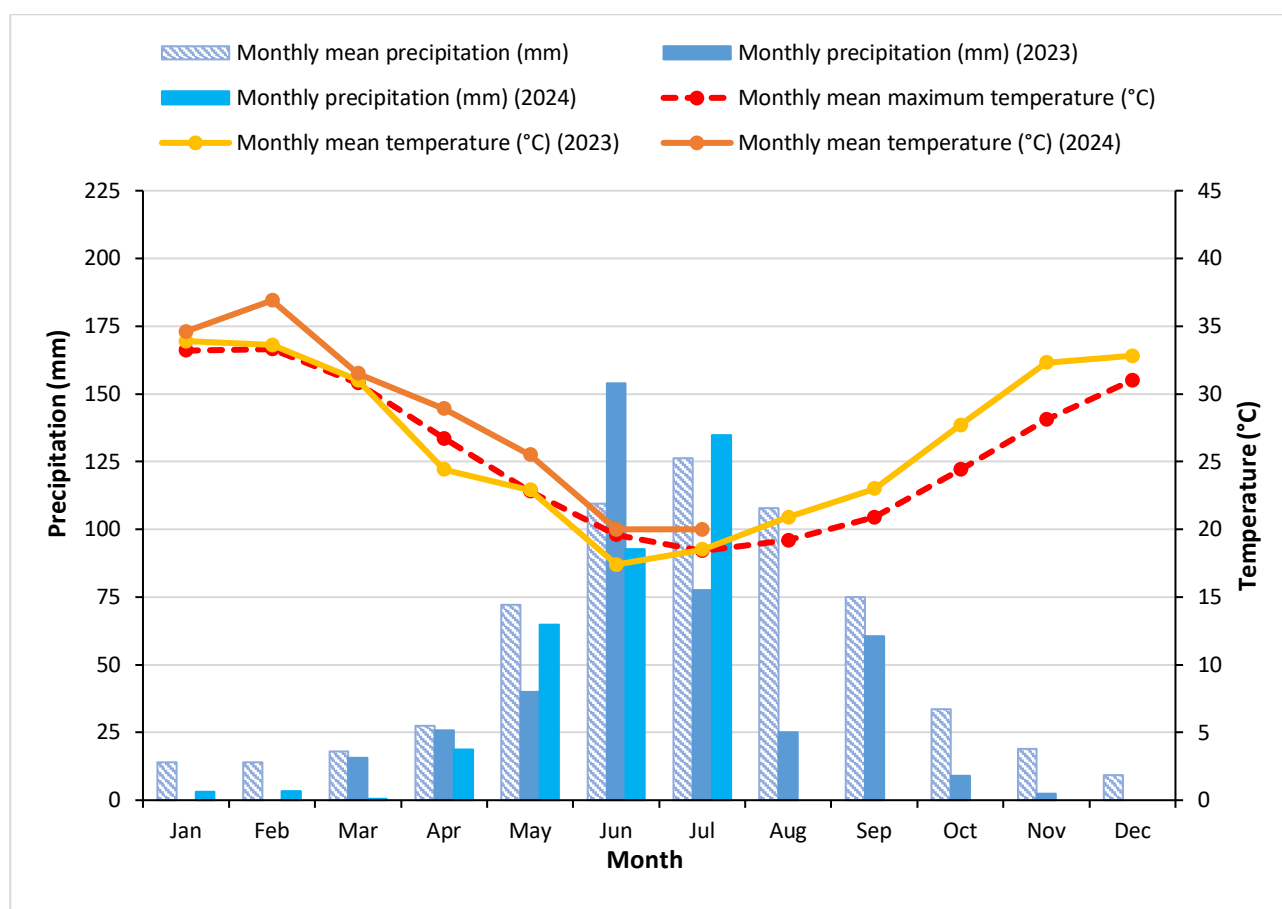
**Graph 2.1** Temperature and Precipitation for Gingin Aero (BoM, 2024)

**Graph 2.1** presents monthly precipitation totals and monthly maximum temperature statistics for 2023–2024, as well as long-term average monthly precipitation and maximum temperature data recorded at Bureau of Meteorology (BoM) Gingin Aero station (station number: 9178; data from 1968–2024) (BoM, 2024), the most relevant meteorological station to the Survey Area with long-term climate data. Gingin receives an annual average of 611.1 mm of rainfall, the majority of which occurs from June to August. Long-term average monthly maximum temperatures generally peak from December to March (31 °C to 33 °C). The rainfall received in the months prior to survey (April to July) was slightly below average (311 mm compared to the long-term average of 335 mm); daily maximum temperatures from January to July 2024 were slightly above the long-term averages.

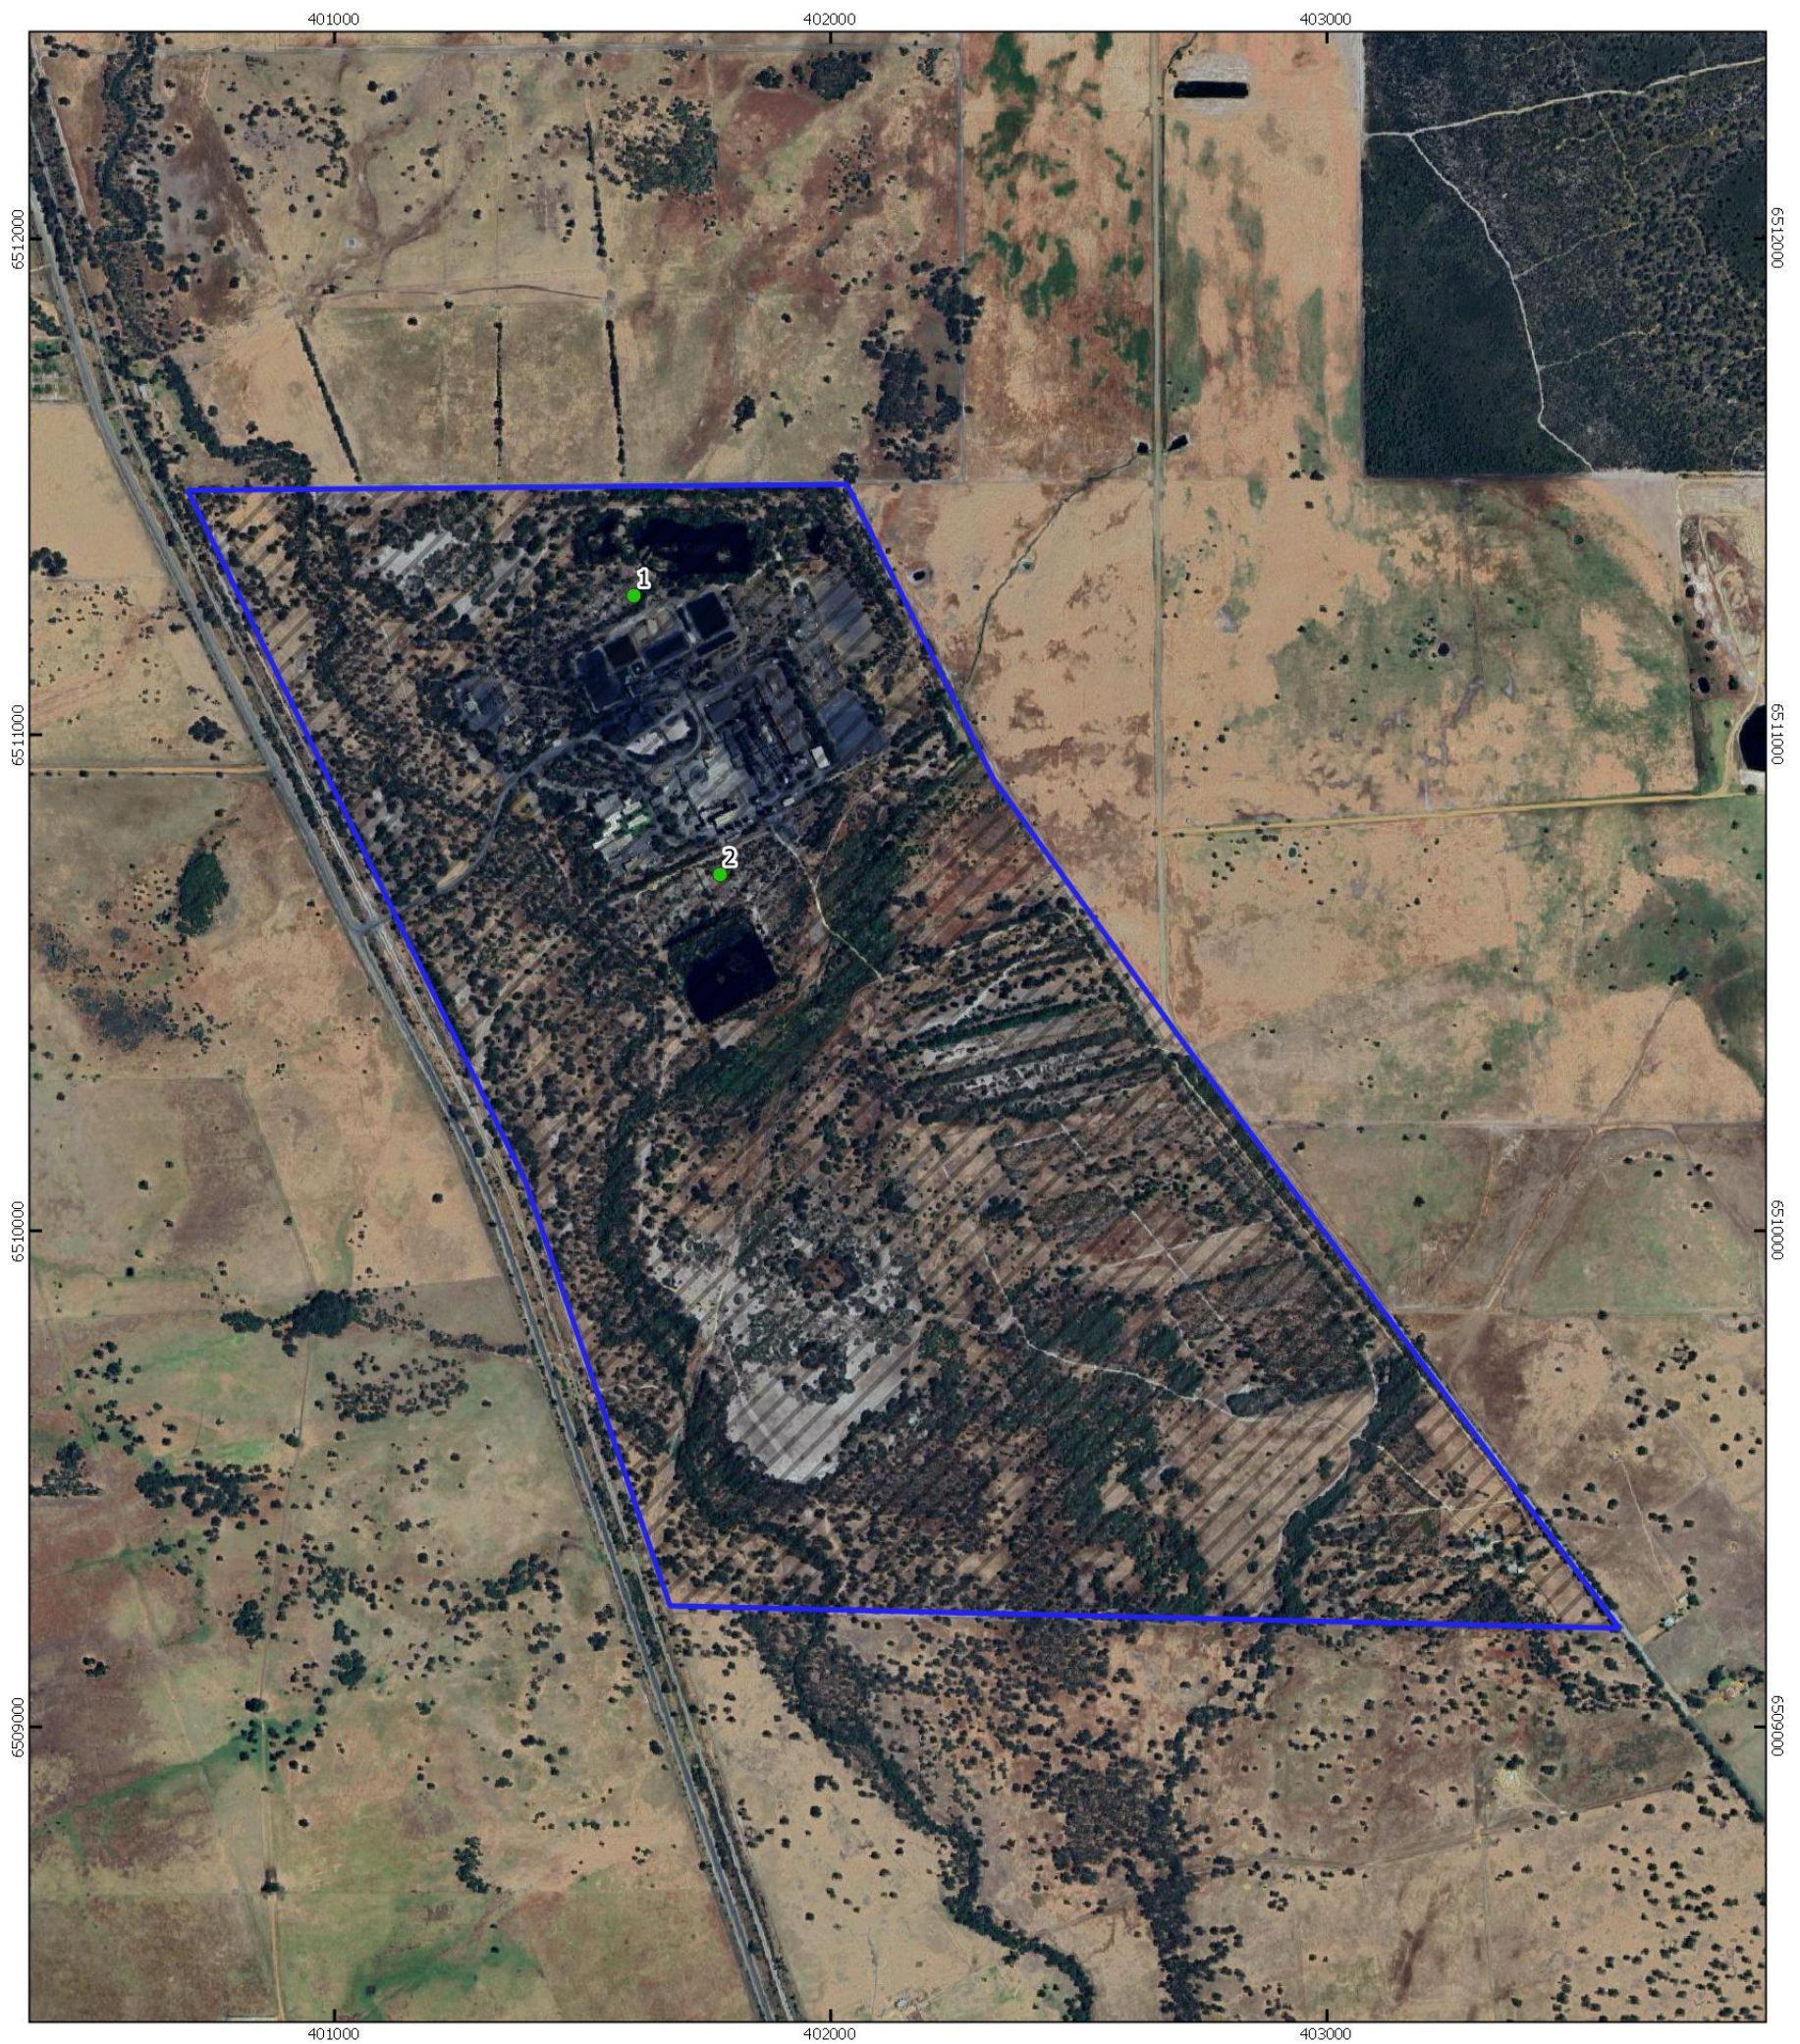
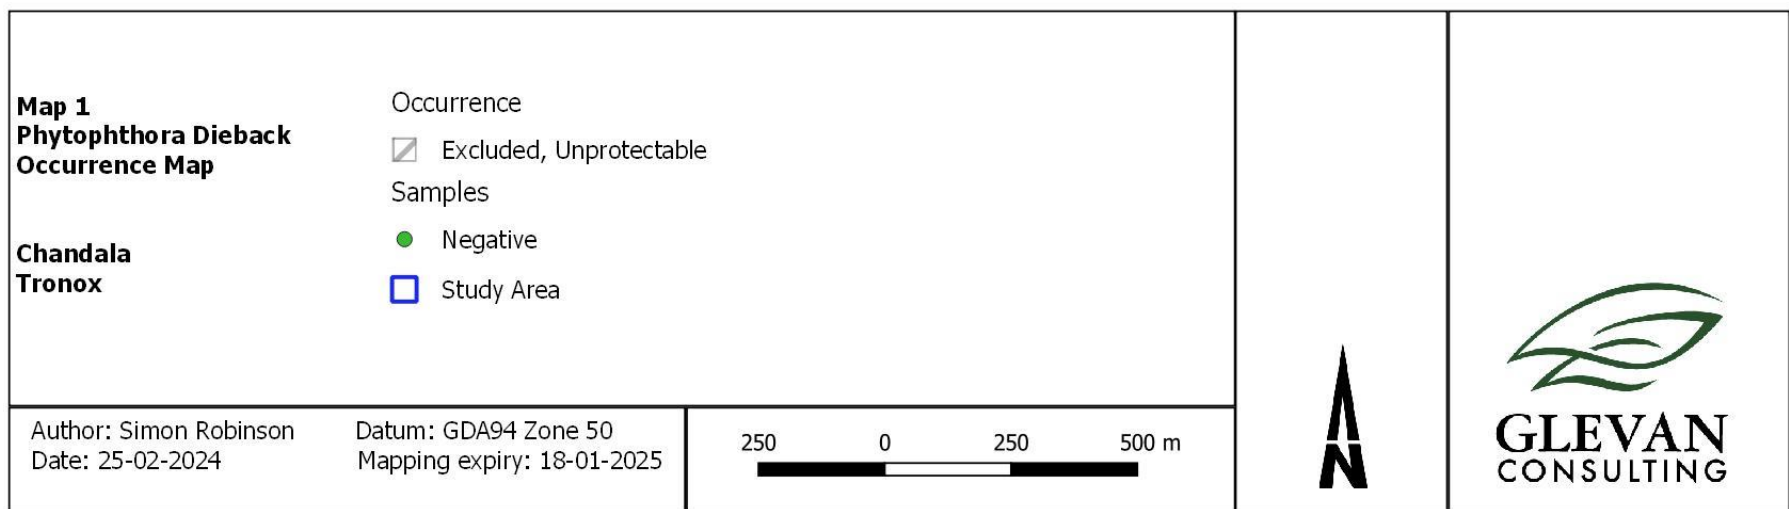
Figure 2 - Phytophthora Dieback Occurrence Map

Phytophthora Dieback is a dynamic disease with autonomous spread of the pathogen not expected to be more than three metres a year upslope in average conditions. In unusual circumstances, such as heavy spring, summer or autumn rainfall, the spread of the disease may be rapid and breach the buffers. These buffers however provide the best chance of hygienic operating conditions within protectable areas over a set twelve-month period. The information on Phytophthora occurrence maps then becomes obsolete.

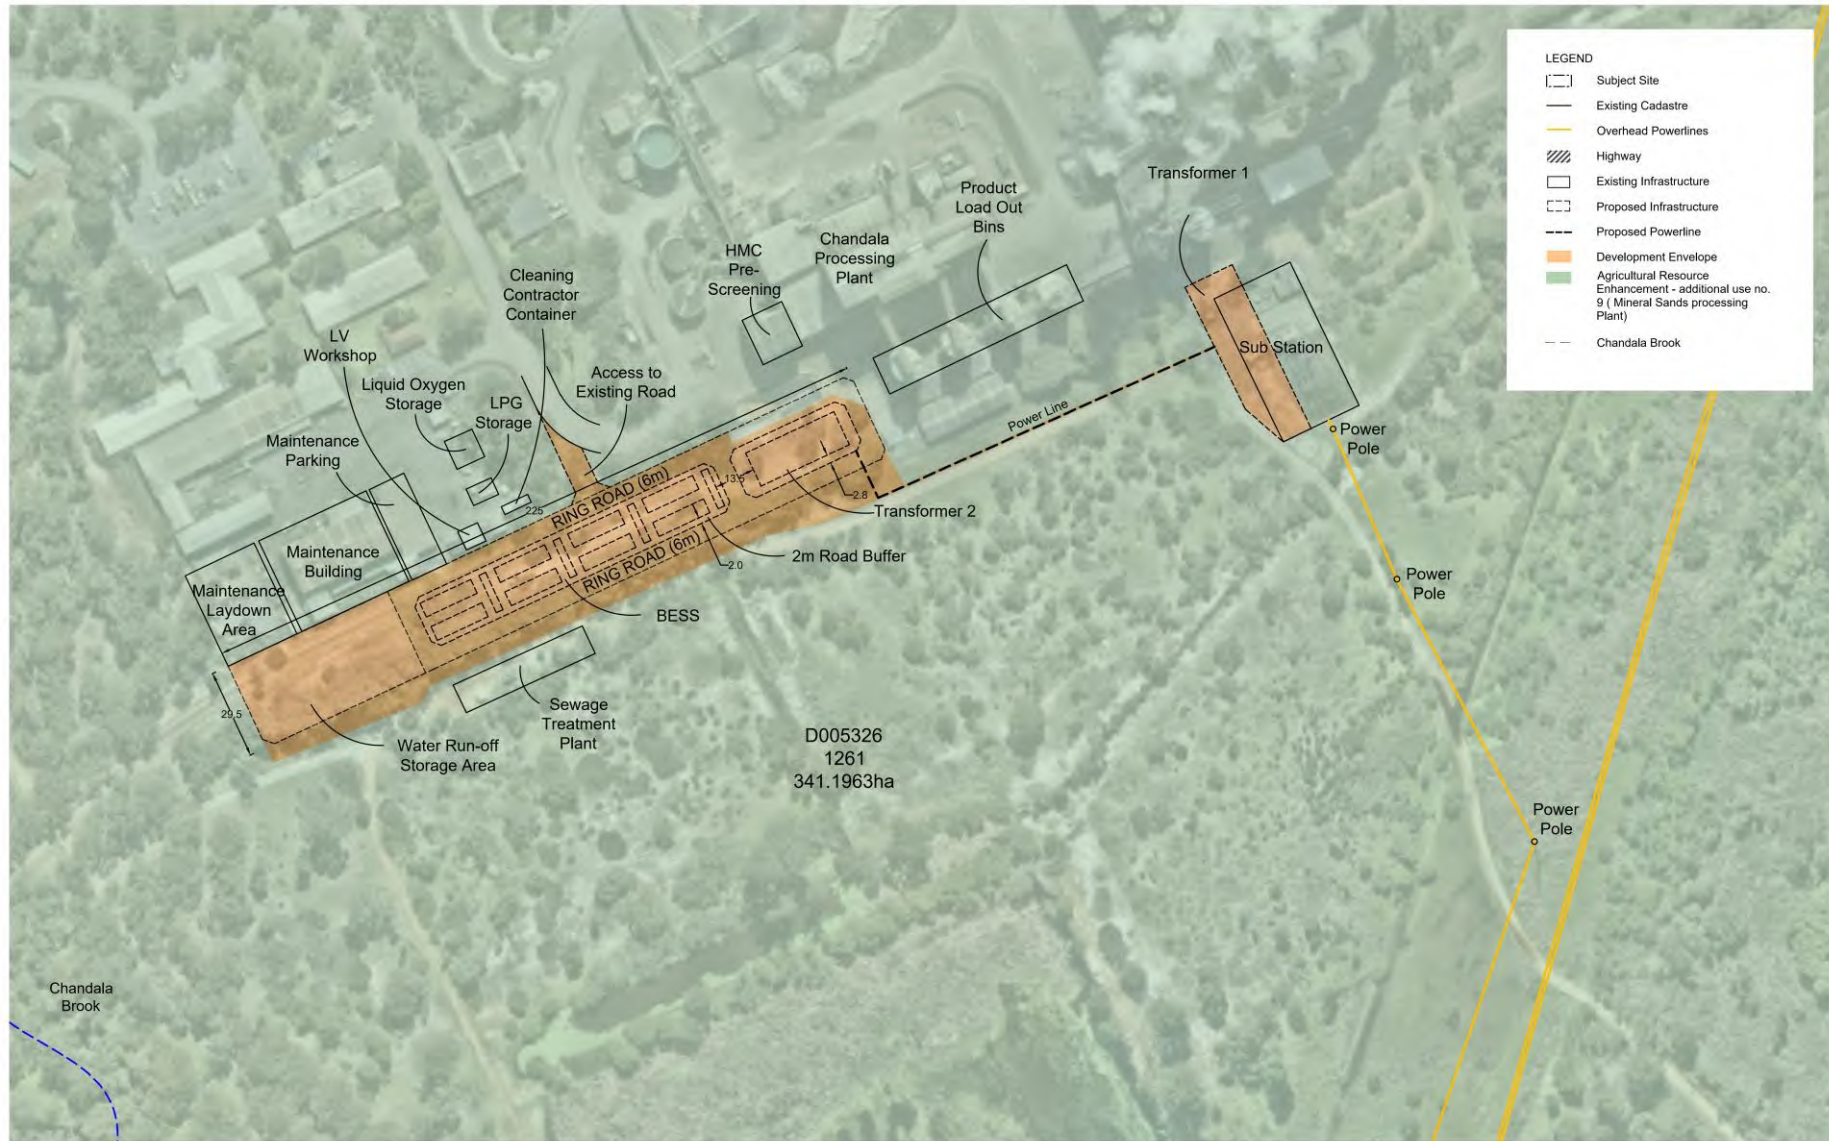
Figure 1-1. Development Layout

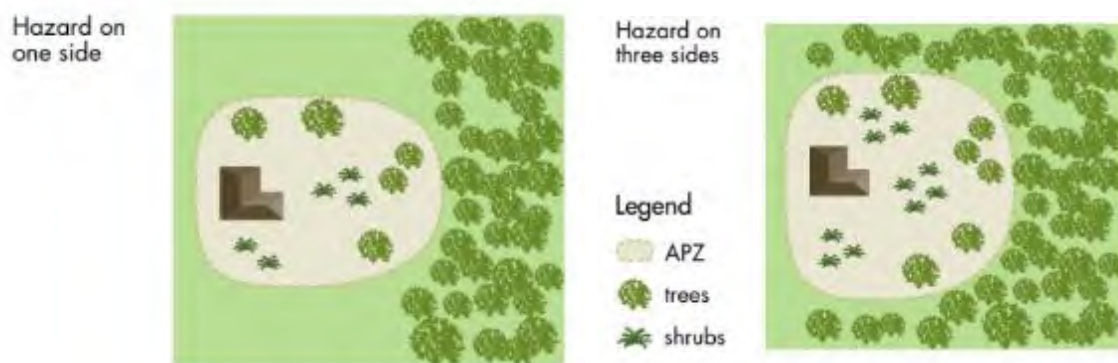
Figure 25: Design of an Asset Protection Zone
