**DEVELOPMENT SERVICES ATTACHMENTS
ORDINARY MEETING OF COUNCIL
WEDNESDAY 19 MARCH 2025**

Development Application

Proposed Short Stay Chalets

Lot 28 (No. 2178) Chittering Road,
Lower Chittering

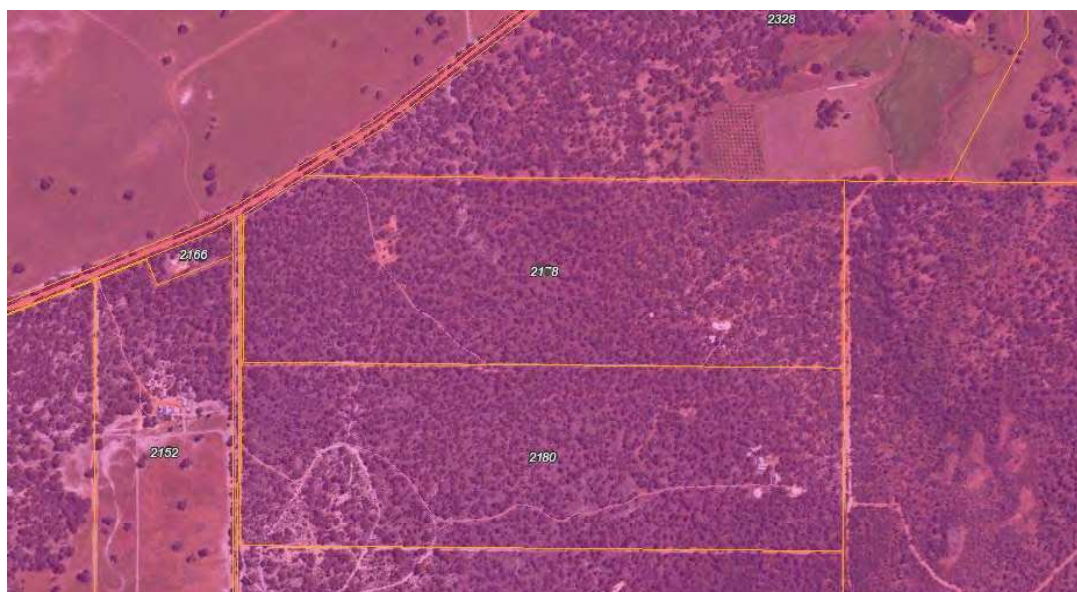
Figure 5 Bushfire Prone Mapping

Section 5.5 of the *Guidelines for Planning in Bushfire Prone Areas*, indicates that development in tourism or recreational land use which involve visitors who are unfamiliar with the surroundings and/or where they present evacuation challenges are identified as *Vulnerable Land-uses*. Given the proposal of short stay accommodation, the development is considered to be a vulnerable land use, which requires the preparation of a Bushfire Emergency Plan (BEP) in addition to a Bushfire Management Plan (BMP).

Given that Lot 28 has been identified as bushfire prone, *Bushfire Prone Planning* have been appointed to coordinate and prepare a Bushfire Management Plan (BMP) and Bushfire Emergency Plan (BEP). A copy of the BMP and associated BEP is attached at **Appendix C**.

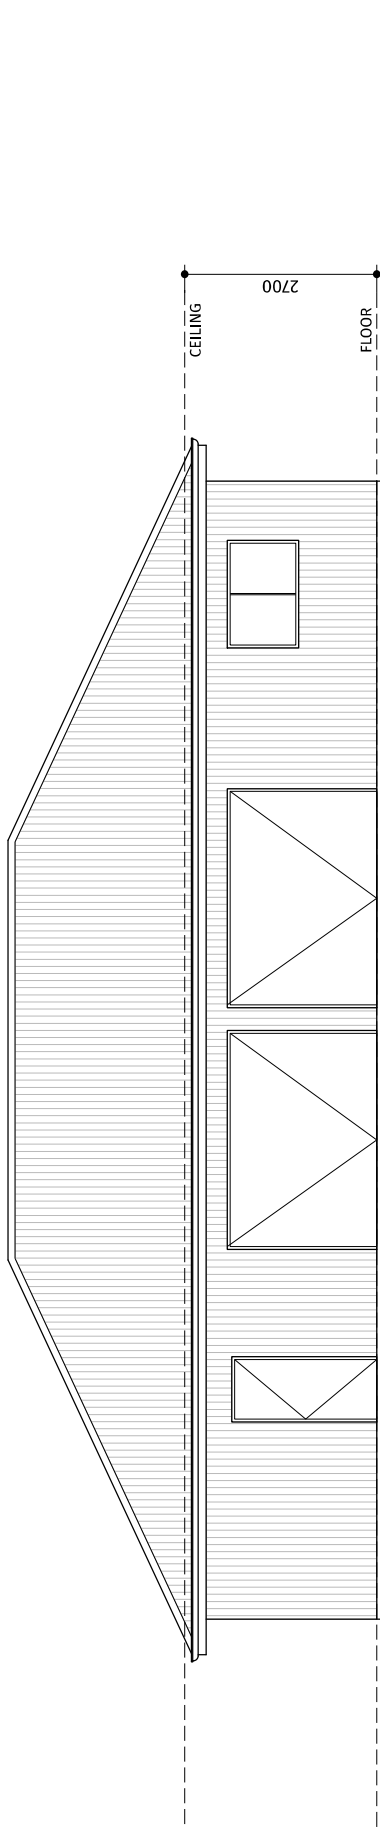
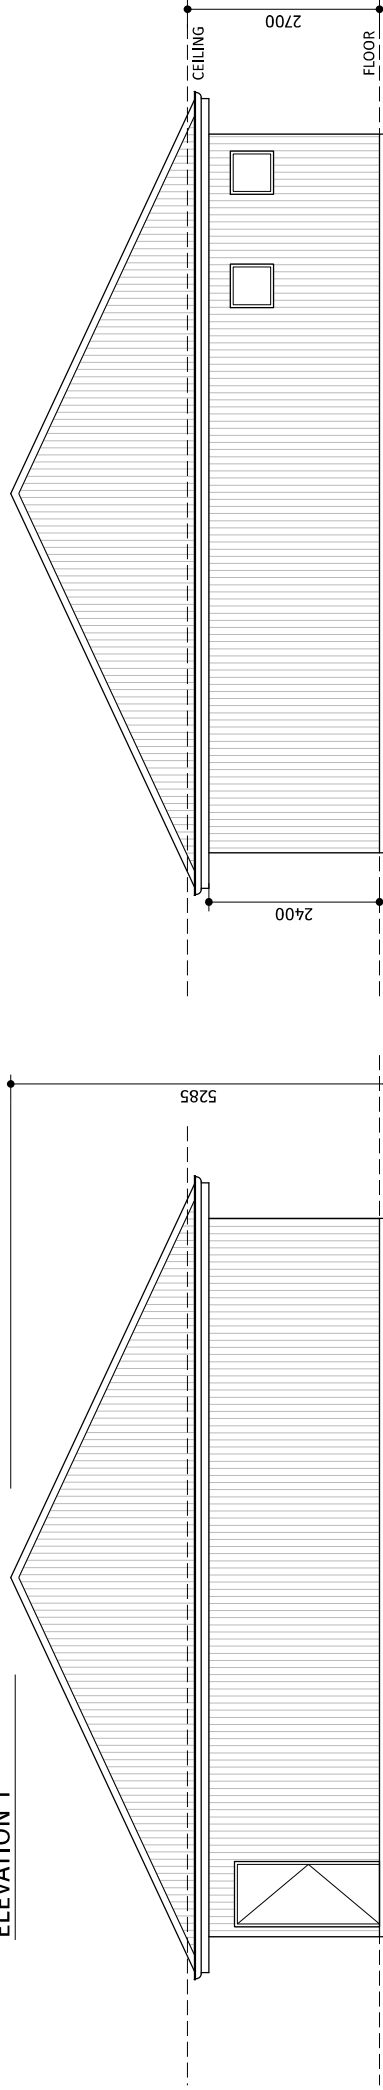
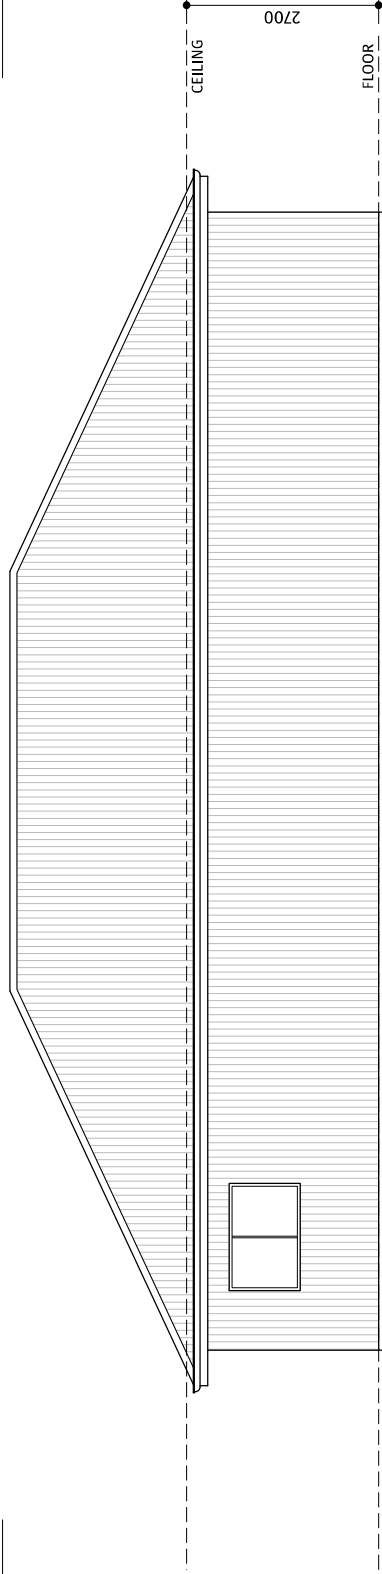
ELEVATION 1

ELEVATION 2

ELEVATION 4

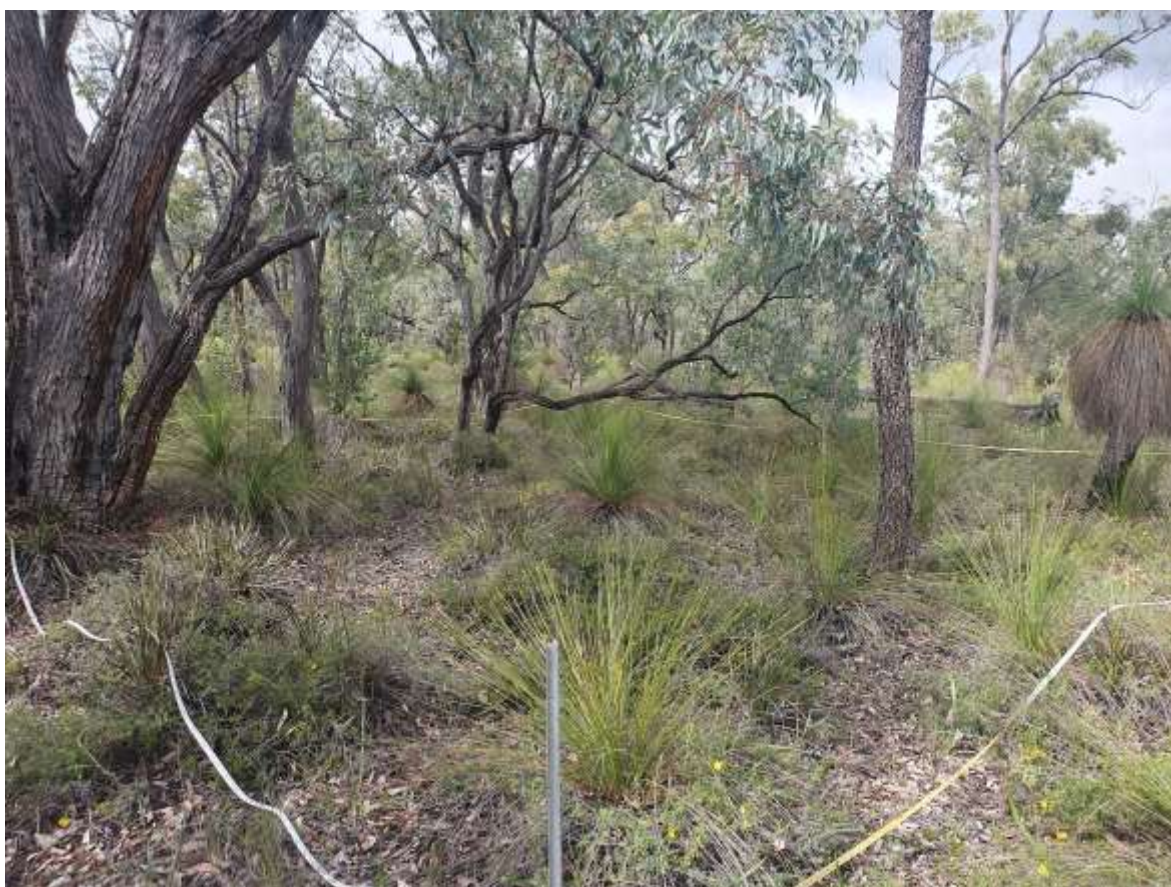
FIELD SHEET – FLORA AND VEGETATION SURVEY

Job Code: 2178 Chittering Rd, Chittering	Date: 05/09//2023	Site: Q1
GPS Datum: (50) 0415213 6509272	Topography: Flat	Litter cover: 30 % twigs, 40 % leaves 10% logs
Age since fire: >10 yrs	Disturbance: Hi Med Lo	Soils: Clay/Loam/Gravel (brown/orange)
Vegetation Description: Jarrah – Marri Woodland		
Vegetation Condition: Very Good		
Observations: No weeds, bush in very good condition

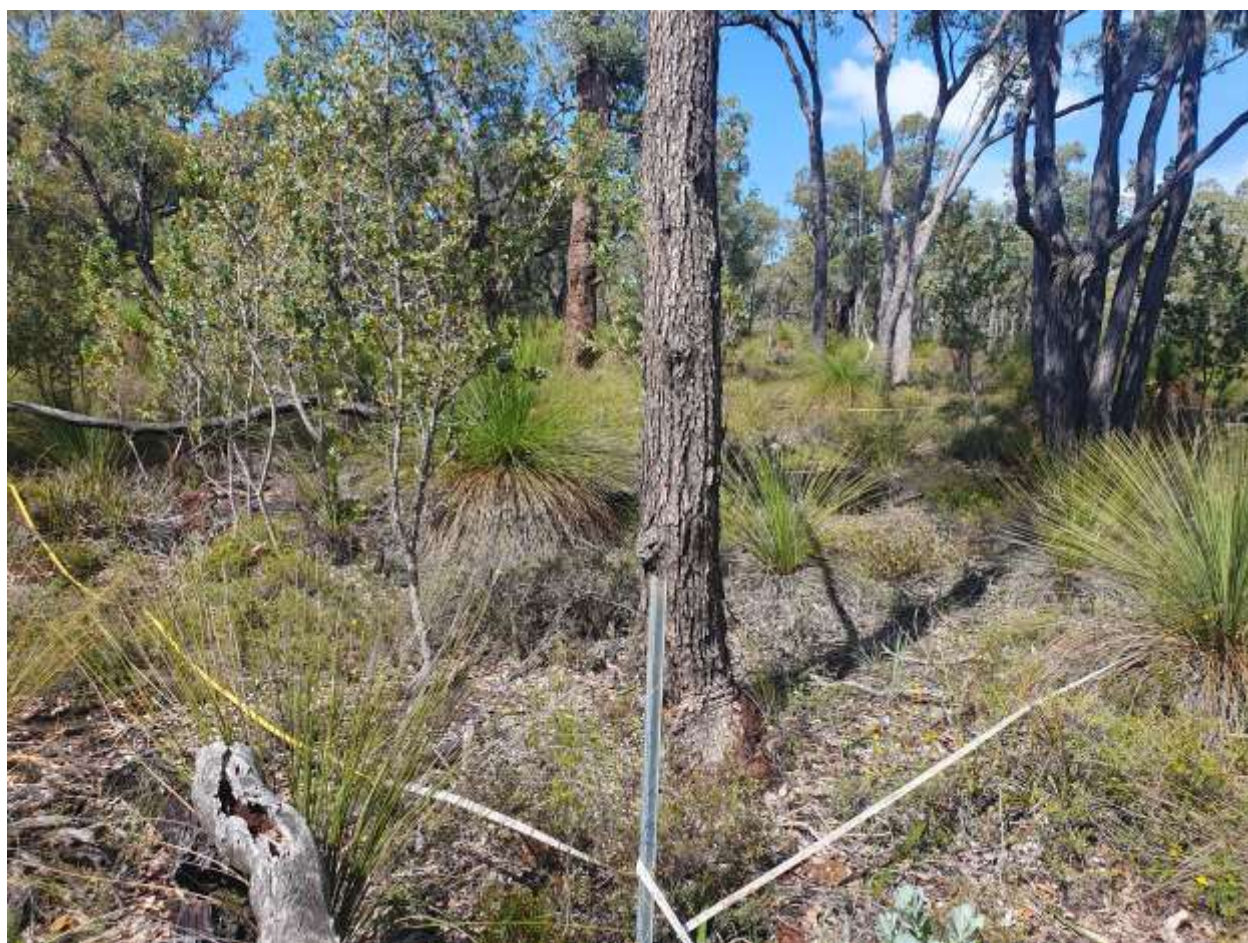
FIELD SHEET – FLORA AND VEGETATION SURVEY

Job Code: 2178 Chittering Rd, Chittering	Date: 05/09//2023	Site: Q2
GPS Datum: (50) 0415292 6509303	Topography: Upper slope	Litter cover: 20 % twigs, 40 % leaves 20% logs
Age since fire: >10 yrs	Disturbance: Hi Med Lo	Soils: Clay/Loam/Gravel (brown/orange)
Vegetation Description: Jarrah – Marri Woodland		
Vegetation Condition: Very Good		
Observations: Bush in very good condition, historic logging

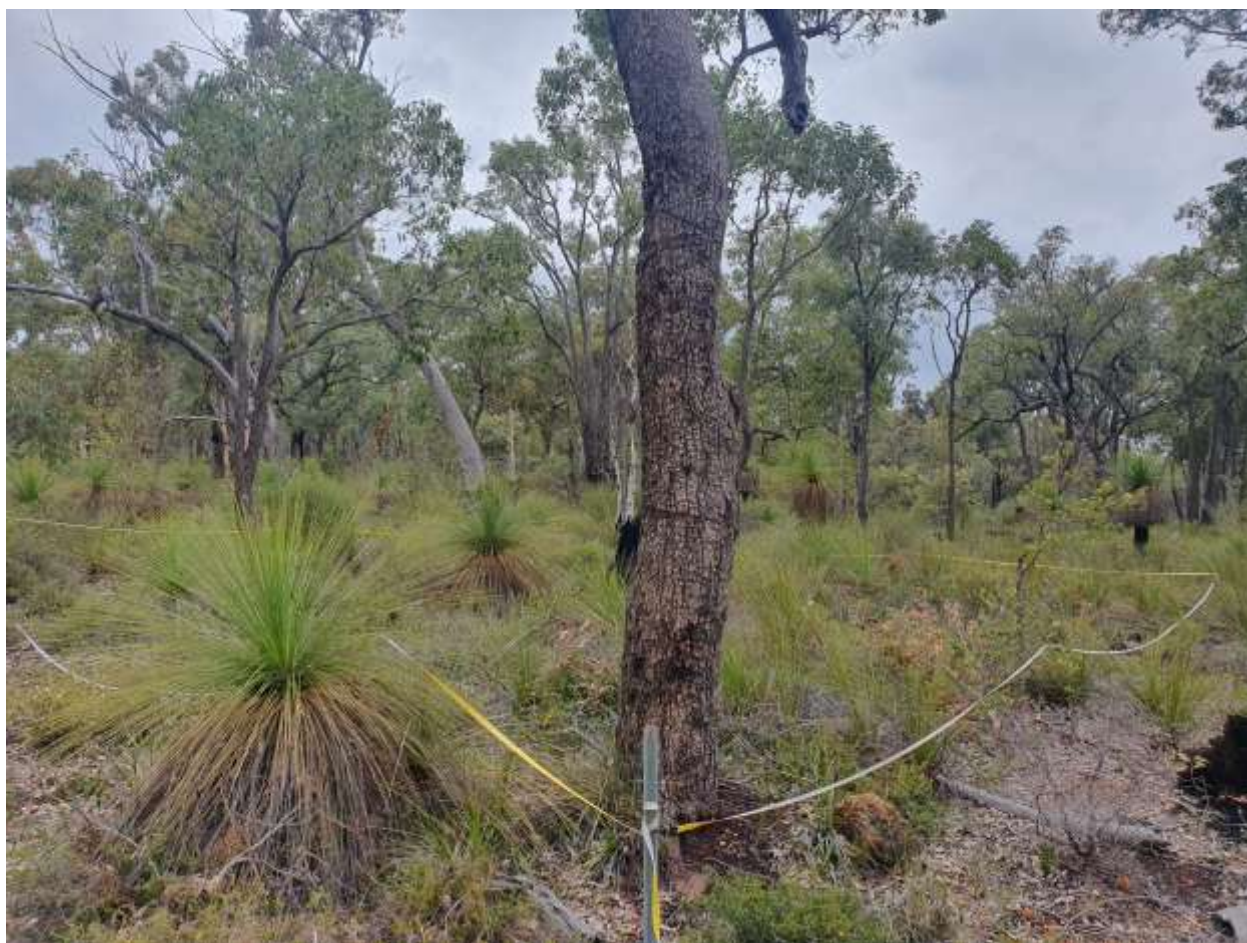
FIELD SHEET – FLORA AND VEGETATION SURVEY

Job Code: 2178 Chittering Rd, Chittering	Date: 05/09//2023	Site: Q3
GPS Datum: (50) 0415346 6509179	Topography: Flat	Litter cover: 20 % twigs, 50 % leaves 10% logs
Age since fire: >10 yrs	Disturbance: Hi Med Lo	Soils: Clay/Loam/Gravel (brown/orange)
Vegetation Description: Jarrah – Marri Woodland		
Vegetation Condition: Very Good		
Observations: Bush in very good condition

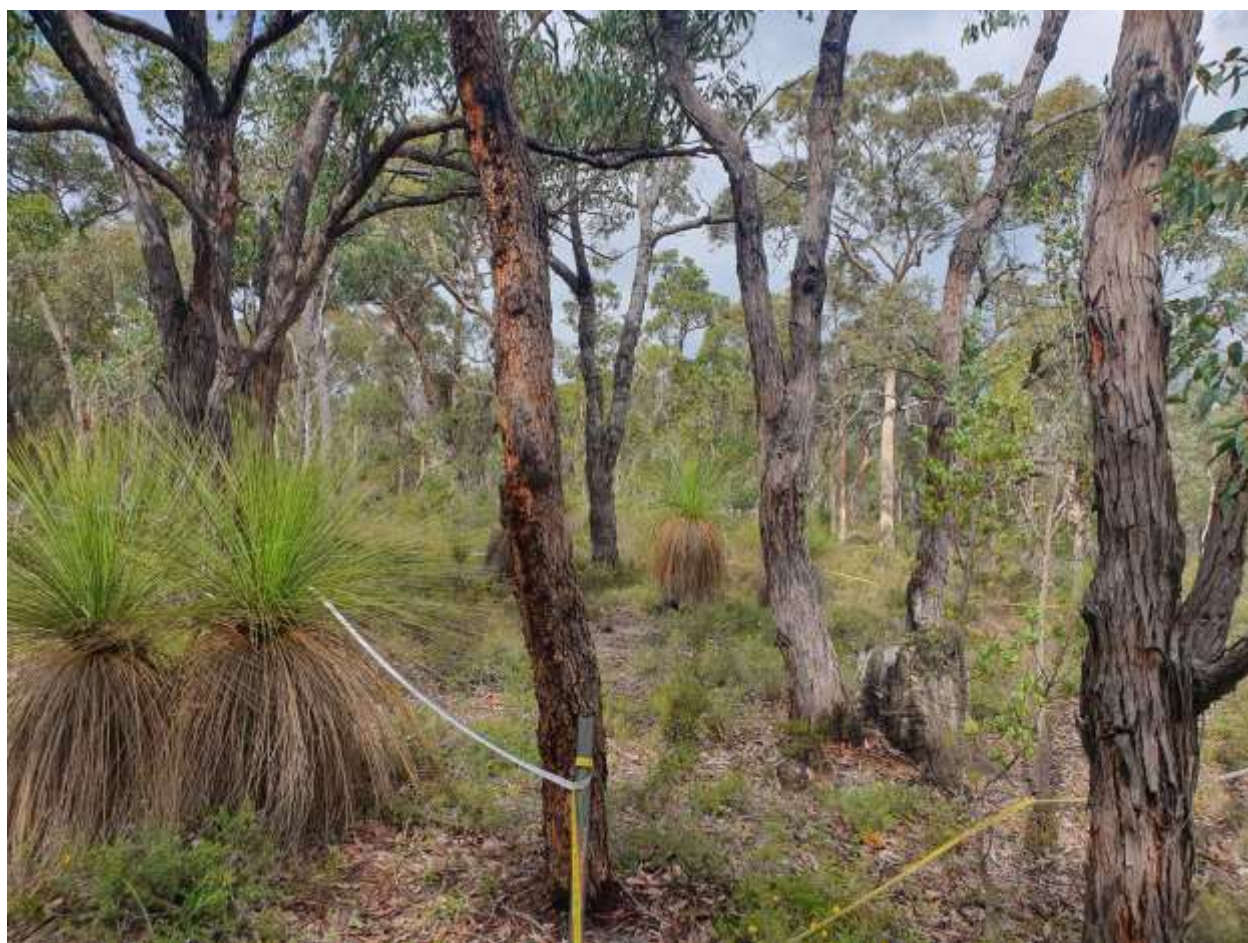
FIELD SHEET – FLORA AND VEGETATION SURVEY

Job Code: 2178 Chittering Rd, Chittering	Date: 05/09//2023	Site: Q4
GPS Datum: (50) 0415591 6509149	Topography: Upper slope	Litter cover: 30 % twigs, 60 % leaves 10% logs
Age since fire: >10 yrs	Disturbance: Hi Med Lo	Soils: Clay/Loam/Gravel (brown/orange)
Vegetation Description: Jarrah – Marri Woodland		
Vegetation Condition: Very Good		
Observations: Bush in very good condition, historic logging. Transition to Powderbark

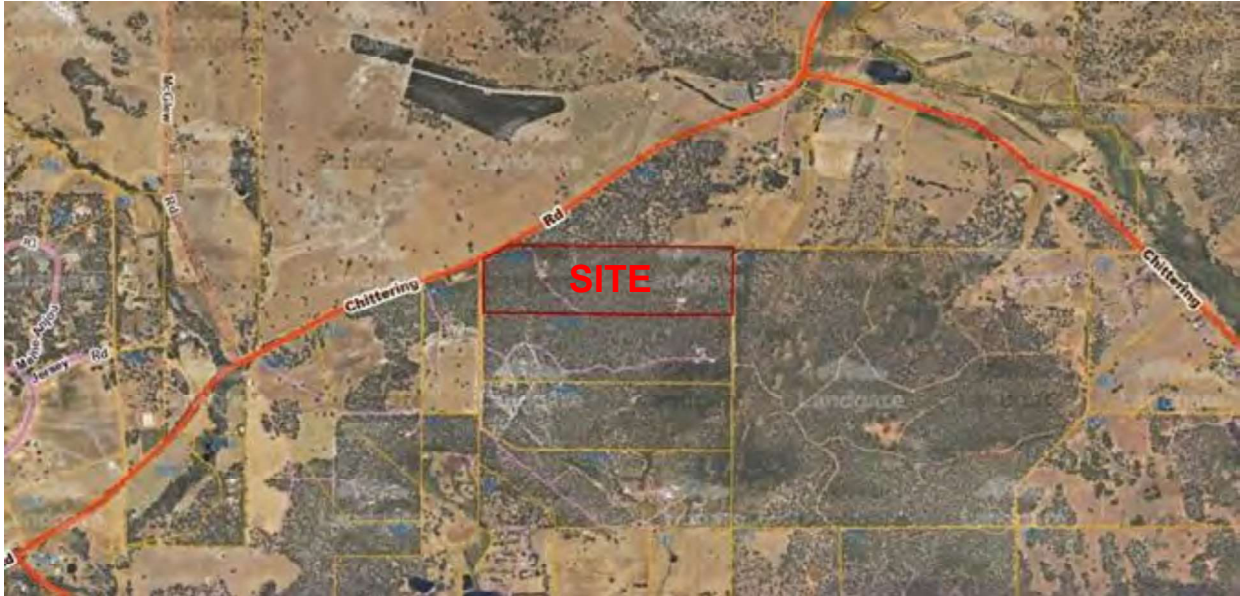
Figure 1. Aerial View of the Site Location (Source: Landgate Map)

Conrad Moller commissioned Local Geotechnics (LG) to prepare a Site Soil Evaluation report for 2178 Chittering Road, Lower Chittering WA (the project). The site location is shown in Figure 1. The area of the site is 35,298 m². The proposed construction a septic system or effluent system for residential development, the site plan is attached in Appendix A.

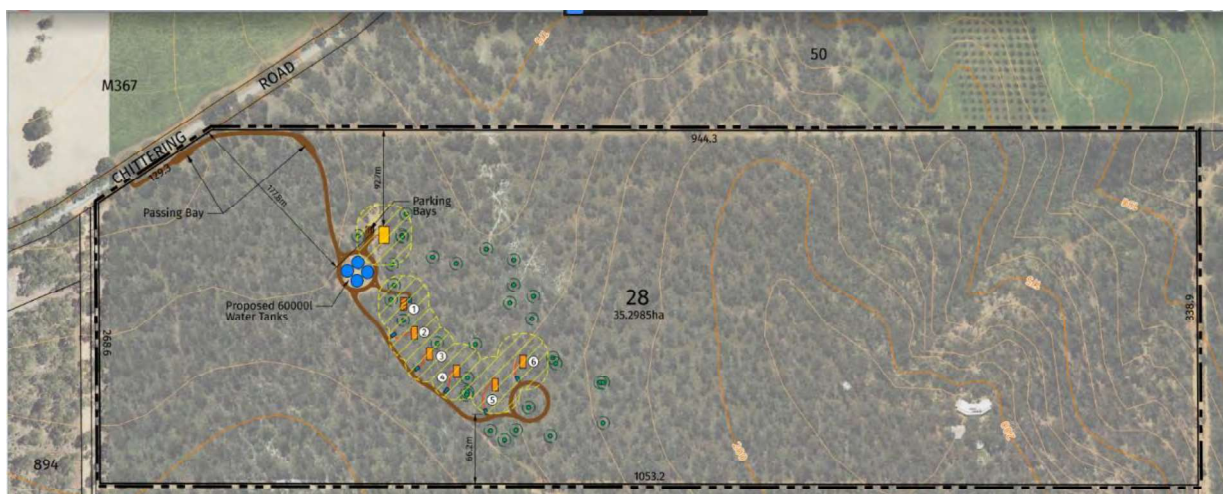
Figure 7. Site plan (LAA can be next to each unit)

A plan of the site is shown in Figure 7. If decomposed unit is installed, which will be under the units and LAA can be next to the unit.

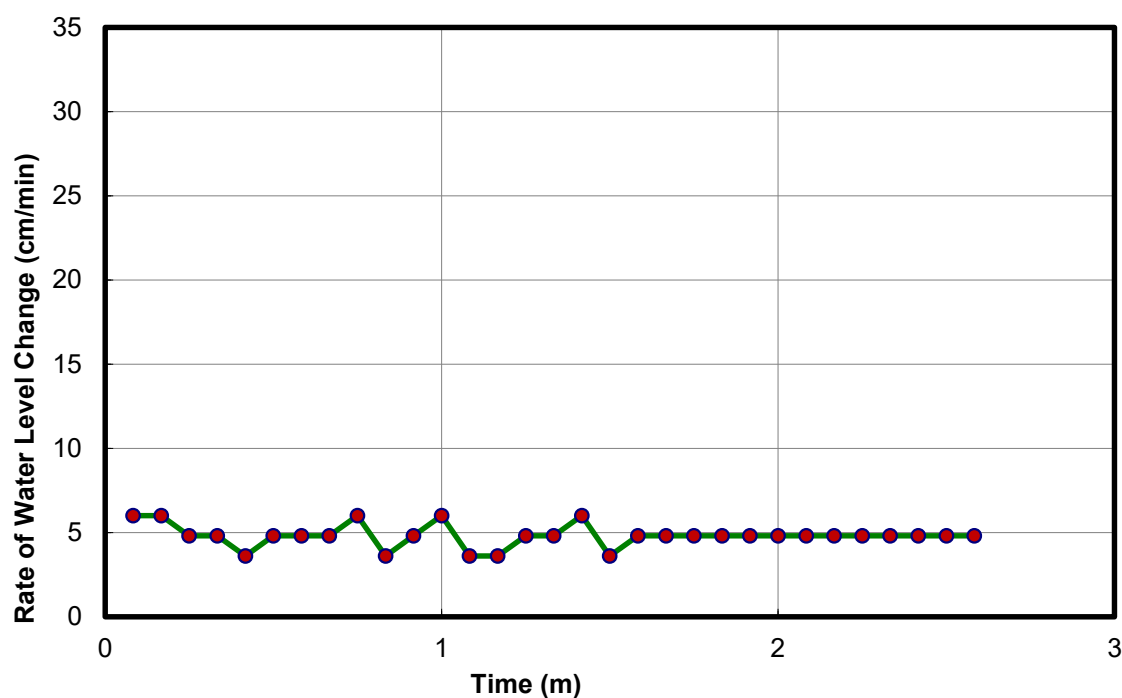
Reference	LG2852023SSE	Test ID	FPT1
Client	Conrad Moller	Date Tested	4 September 2023
Project	Site Soil Evaluation	Date Completed	4 September 2023
Location	2178 Chittering Road, Lower Chittering WA	Instrument Type	Guelph Permeameter
Position	<div> <div> Northing: 6 509 282 </div> <div> Easting: 415 181 </div> </div>	Tested by	R Hai

Notes: Test was conducted at a depth of 0.3 m from the existing surface level

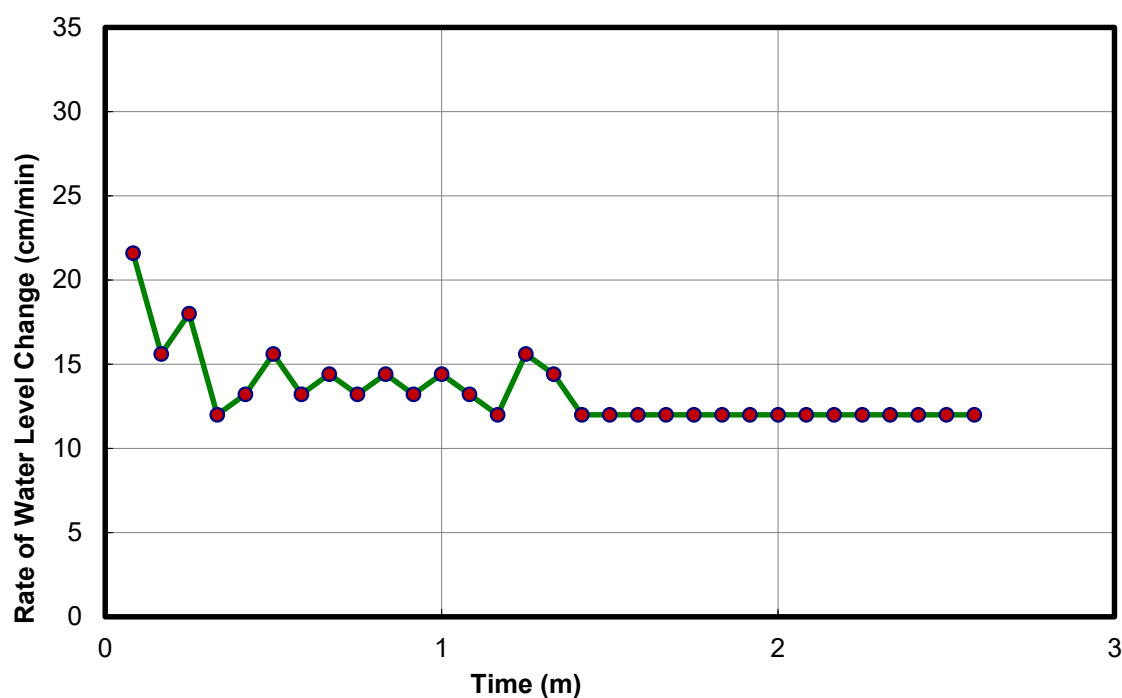
Reference	LG2852023SSE		Test ID	FPT2
Client	Conrad Moller		Date Tested	4 September 2023
Project	Site Soil Evaluation		Date Completed	4 September 2023
Location	2178 Chittering Road, Lower Chittering WA		Instrument Type	Guelph Permeameter
Position	Northing: 6 509 190	Easting: 415 346	Tested by	R Hai

Notes: Test was conducted at a depth of 0.3 m from the existing surface level

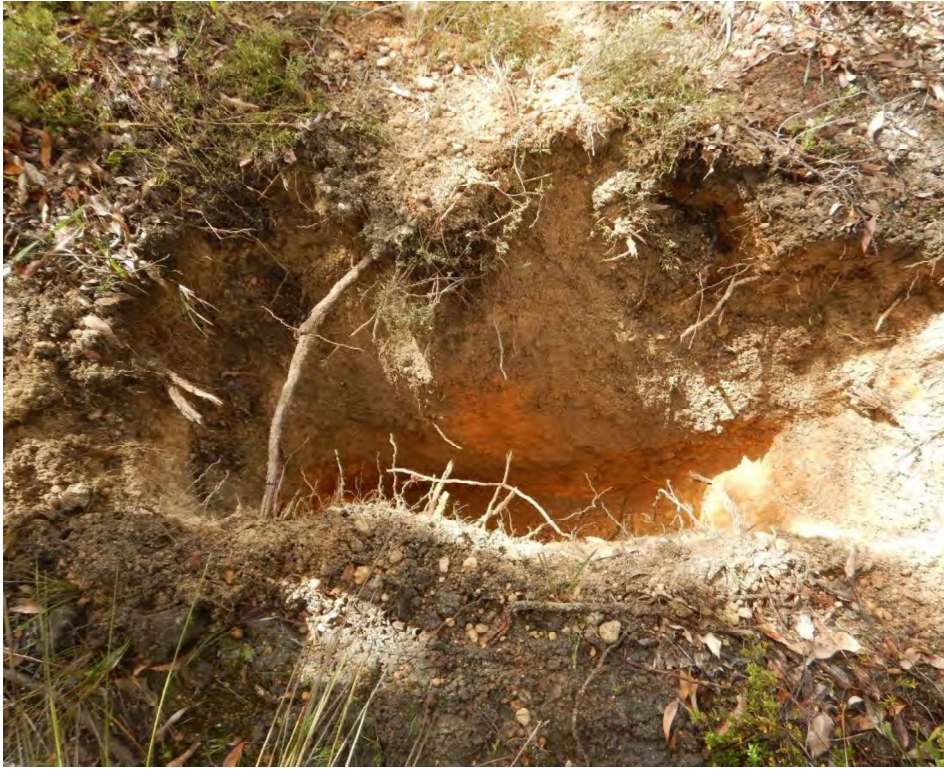
Photo 5. Soil Profile (TP1)

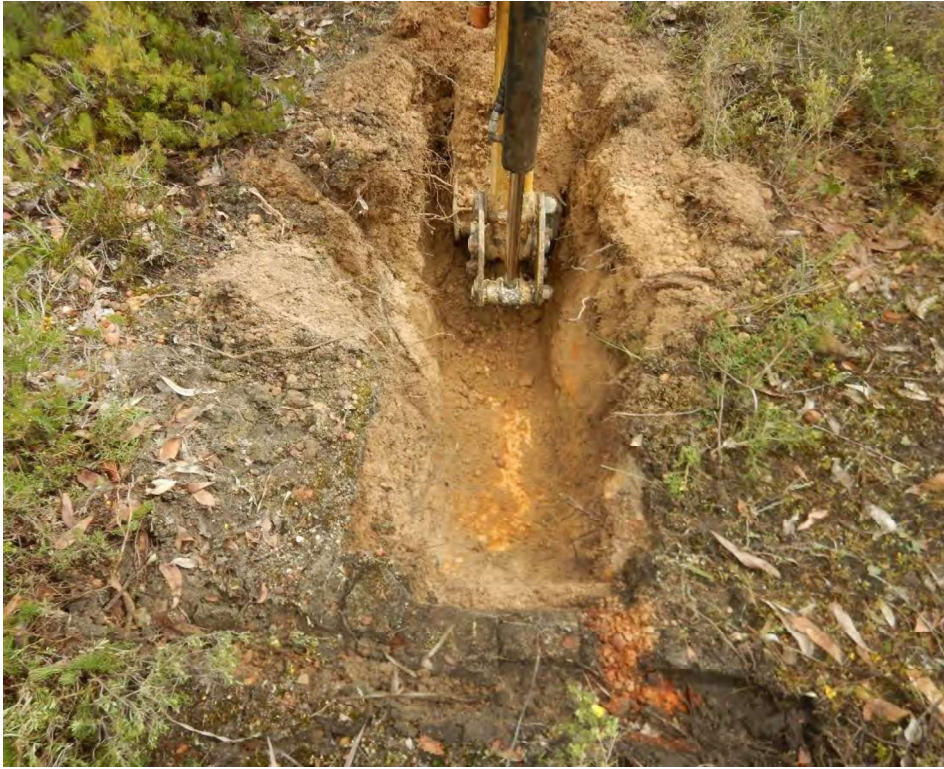
Photo 7. Soil Profile (TP3)

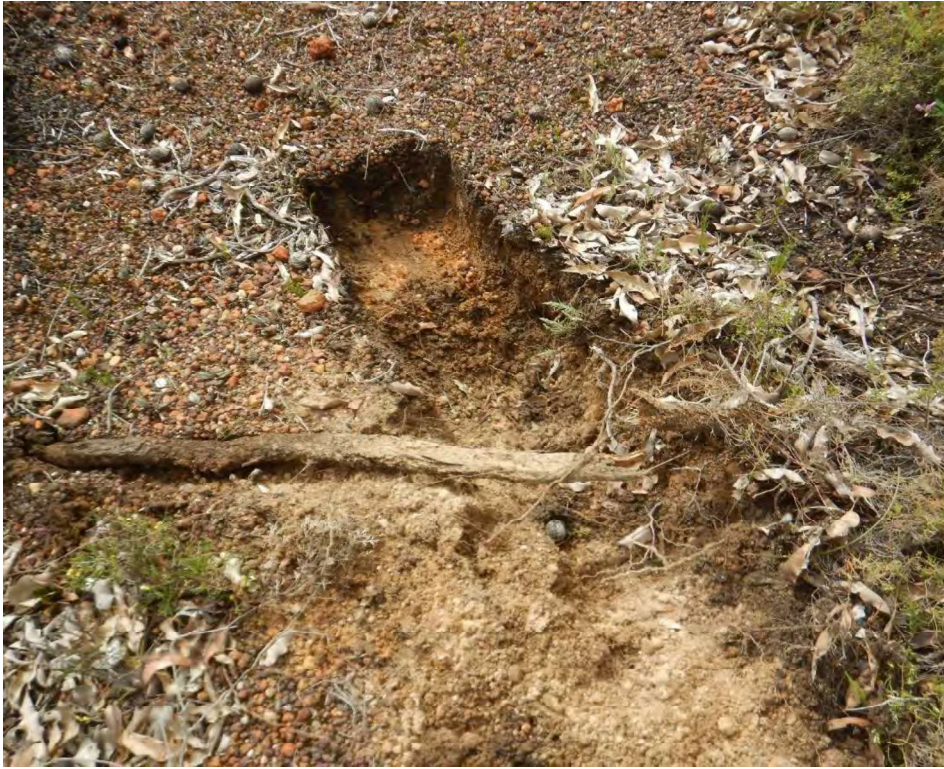
Photo 9. Soil Profile at Test Location 06 (TP6)

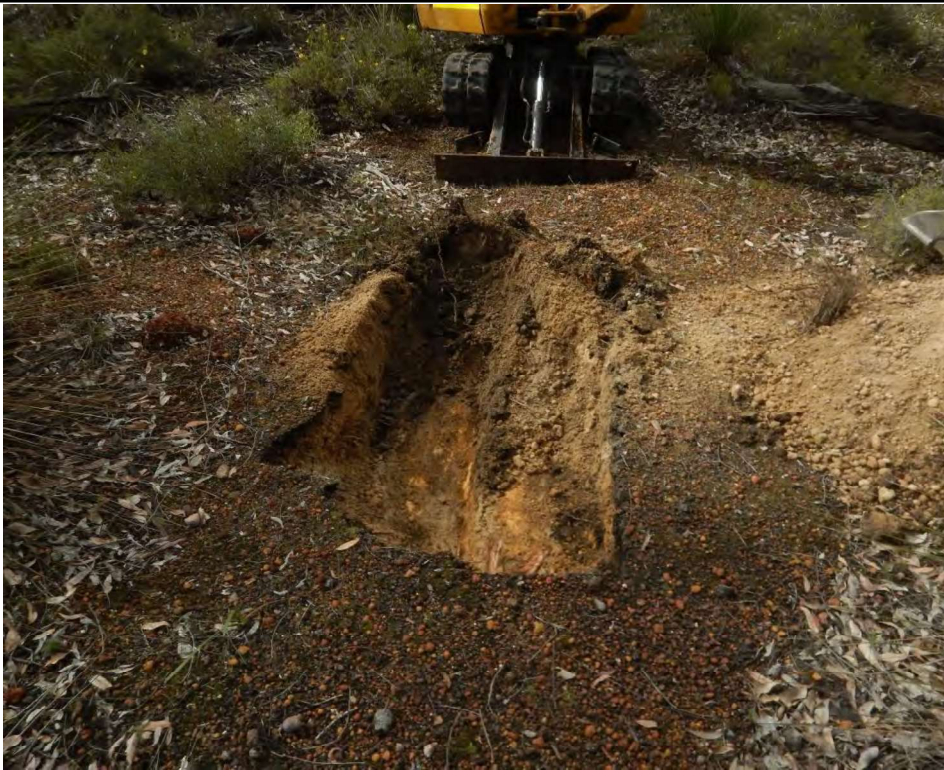
Photo 10. Soil Profile at Test Location 07 (TP7)

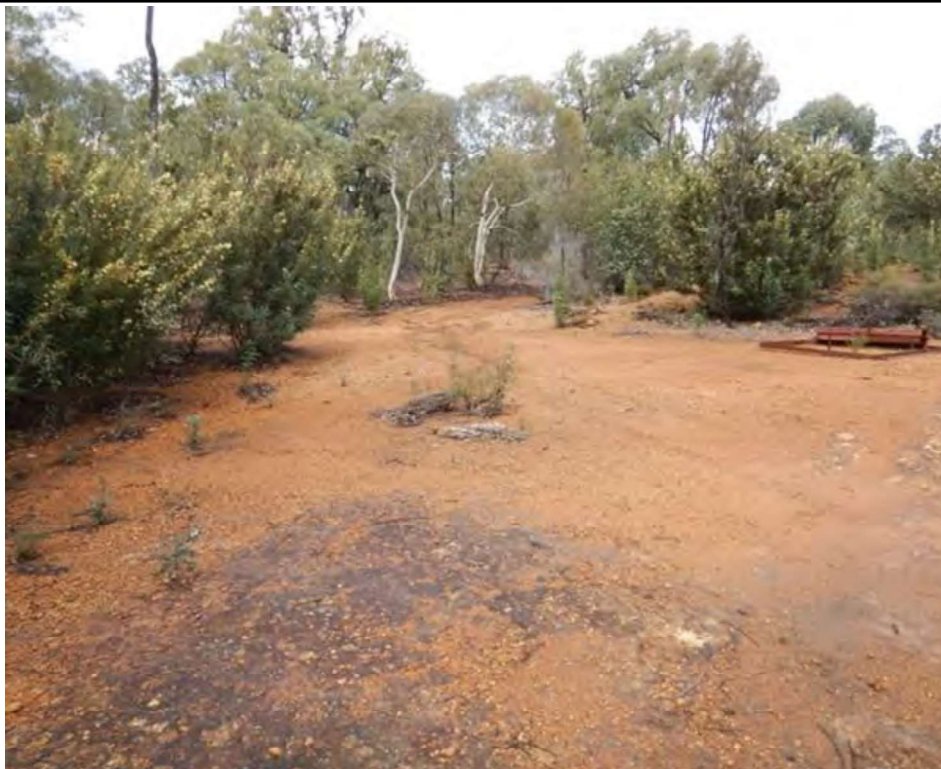
Photo 11. Rock Outcrops at Test Location 02 (TP2)

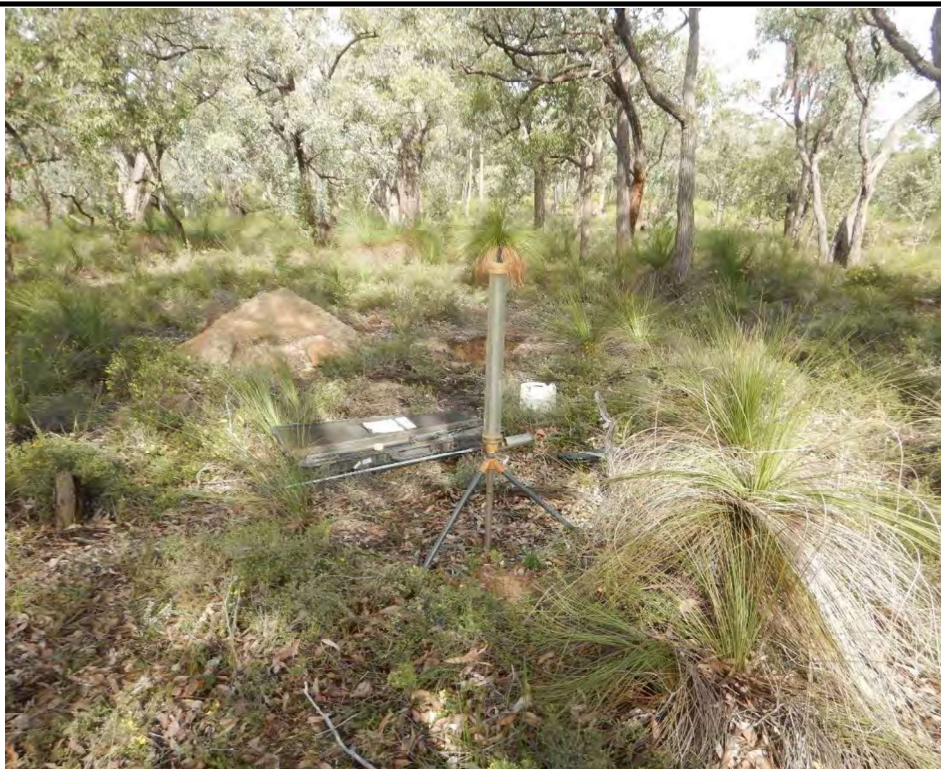
Photo 12. Conducting FPT at Test Location 01 (FPT1)

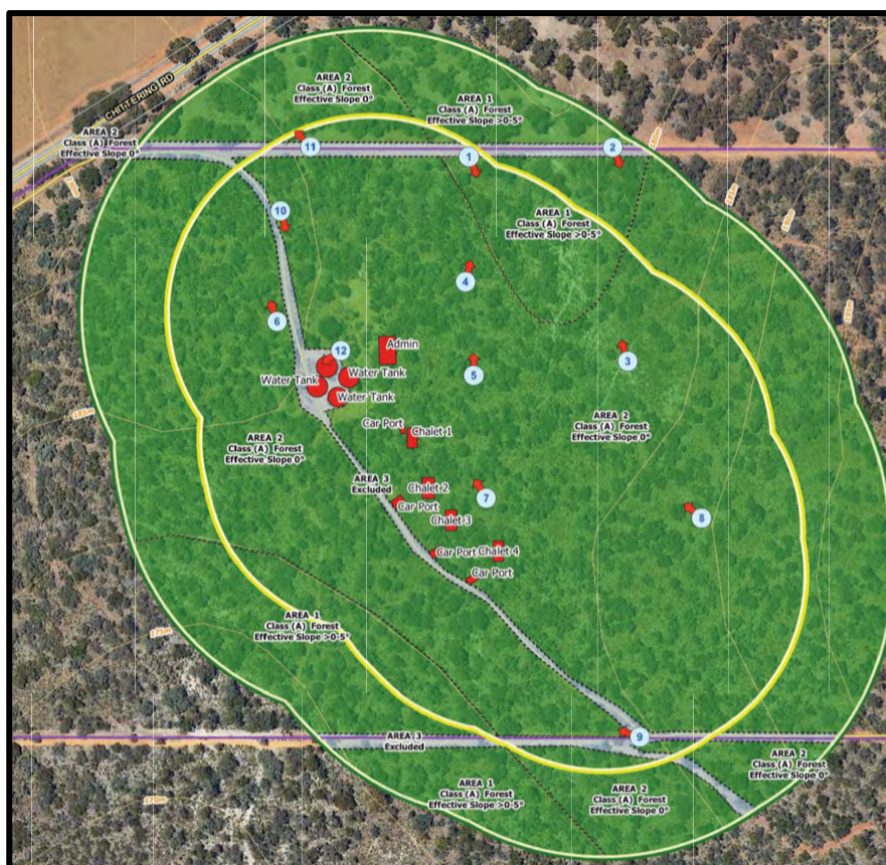
BFMP_Figure 3.1

Figure 3.1 extracted from the applicant's BFMP clearly shows the location of the farmstay within a ridgeline on the property. The location and height of the structures, specifically the proposed shelter, will be visible from the line of sight from the Chittering Road end as shown in photograph 10 of the BFMP and from my property boundary as shown in photograph 9 of the BFMP – both shown below.

It is obvious that the proposed structures will be clearly visible from my property and from Chittering Road; therefore, they do not comply with Clause 5.2 of LPS6 and cannot be supported.

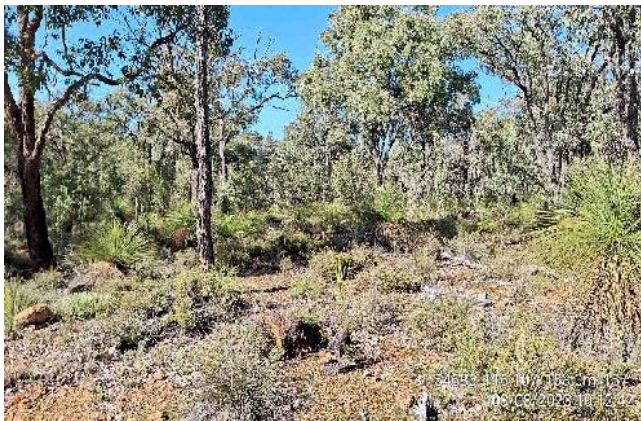
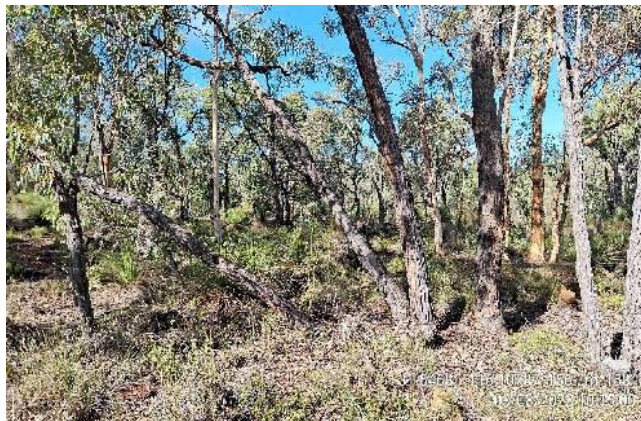
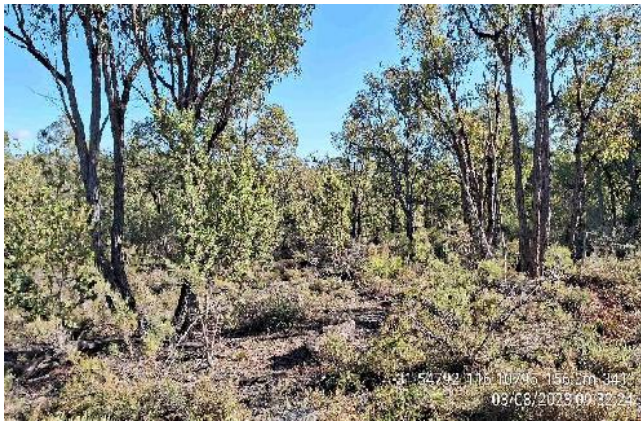
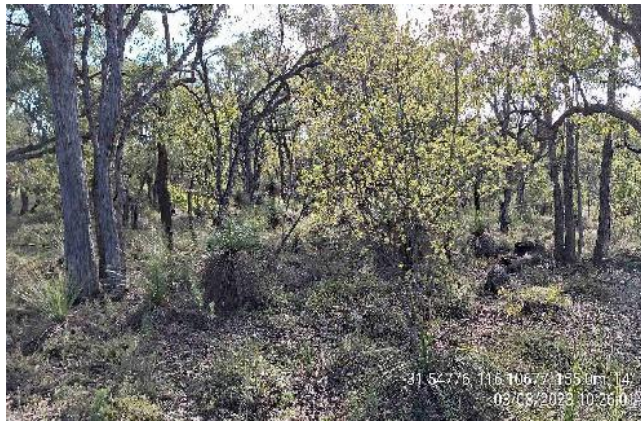
VEGETATION AREA 1						
Classification	A. FOREST					
Types Identified	Open forest A-03					
Exclusion Clause	N/A					
Effective Slope	Measured	d/slope 4 degrees	Applied Range (Method 1)		Downslope >0-5 degrees	
Foliage Cover (all layers)	30-70%	Shrub/Heath Height	1-2m		Tree Height	8-12m
Dominant & Sub-Dominant Layers (species as relevant)	Mixed eucalyptus species including jarrah up to 12m in height.					
Understorey:	Grass trees and scattered banksia up to 2m over low shrubs.					
Additional Justification:	Not Required.					
Post Development Assumptions:	N/A					
<div><div>

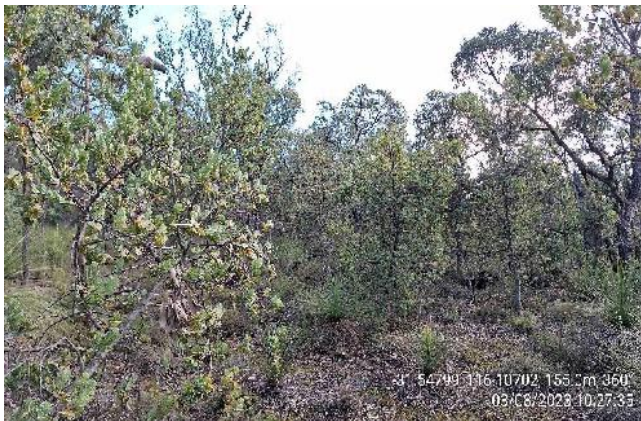
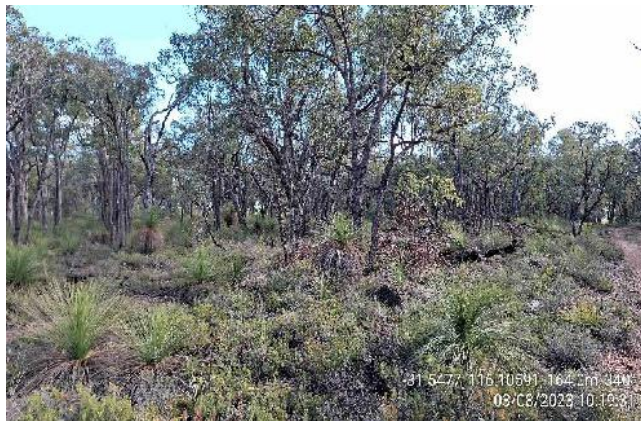
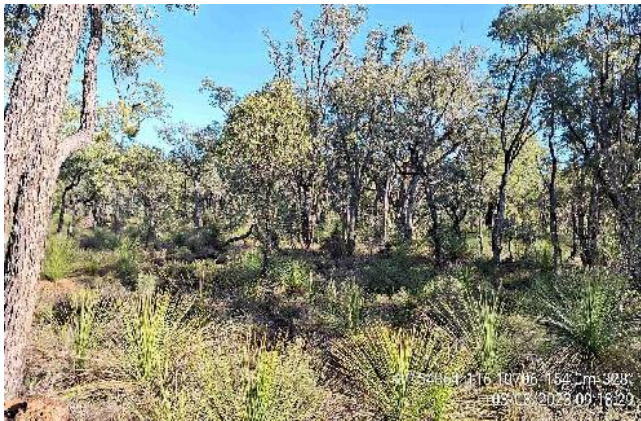
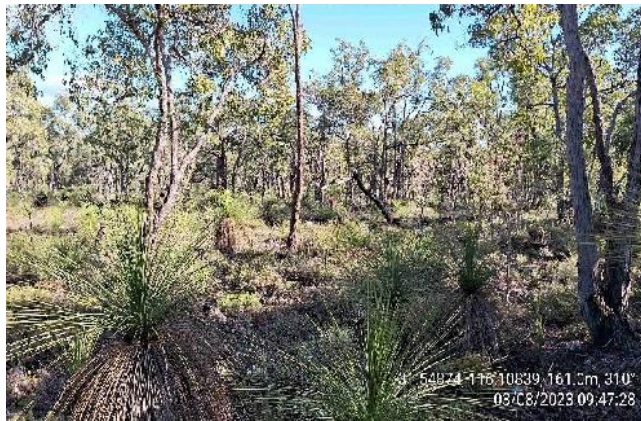
VEGETATION AREA 2							
Classification	A. FOREST						
Types Identified	Open forest A-03						
Exclusion Clause	N/A						
Effective Slope	Measured	flat 0 degrees		Applied Range (Method 1)		Upslope or flat 0 degrees	
Foliage Cover (all layers)	30-70%		Shrub/Heath Height	1-2m		Tree Height	8-12m
Dominant & Sub-Dominant Layers (species as relevant)	Mixed eucalyptus species including jarrah up to 12m in height.						
Understorey:	Grass trees and scattered banksia up to 2m over low shrubs.						
Additional Justification:	Not Required.						
Post Development Assumptions:	Area to be managed to a low threat state. All remaining trees to be pruned up to 2m and understorey to be managed in perpetuity.						
<div><div>

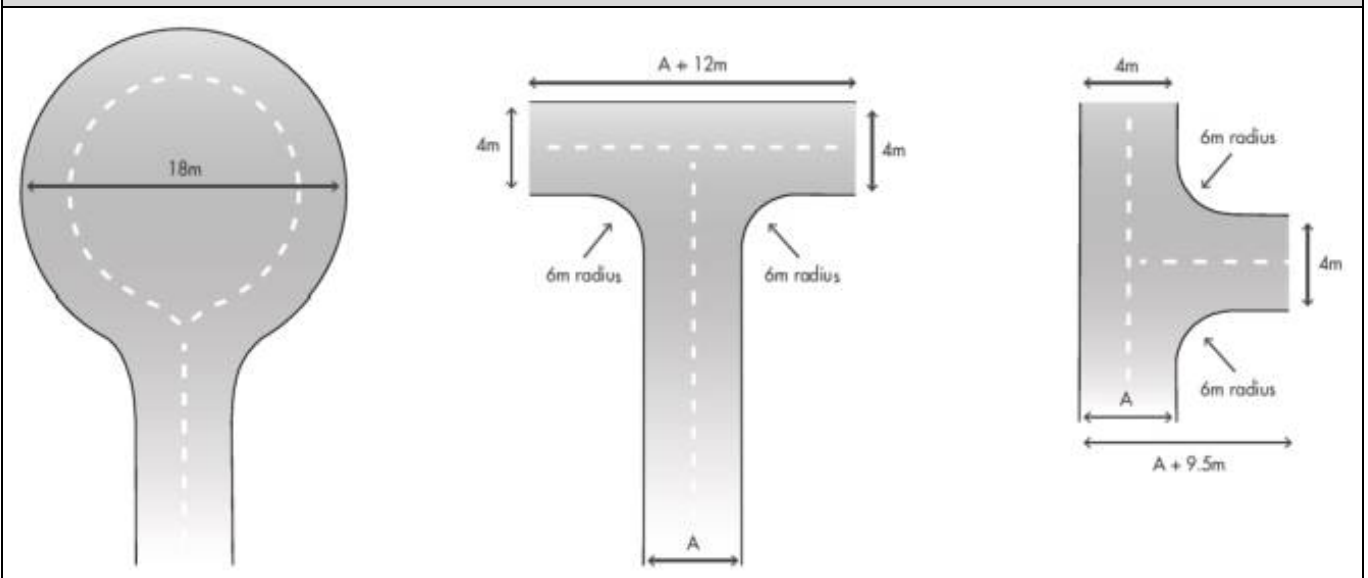
Turnaround Area Dimensions for No-through Road, Battle-axe Legs and Private Driveways ⁴

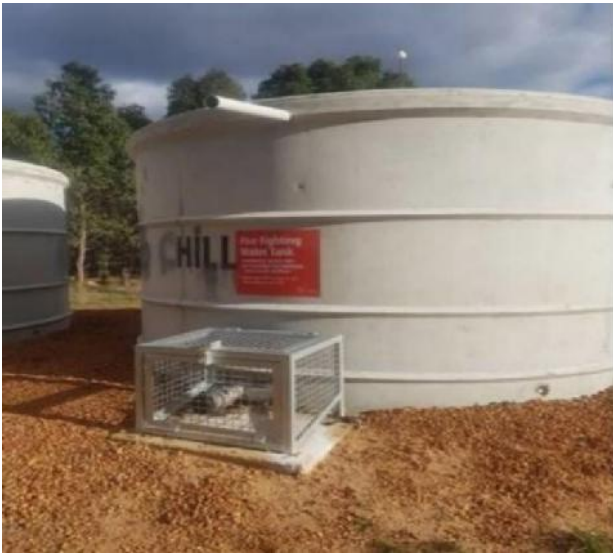
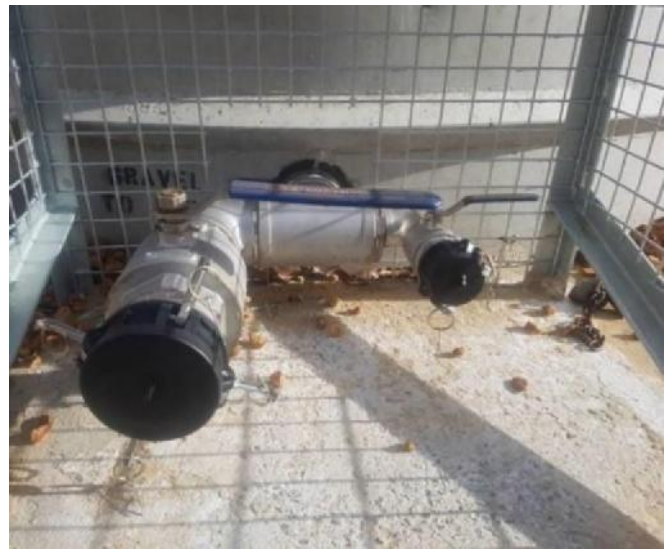
Strategic 47,000 Litre Concrete Tank & Protected Fittings

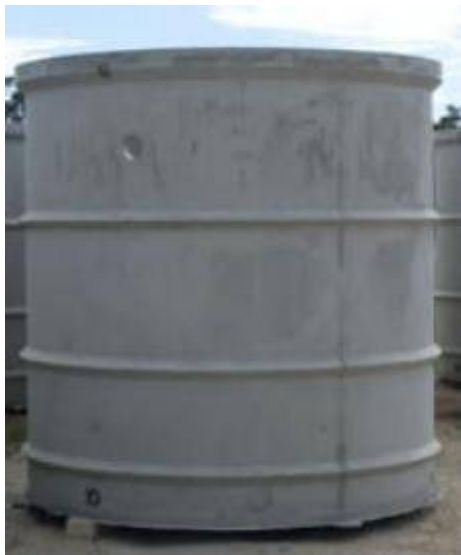
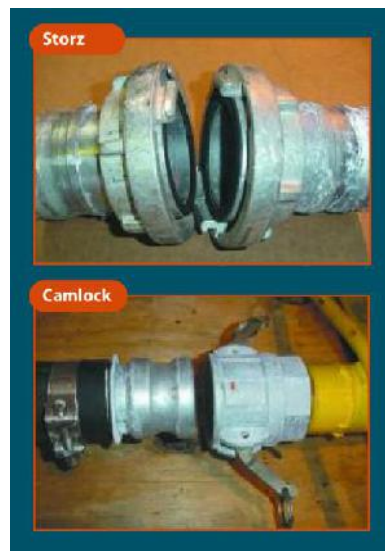
10,000 Litre Concrete Tank

Storz and Camlock Couplings

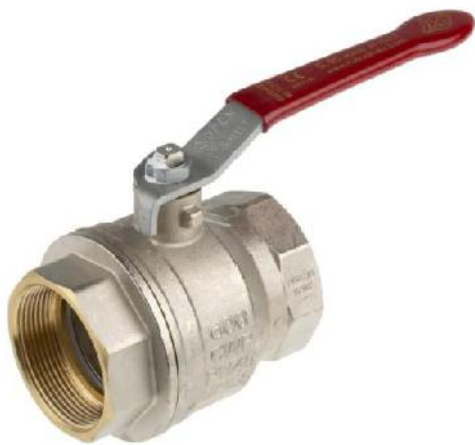
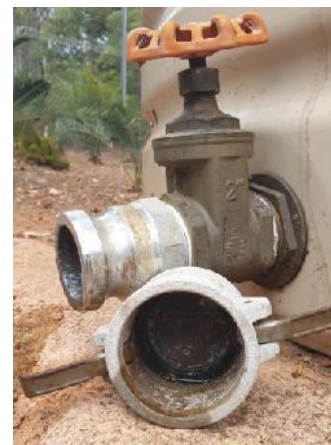
Full Flow 50mm Ball Valve

Full Flow 50mm Gate Valve and Male Camlock
