**DEVELOPMENT SERVICES ATTACHMENTS
ORDINARY MEETING OF COUNCIL
WEDNESDAY 15 MARCH 2023**

Muchea Industrial Area – Precinct 2A

Request for Amendment to the Shire of Chittering *Local Planning Scheme No. 6*

Taylor Burrell Barnett
Town Planning and Design

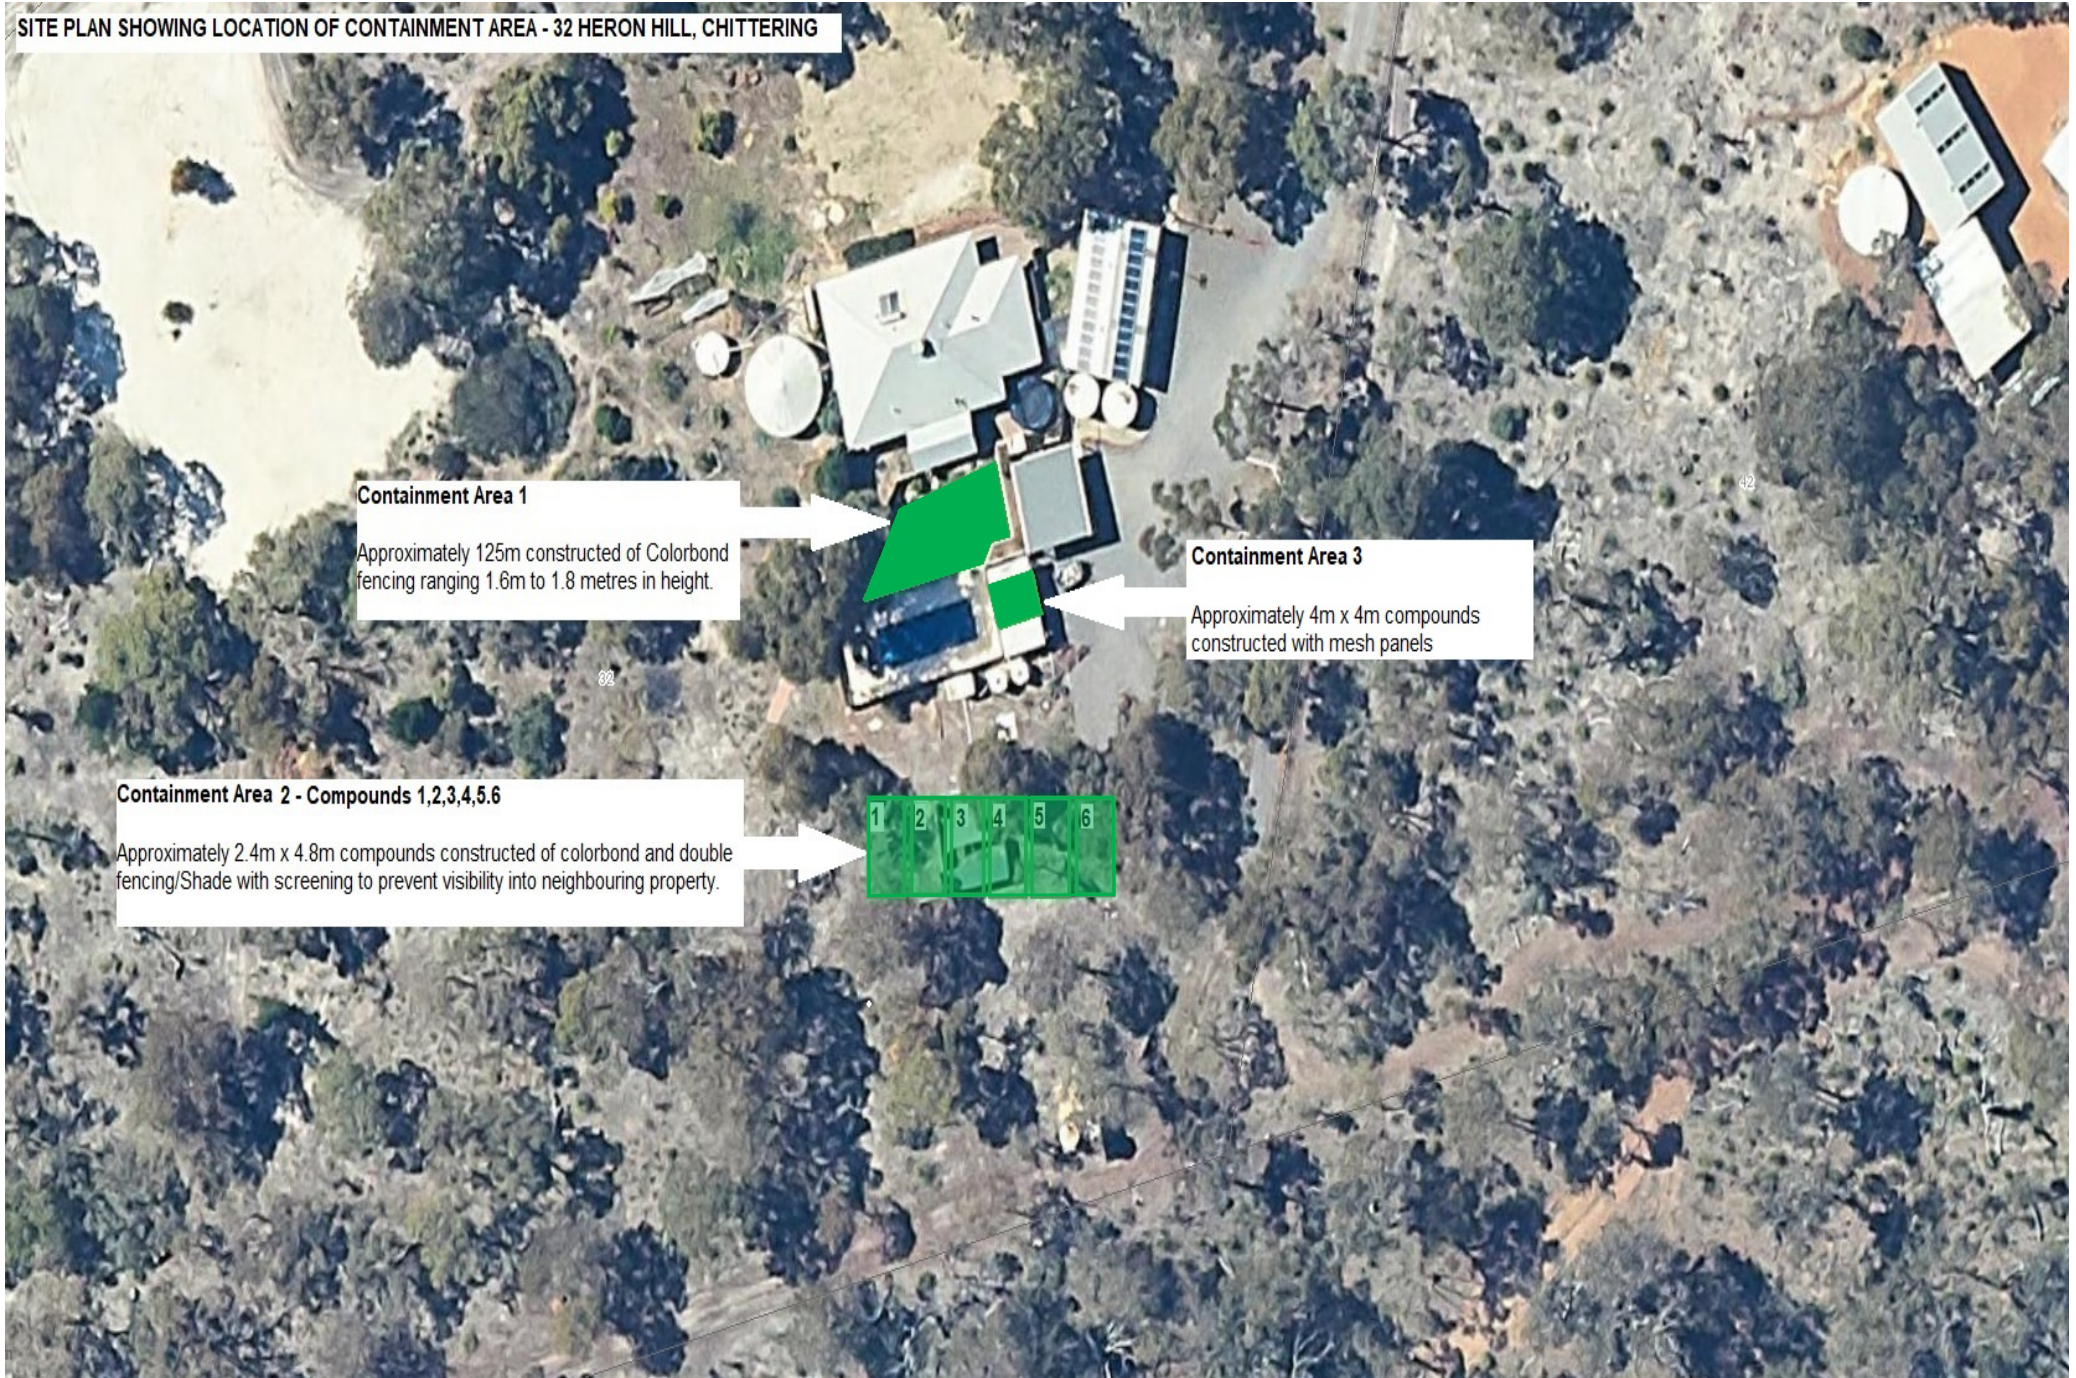
SITE PLAN SHOWING DOG CONTAINMENT SYSTEM LINE - 32 HERON HILL, CHITTERING

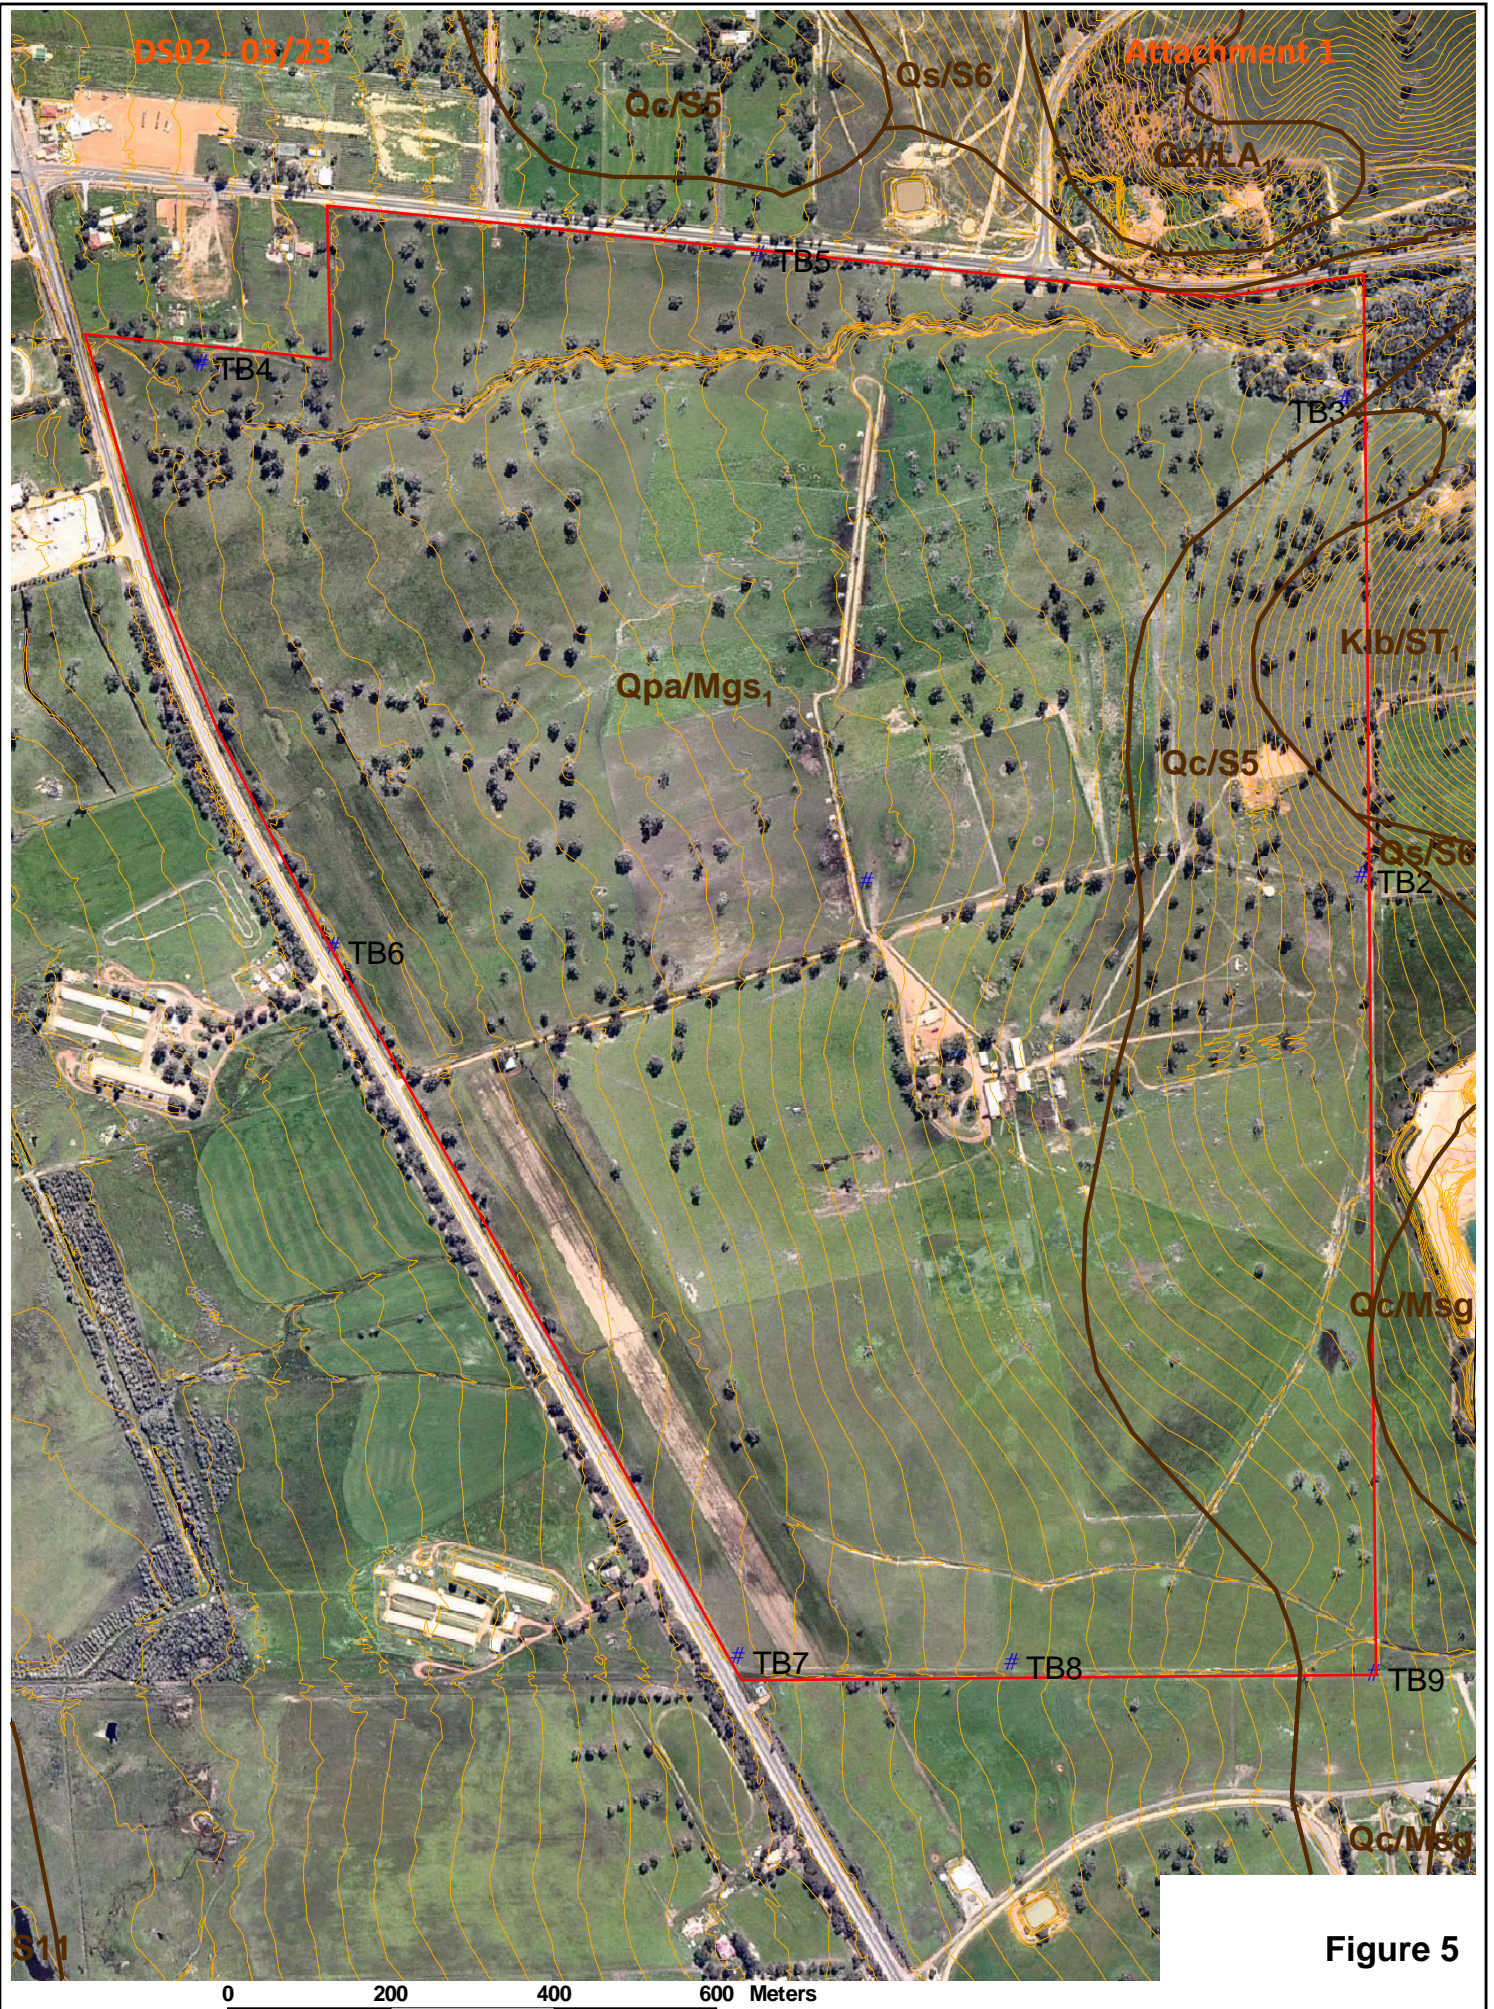
Figure 5

- Site boundary
- Borehole
- 1m Topographic contour (m AHD)
- Geological boundary

PHYSIOGRAPHY

The geological map for the area indicates the majority of the site to be underlain by the Guildford Formation consisting of clay, sand, silt and gravels. Quartz sand is noted in the centre and along the eastern boundary, with lateritic gravels towards the north eastern corner.

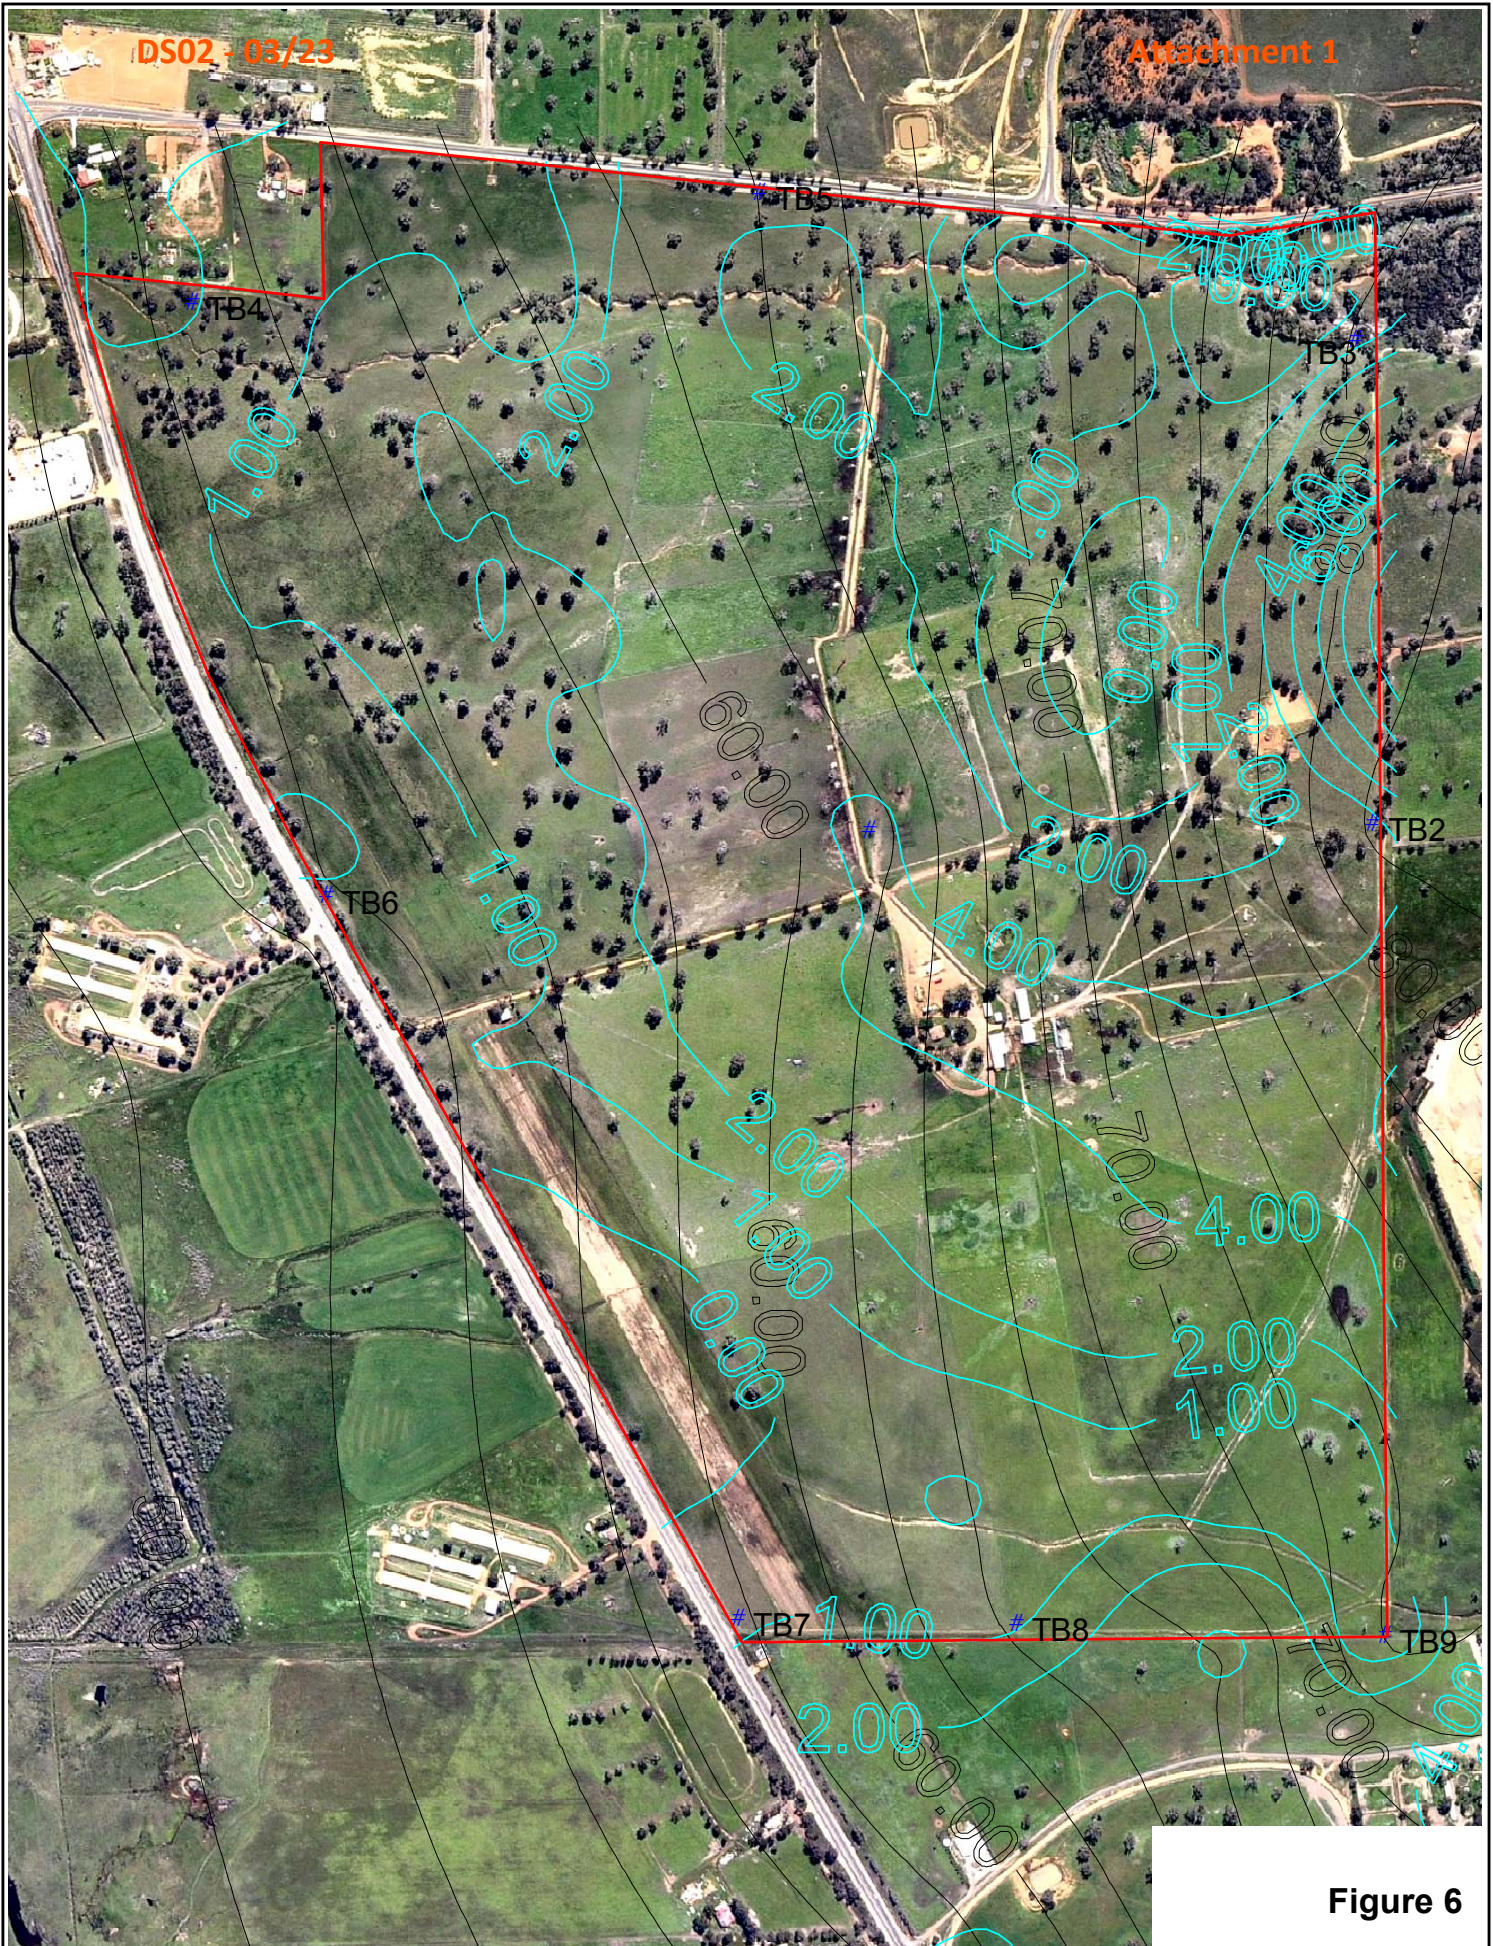
Figure 6

GROUNDWATER HYDROLOGY

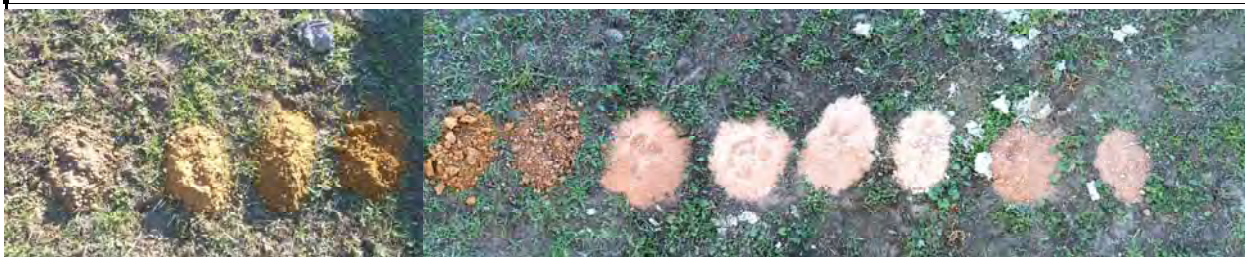
SOIL PROFILE LOG

PROJECT NUMBER:	J20008
SITE ID:	TB1
EASTING:	405754
NORTHING:	6505172
METHOD:	Auger rig
TOTAL DEPTH (mbgl):	6
REFUSAL (Y/N):	N
DATE:	13/06/2017
DEPTH TO WATER (mbgl)	-

SOIL PROFILE		SAMPLE DATA	
DEPTH (m)	SOIL DESCRIPTION	SAMPLE ID	INTERVAL (m)
0.5	Brown gravelly sand		
1 - 1.5	Orange gravelly loam		
2	Orange-brown clay-loam		
2.5	Orange-brown loamy clay		
3	Red-brown loamy clay		
3.5 - 5	Pink clay		
5.5 - 6	Red clay

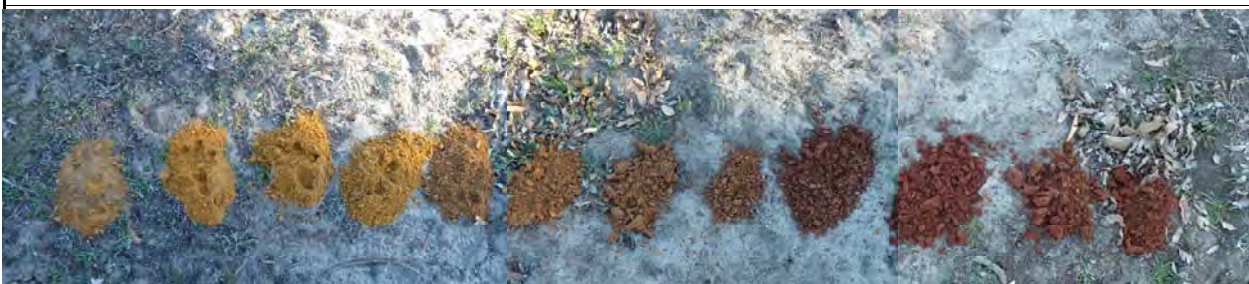
SOIL PROFILE LOG

PROJECT NUMBER:	J20008
SITE ID:	TB2
EASTING:	406361
NORTHING:	6505180
METHOD:	Auger rig
TOTAL DEPTH (mbgl):	6
REFUSAL (Y/N):	N
DATE:	13/06/2017
DEPTH TO WATER (mbgl)	-

SOIL PROFILE		SAMPLE DATA	
DEPTH (m)	SOIL DESCRIPTION	SAMPLE ID	INTERVAL (m)
0.5 - 2	Orange slightly clayey sand		
2.5	Orange-brown gravelly loam		
3	Orange-brown gravelly clay-loam		
3.5 - 4	Red-brown loamy clay		
4.5	Red gravelly loamy clay		
5-Jun	Red loamy clay

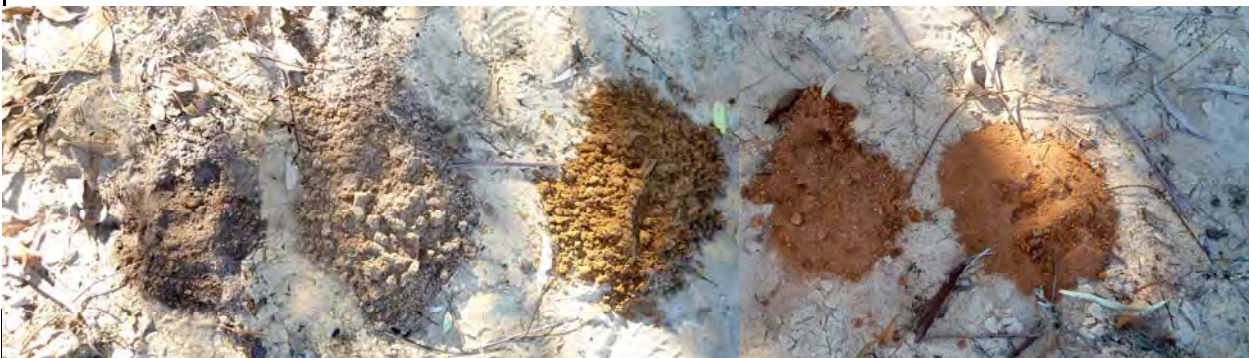
SOIL PROFILE LOG

PROJECT NUMBER:	J20008
SITE ID:	TB3
EASTING:	406340
NORTHING:	6505764
METHOD:	Auger rig
TOTAL DEPTH (mbgl):	2
REFUSAL (Y/N):	Y
DATE:	13/06/2017
DEPTH TO WATER (mbgl)	-

SOIL PROFILE		SAMPLE DATA	
DEPTH (m)	SOIL DESCRIPTION	SAMPLE ID	INTERVAL (m)
0.5	Grey sand		
1	Grey-brown sand, damp		
1.5	Brown slightly gravelly sand, damp		
2	Red-brown gravelly clay		
2.4	Refusal on granite(?)

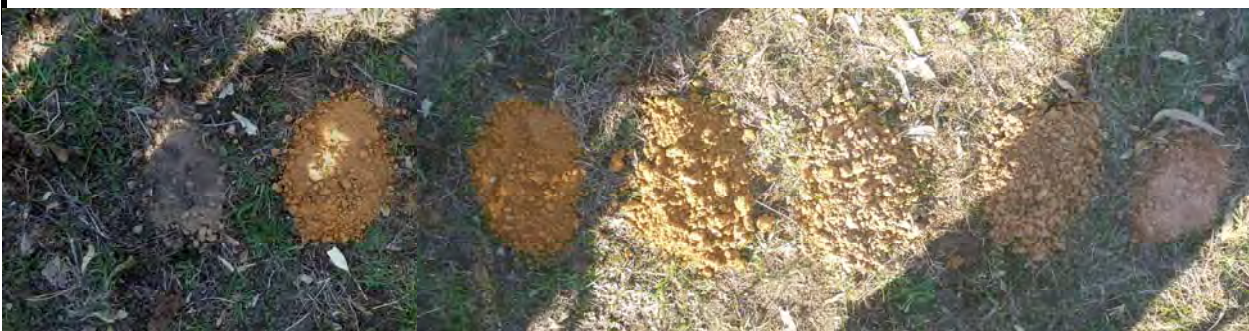
SOIL PROFILE LOG

PROJECT NUMBER:	J20008
SITE ID:	TB4
EASTING:	404938
NORTHING:	6505808
METHOD:	Auger rig
TOTAL DEPTH (mbgl):	4
REFUSAL (Y/N):	n
DATE:	13/06/2017
DEPTH TO WATER (mbgl)	-

SOIL PROFILE		SAMPLE DATA	
DEPTH (m)	SOIL DESCRIPTION	SAMPLE ID	INTERVAL (m)
0.5	Grey-brown gravelly sand		
1	Orange gravelly sand		
1.5	Orange gravelly loamy sand		
2	Orange loamy clay		
2.5 - 3	Orange-brown/grey mottled well structured clay		
3.5	Pink-brown hard clay, dry		
4	Pink hard clay, dry

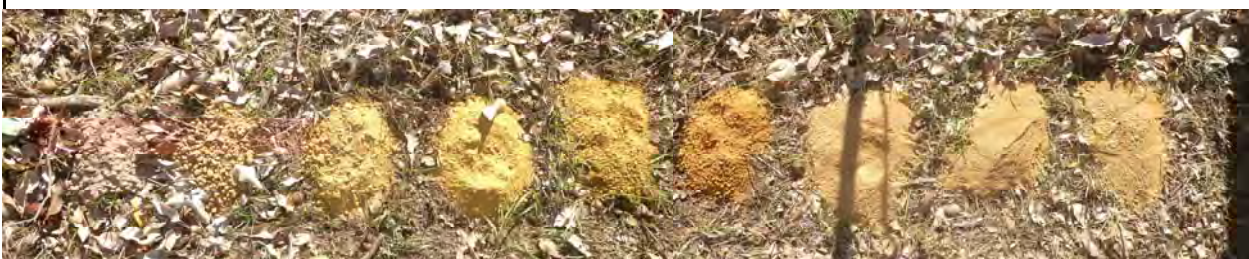
SOIL PROFILE LOG

PROJECT NUMBER:	J20008
SITE ID:	TB5
EASTING:	405623
NORTHING:	6505941
METHOD:	Auger rig
TOTAL DEPTH (mbgl):	4
REFUSAL (Y/N):	N
DATE:	13/06/2017
DEPTH TO WATER (mbgl)	-

SOIL PROFILE		SAMPLE DATA	
DEPTH (m)	SOIL DESCRIPTION	SAMPLE ID	INTERVAL (m)
0.5	Brown gravelly sand		
1	Orange-brown sandy gravel		
1.5	Orange-yellow gravelly loamy sand		
2 - 2.5	Orange-yellow sandy clay		
3	Orange-brown sandy clay		
3.5 - 4	Yellow-brown sandy clay

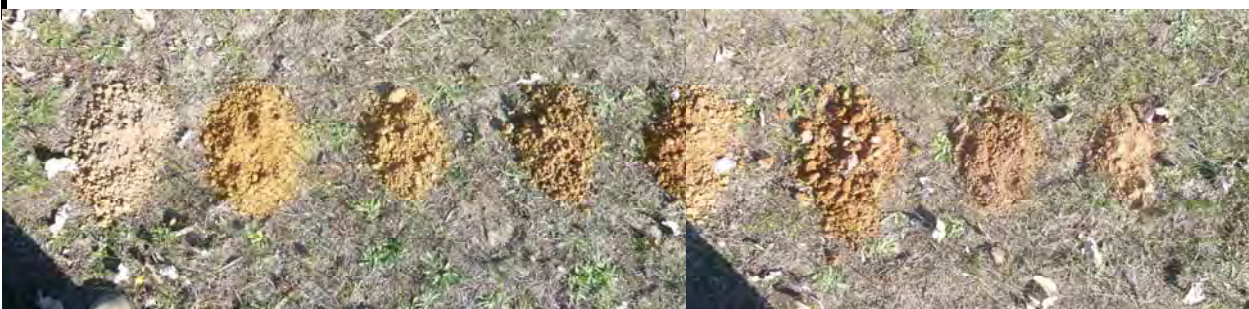
SOIL PROFILE LOG

PROJECT NUMBER:	J20008
SITE ID:	TB6
EASTING:	405100
NORTHING:	6505093
METHOD:	Auger rig
TOTAL DEPTH (mbgl):	4
REFUSAL (Y/N):	N
DATE:	13/06/2017
DEPTH TO WATER (mbgl)	-

SOIL PROFILE		SAMPLE DATA	
DEPTH (m)	SOIL DESCRIPTION	SAMPLE ID	INTERVAL (m)
0.5	Brown gravelly sand		
1 - 1.5	Orange-brown gravelly loam		
2	Orange-brown gravelly loamy clay		
2.5	Red-brown moderately structured gravelly clay		
3	Red-yellow-brown well structured gravelly clay, damp		
3.5	Red-brown/grey mottled clay		
4	Red clay, dry

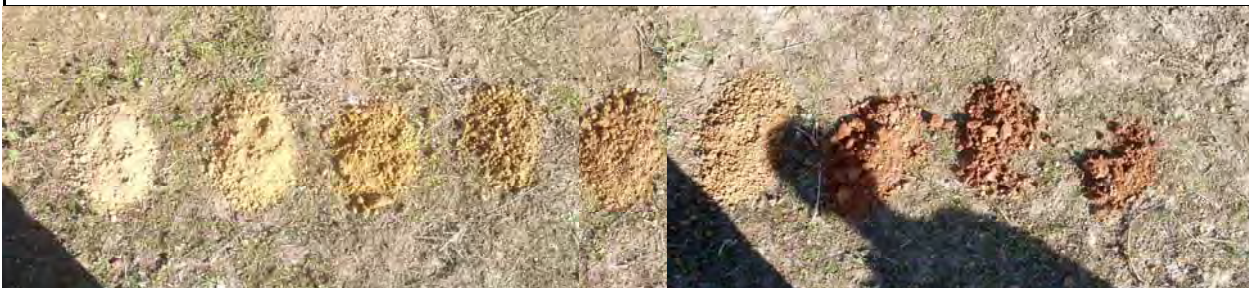
SOIL PROFILE LOG

PROJECT NUMBER:	J20008
SITE ID:	TB7
EASTING:	405596
NORTHING:	6504222
METHOD:	Auger rig
TOTAL DEPTH (mbgl):	4
REFUSAL (Y/N):	N
DATE:	13/06/2017
DEPTH TO WATER (mbgl)	-

SOIL PROFILE		SAMPLE DATA	
DEPTH (m)	SOIL DESCRIPTION	SAMPLE ID	INTERVAL (m)
0.5	Pale brown gravelly sand		
1	Yellow-brown gravelly sandy loam		
1.5	Yellow-brown gravelly loamy clay		
2	Brown gravelly loamy clay		
2.5 - 3	Red-brown slightly mottled gravelly clay		
3.5 - 4	Red/orange/grey slightly mottled gritty clay

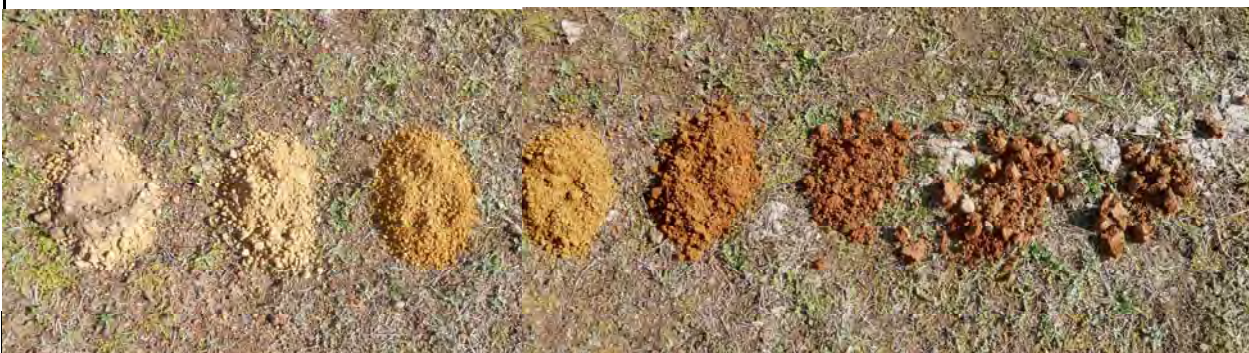
SOIL PROFILE LOG

PROJECT NUMBER:	J20008
SITE ID:	TB8
EASTING:	405932
NORTHING:	6504216
METHOD:	Auger rig
TOTAL DEPTH (mbgl):	4
REFUSAL (Y/N):	N
DATE:	13/06/2017
DEPTH TO WATER (mbgl)	-

SOIL PROFILE		SAMPLE DATA	
DEPTH (m)	SOIL DESCRIPTION	SAMPLE ID	INTERVAL (m)
0.5 - 1	Yellow-brown gravelly sand		
1.5	Orange-brown gravelly loam		
2	Orange-brown gravelly clay-loam		
2.5 - 4	Red-brown sandy loamy clay

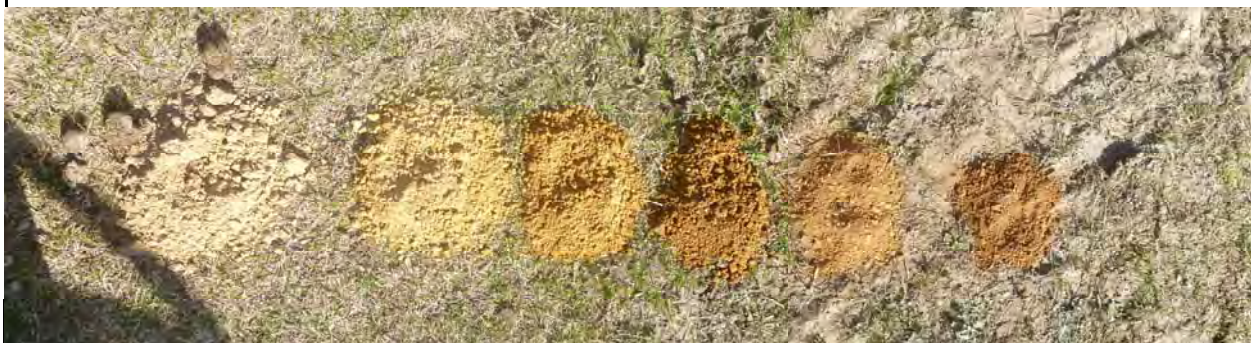
PROJECT NUMBER:	J20008
SITE ID:	TB9
EASTING:	406375
NORTHING:	6504202
METHOD:	Auger rig
TOTAL DEPTH (mbgl):	3
REFUSAL (Y/N):	N
DATE:	13/06/2017
DEPTH TO WATER (mbgl)	-

SOIL PROFILE		SAMPLE DATA	
DEPTH (m)	SOIL DESCRIPTION	SAMPLE ID	INTERVAL (m)
0.5	Yellow-brown slightly gravelly silty sand		
1 - 1.5	Yellow-brown sandy loam with occasional gravel		
2	Brown slightly gravelly clay-loam		
2.5 - 3	Red-brown silty clay, dry & very hard

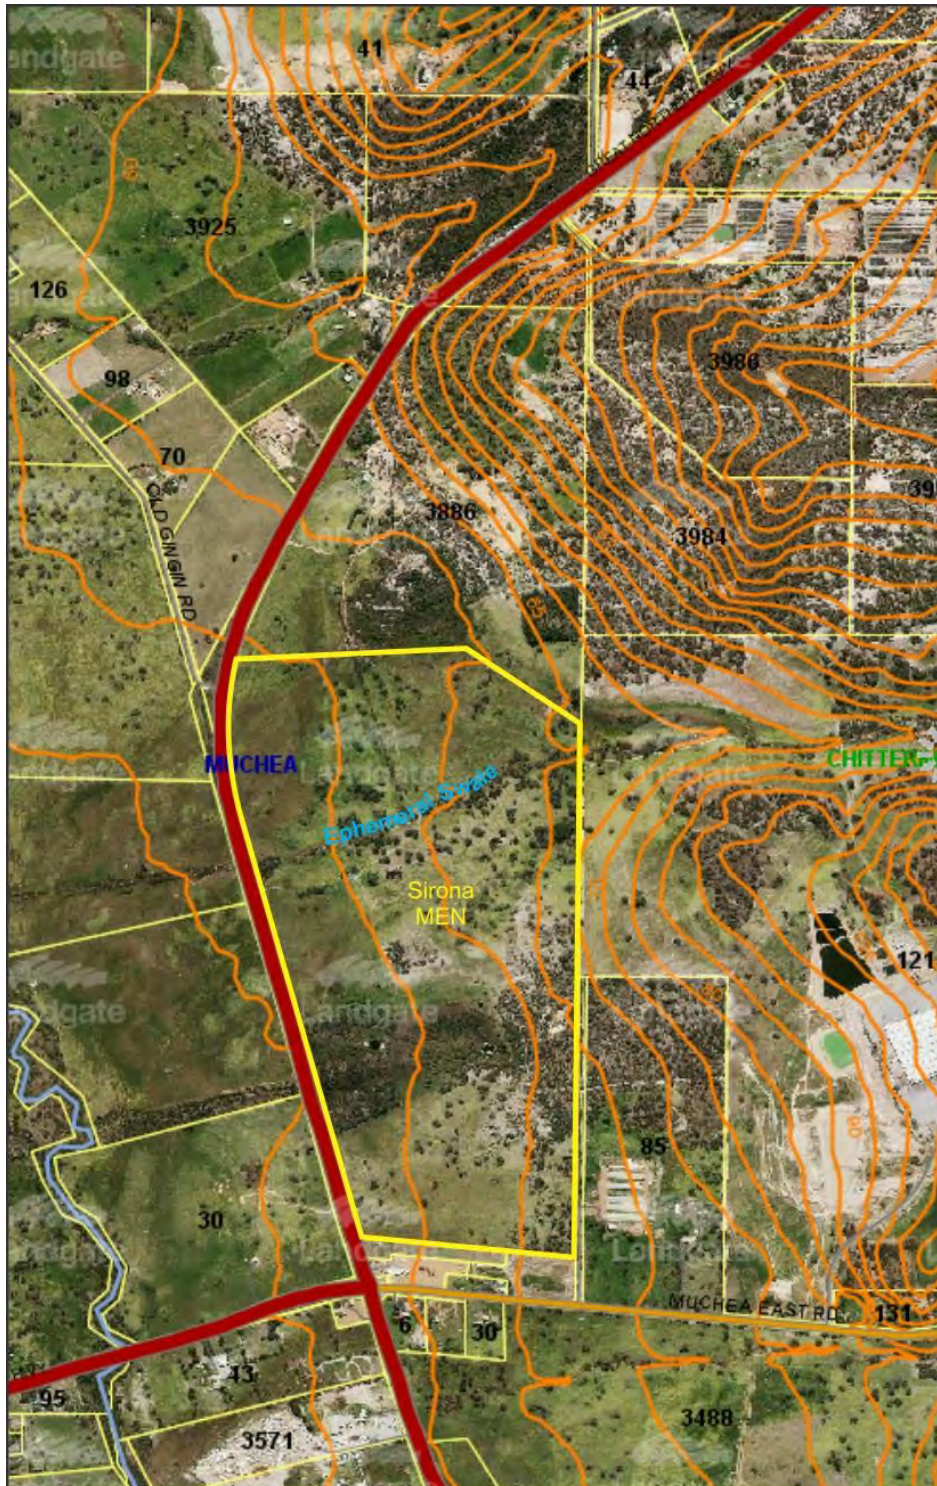
Figure 4 Contour map (5m contour lines) of the Harvis MEN development showing ephemeral swale

Phase 1 of the MEN development is being undertaken by development group Harvis Capital Pty Ltd (Harvis). The Harvis development is located on the northern end of the proposed MEN. The site is slightly undulating with an ephemeral swale running through the development (Figure 4). The development is well placed and has been planned around the proposed Perth Darwin Highway.

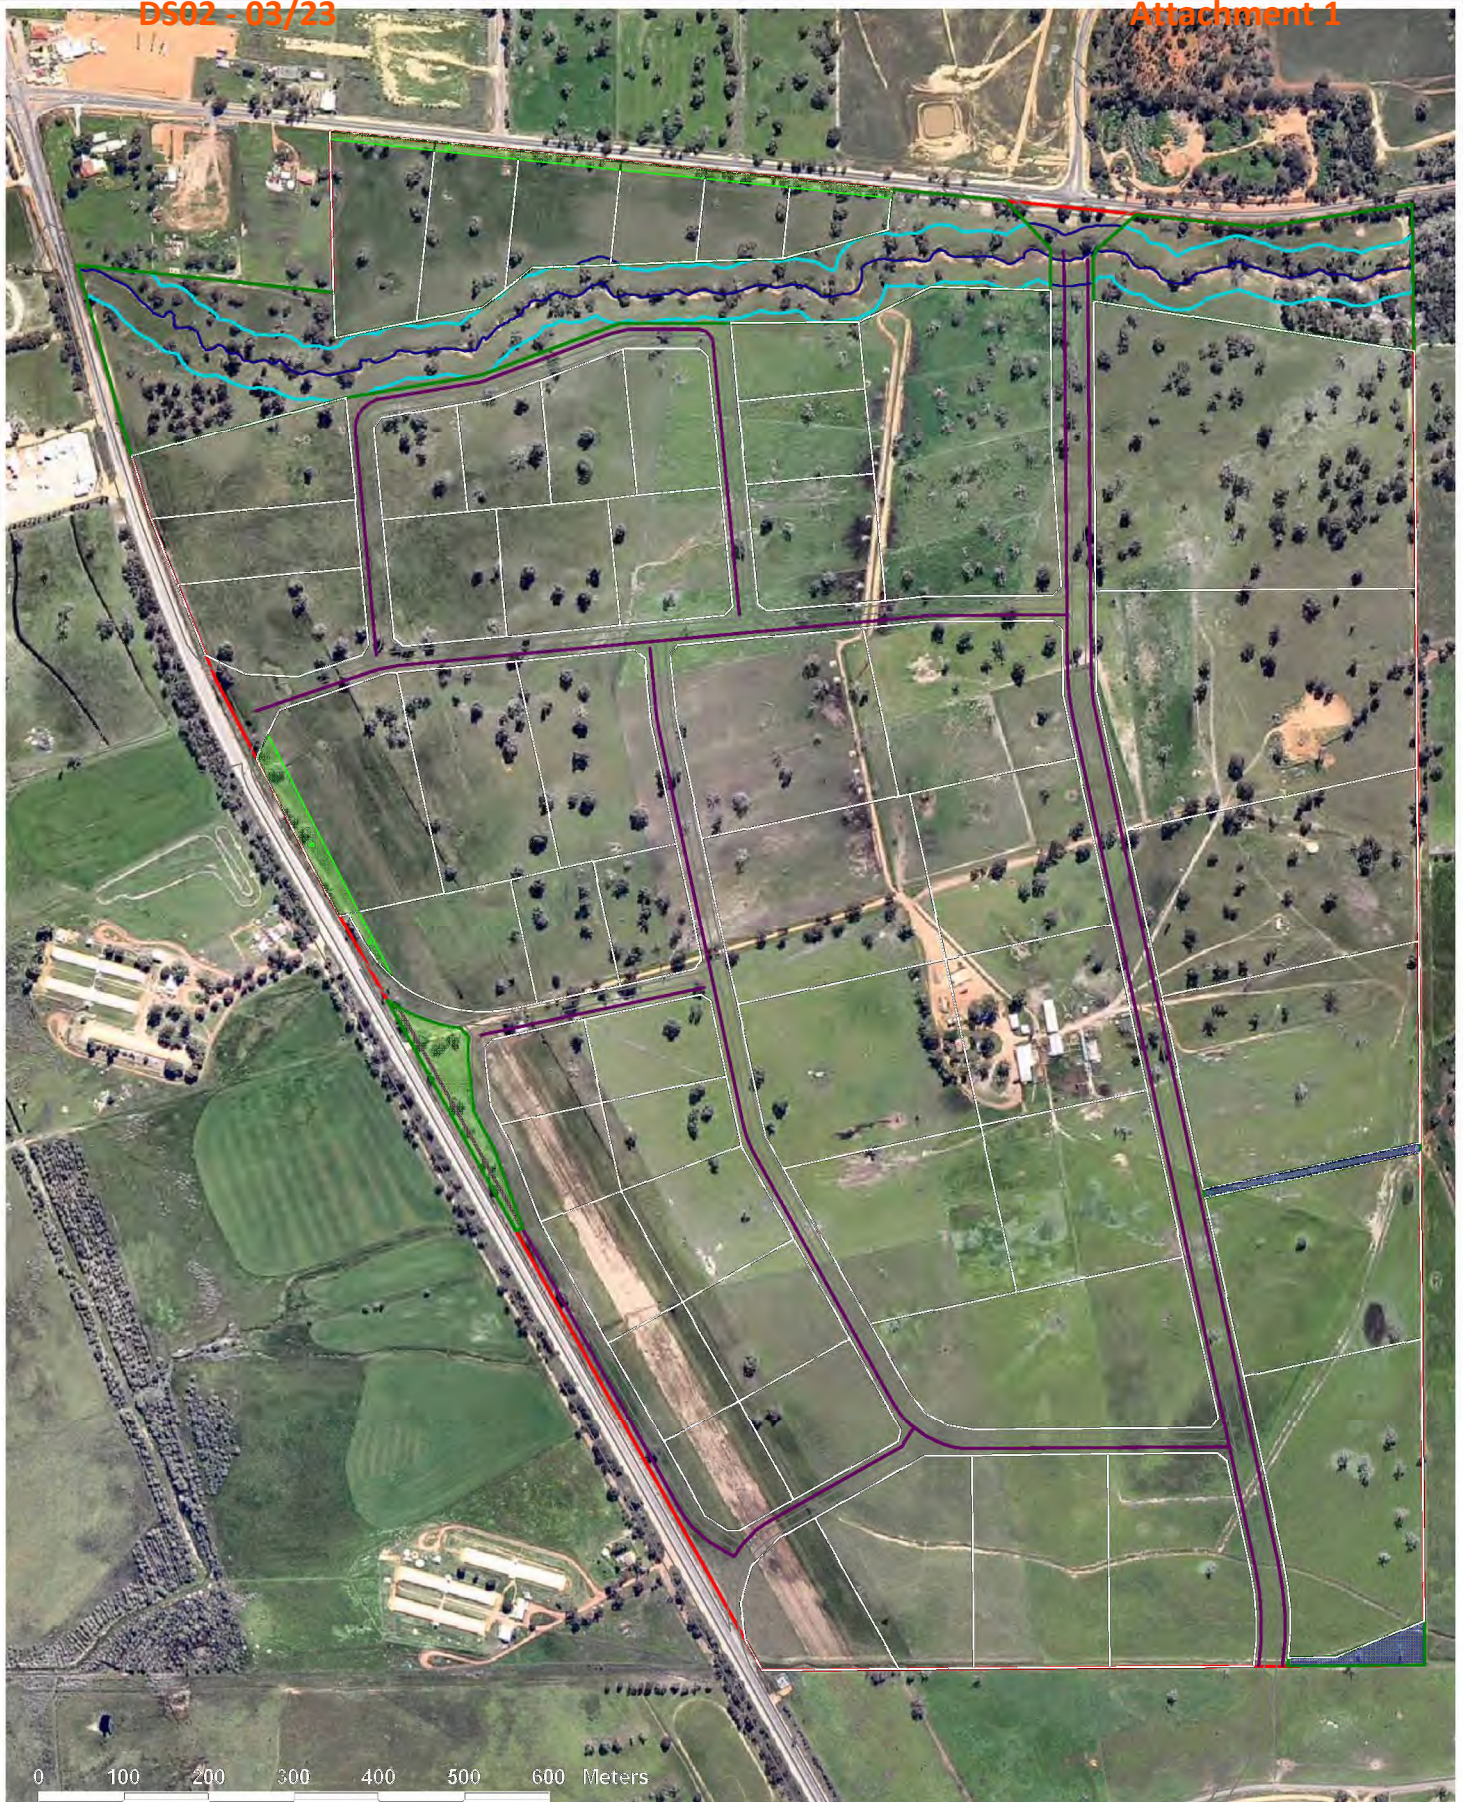
- Site boundary
- - - Proposed lot boundary
- Creekline
- Foreshore reserve
- Bioretention swale
- POS
- ▨ Drainage reserve
- ▨ Tree retention

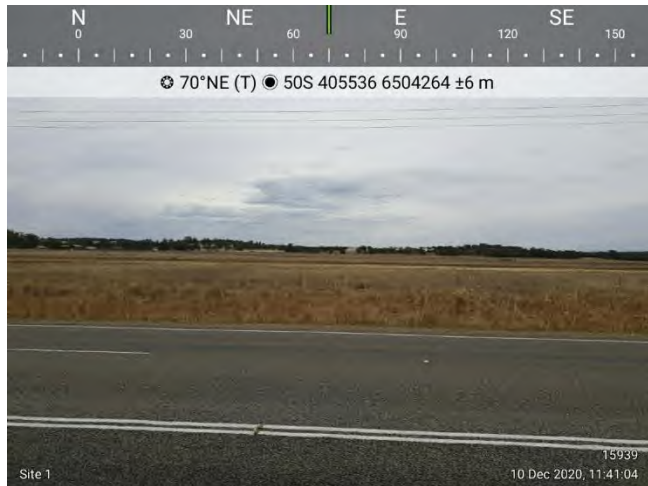
Photo Point 1

Classified vegetation is onsite unmanaged grassland, grazing paddocks.
Slope under the vegetation has been assessed as flat land.

Plot 1 Classification or Exclusion Clause Class G Grassland

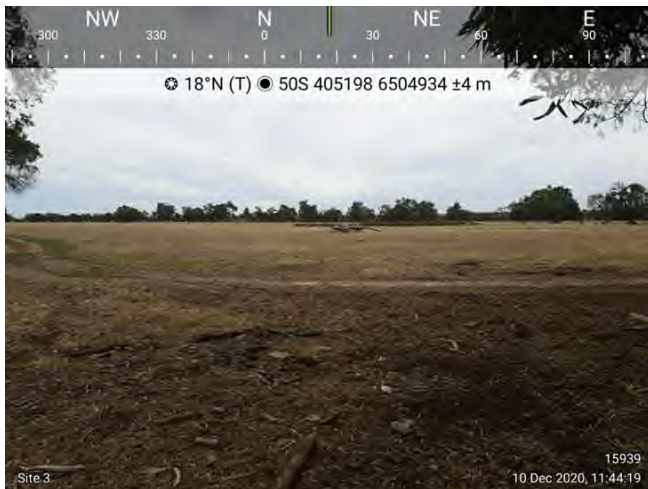
Photo Point 2

Classified vegetation is onsite unmanaged grassland, Onsite paddocks with scattered trees up to 10m.
Slope under the vegetation has been assessed as flat land.

Plot 1 Classification or Exclusion Clause Class G Grassland

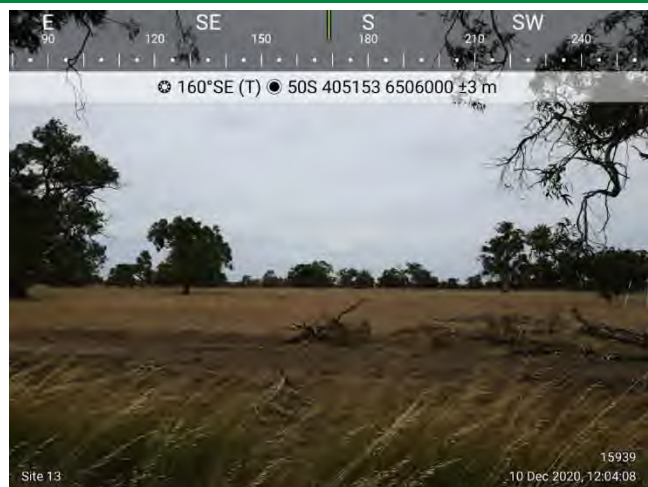
Photo Point 3

Classified vegetation is onsite unmanaged grassland, Onsite paddocks with scattered trees up to 10m.
Slope under the vegetation has been assessed as flat land.

Plot 2 Classification or Exclusion Clause Class G Grassland

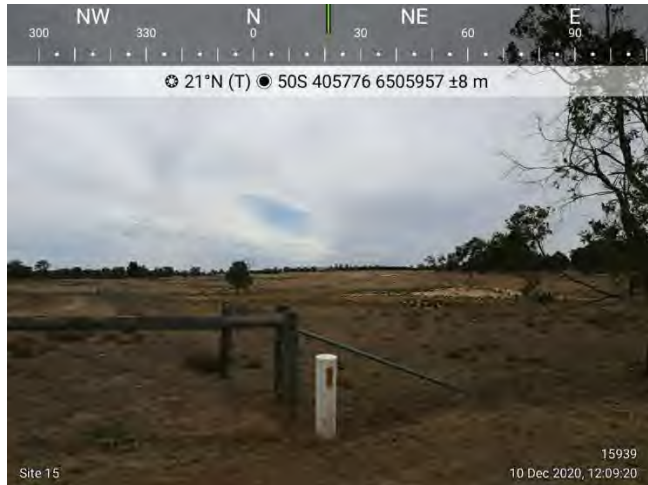
Photo Point 4

Classified vegetation is offsite unmanaged grassland.
Slope under the vegetation has been assessed as flat land.

Plot 2 Classification or Exclusion Clause Class G Grassland

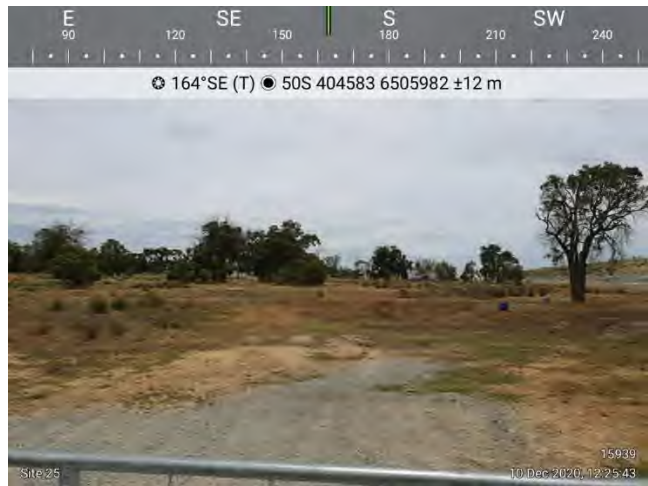
Photo Point 5

Classified vegetation is onsite unmanaged grassland, Offsite paddocks with scattered trees up to 8m.
Slope under the vegetation has been assessed as flat land.

Plot 2 Classification or Exclusion Clause Class G Grassland

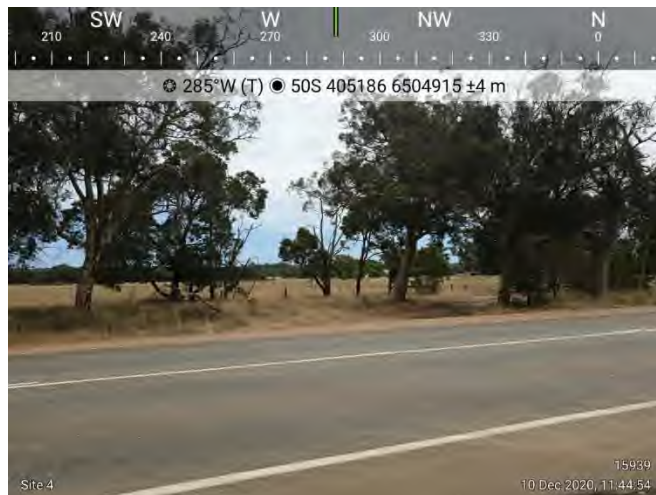
Photo Point 6

Classified vegetation is offsite unmanaged grassland.
Grass paddocks with minor tree line along road verge.
Slope under the vegetation has been assessed as flat land.

Plot 3 Classification or Exclusion Clause Class B Woodland

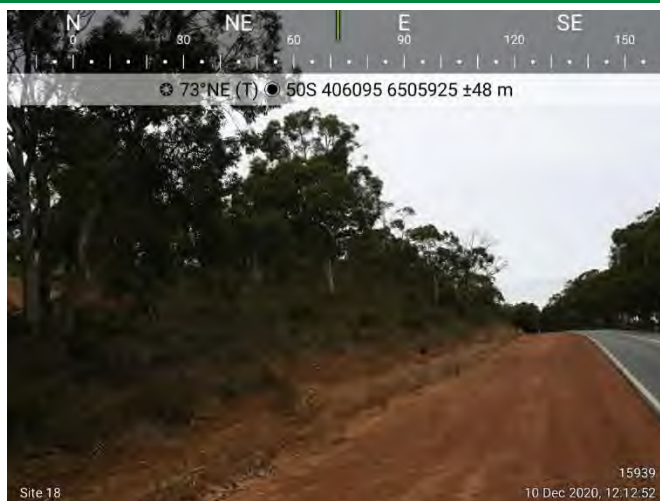
Photo Point 9

Classified vegetation is low open forest with canopy cover and shrub understorey, trees up to 10m.

Slope under the vegetation has been assessed as flat land.

Plot 4	Classification or Exclusion Clause	Class A Forest
--------	------------------------------------	----------------

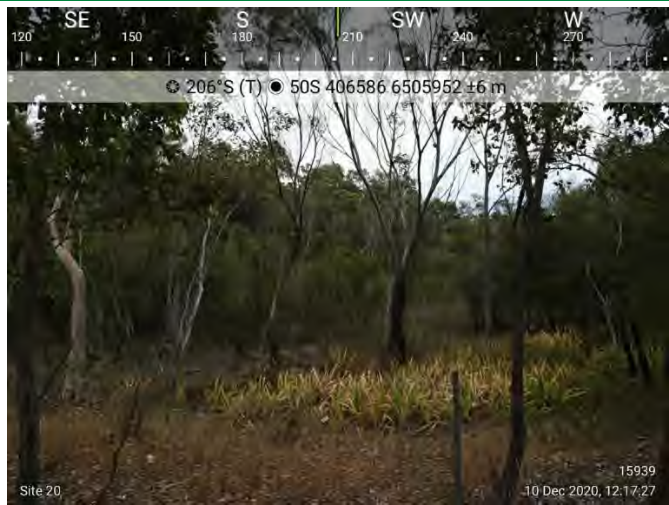
Photo Point 10

Classified vegetation is low open forest with canopy cover and shrub understorey, trees up to 10m.

Low open forest vegetation along watercourse
Slope under the vegetation has been assessed as flat land.

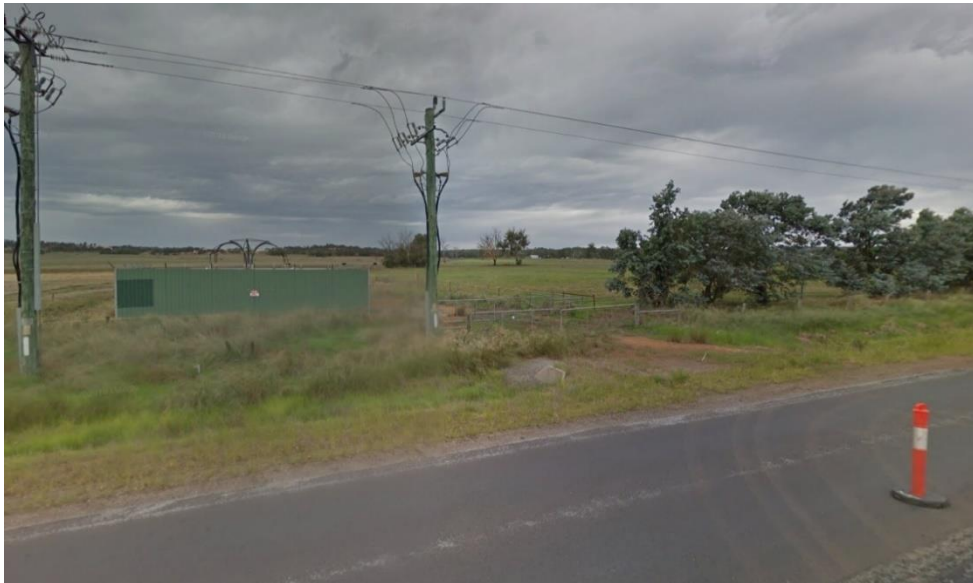
Figure 3-2 Existing power infrastructure.
