**DEVELOPMENT SERVICES ATTACHMENTS
ORDINARY MEETING OF COUNCIL
WEDNESDAY 15 MARCH 2023**

Muchea Industrial Area – Precinct 2A

Request for Amendment to the Shire of Chittering *Local Planning Scheme No. 6*

Taylor Burrell Barnett
Town Planning and Design

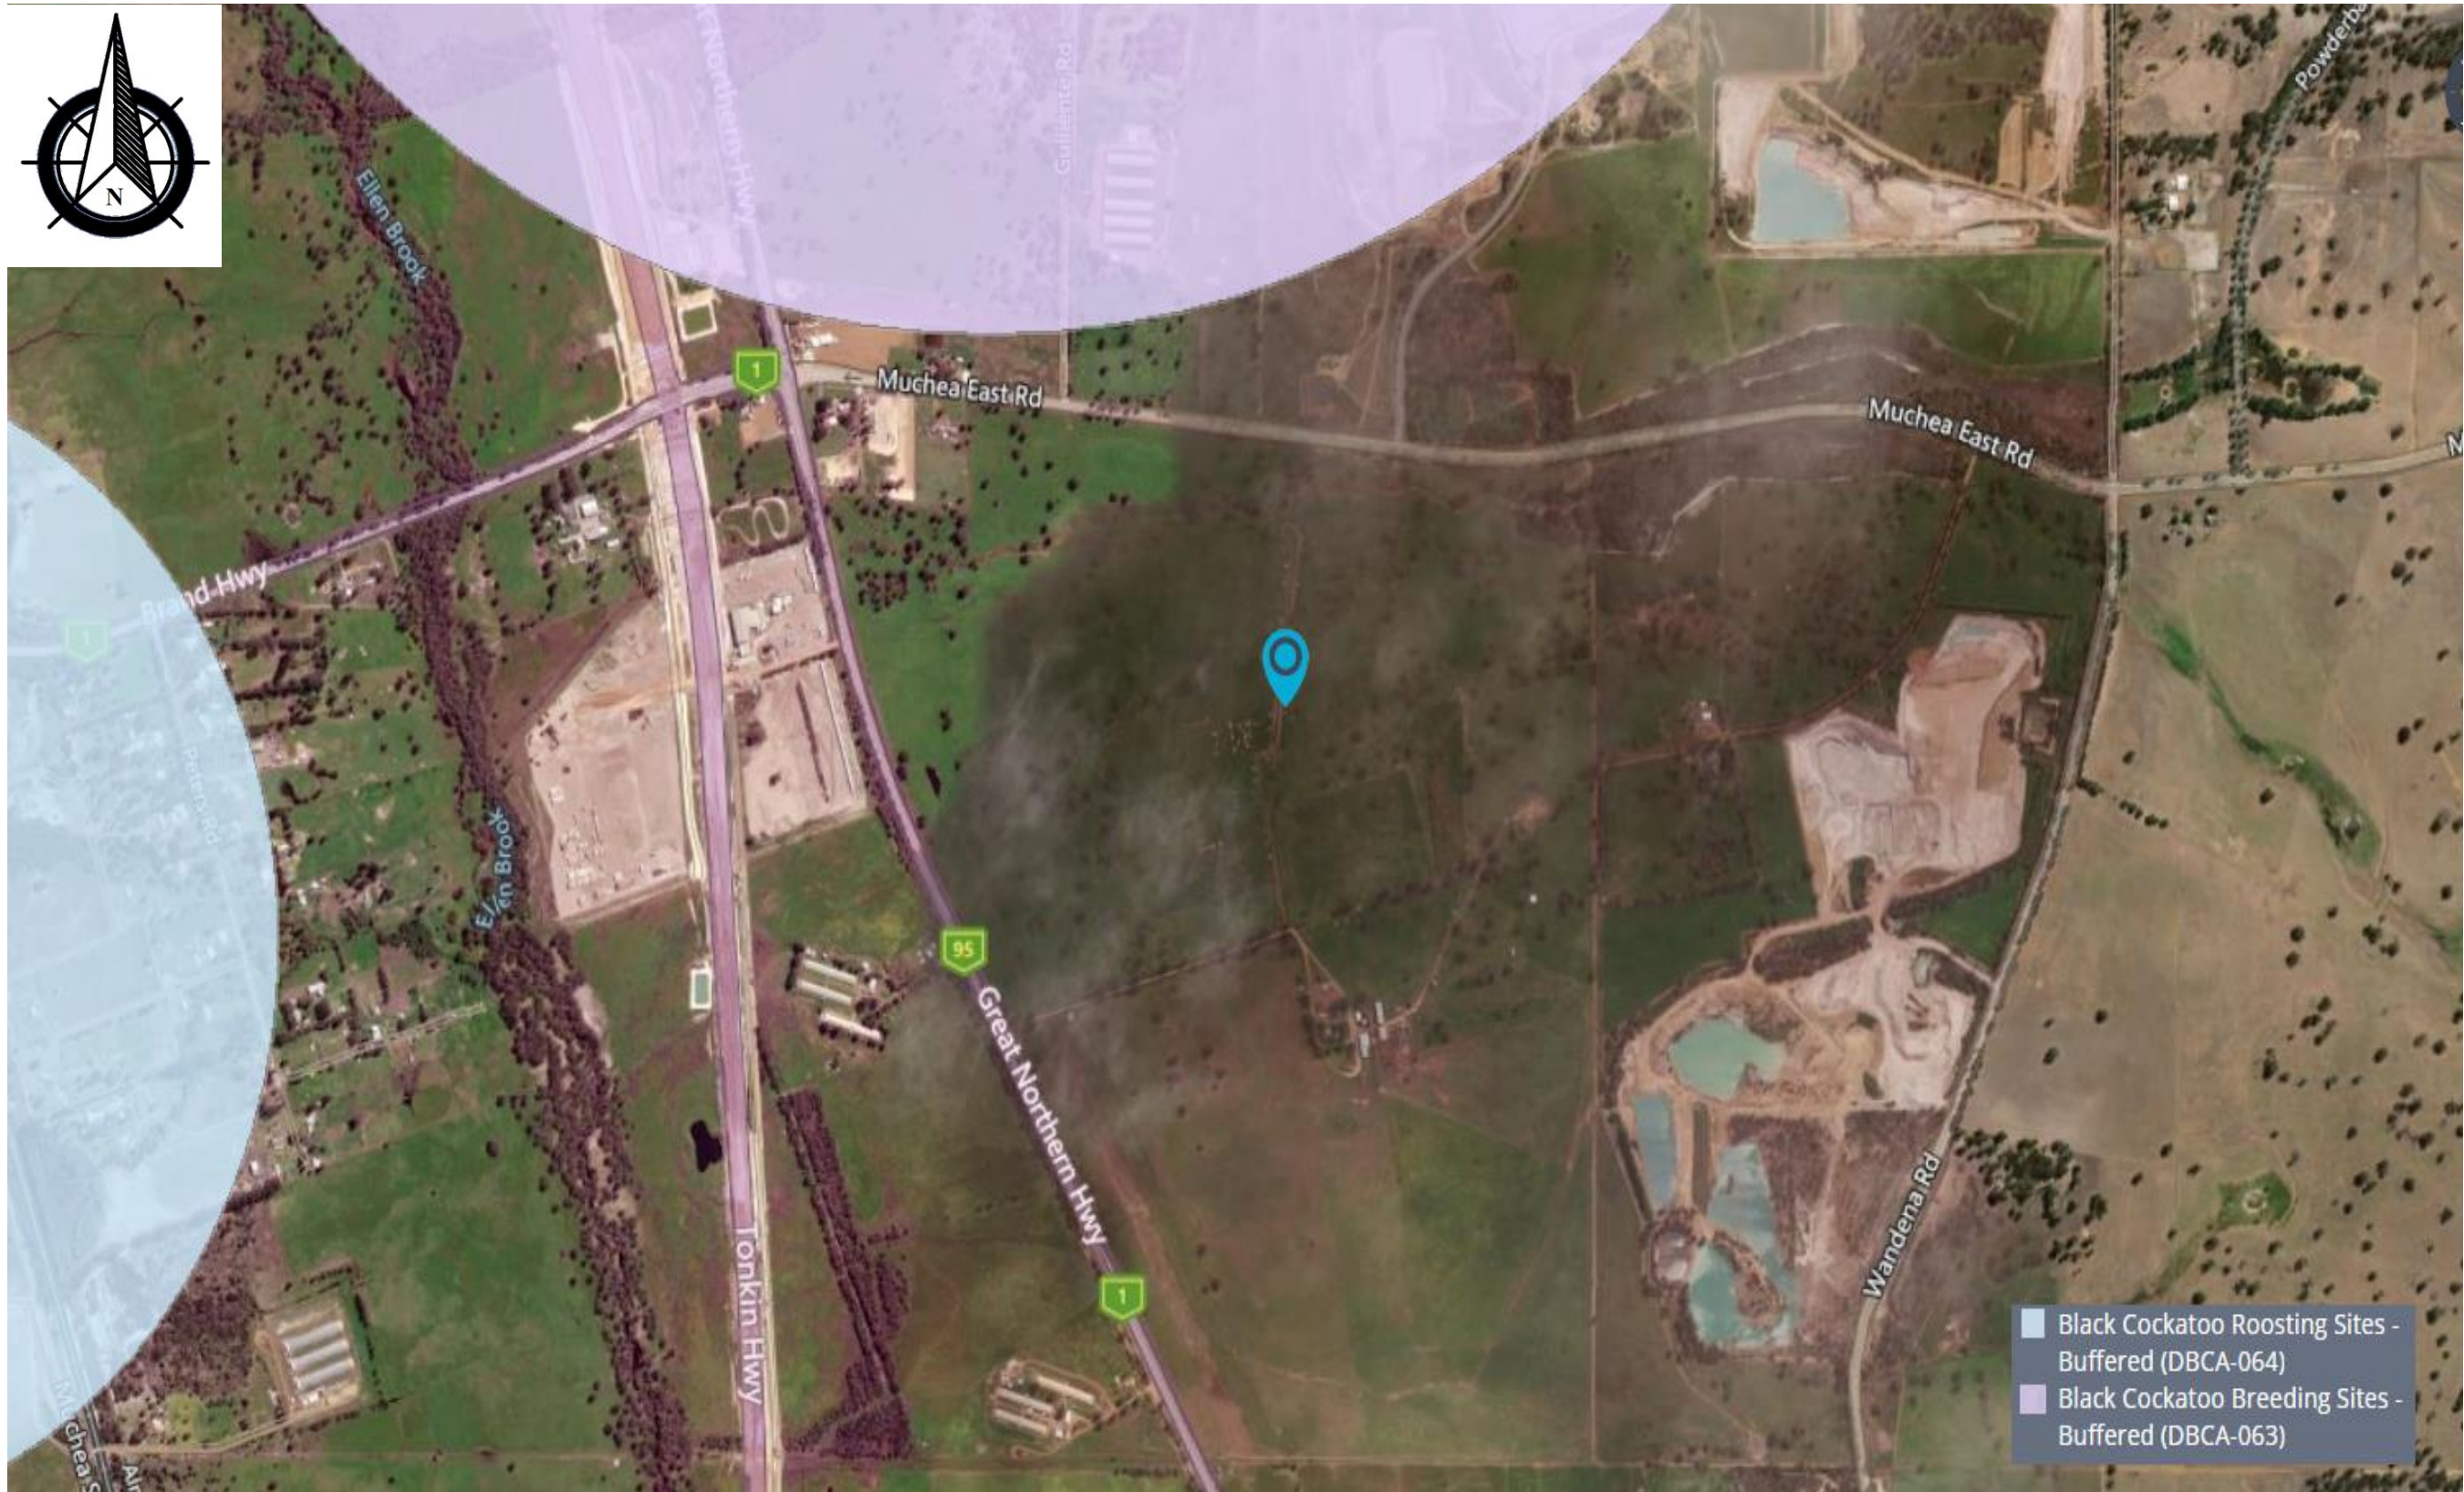
PROJECT	3488 (LOT M1456) & LOT 50 GREAT NORTHERN HIGHWAY	Scale:	N.T.S
CLIENT	IPARKS	Drawn:	HW
LOCATION	3488 (LOT M1456) & LOT 50 GREAT NORTHERN HIGHWAY	Date:	20.10.20
TITLE	BLACK COCKATOO ROSSTING AND BREEDING SITES	Reference:	PC20171.SKT.008
			Rev. A

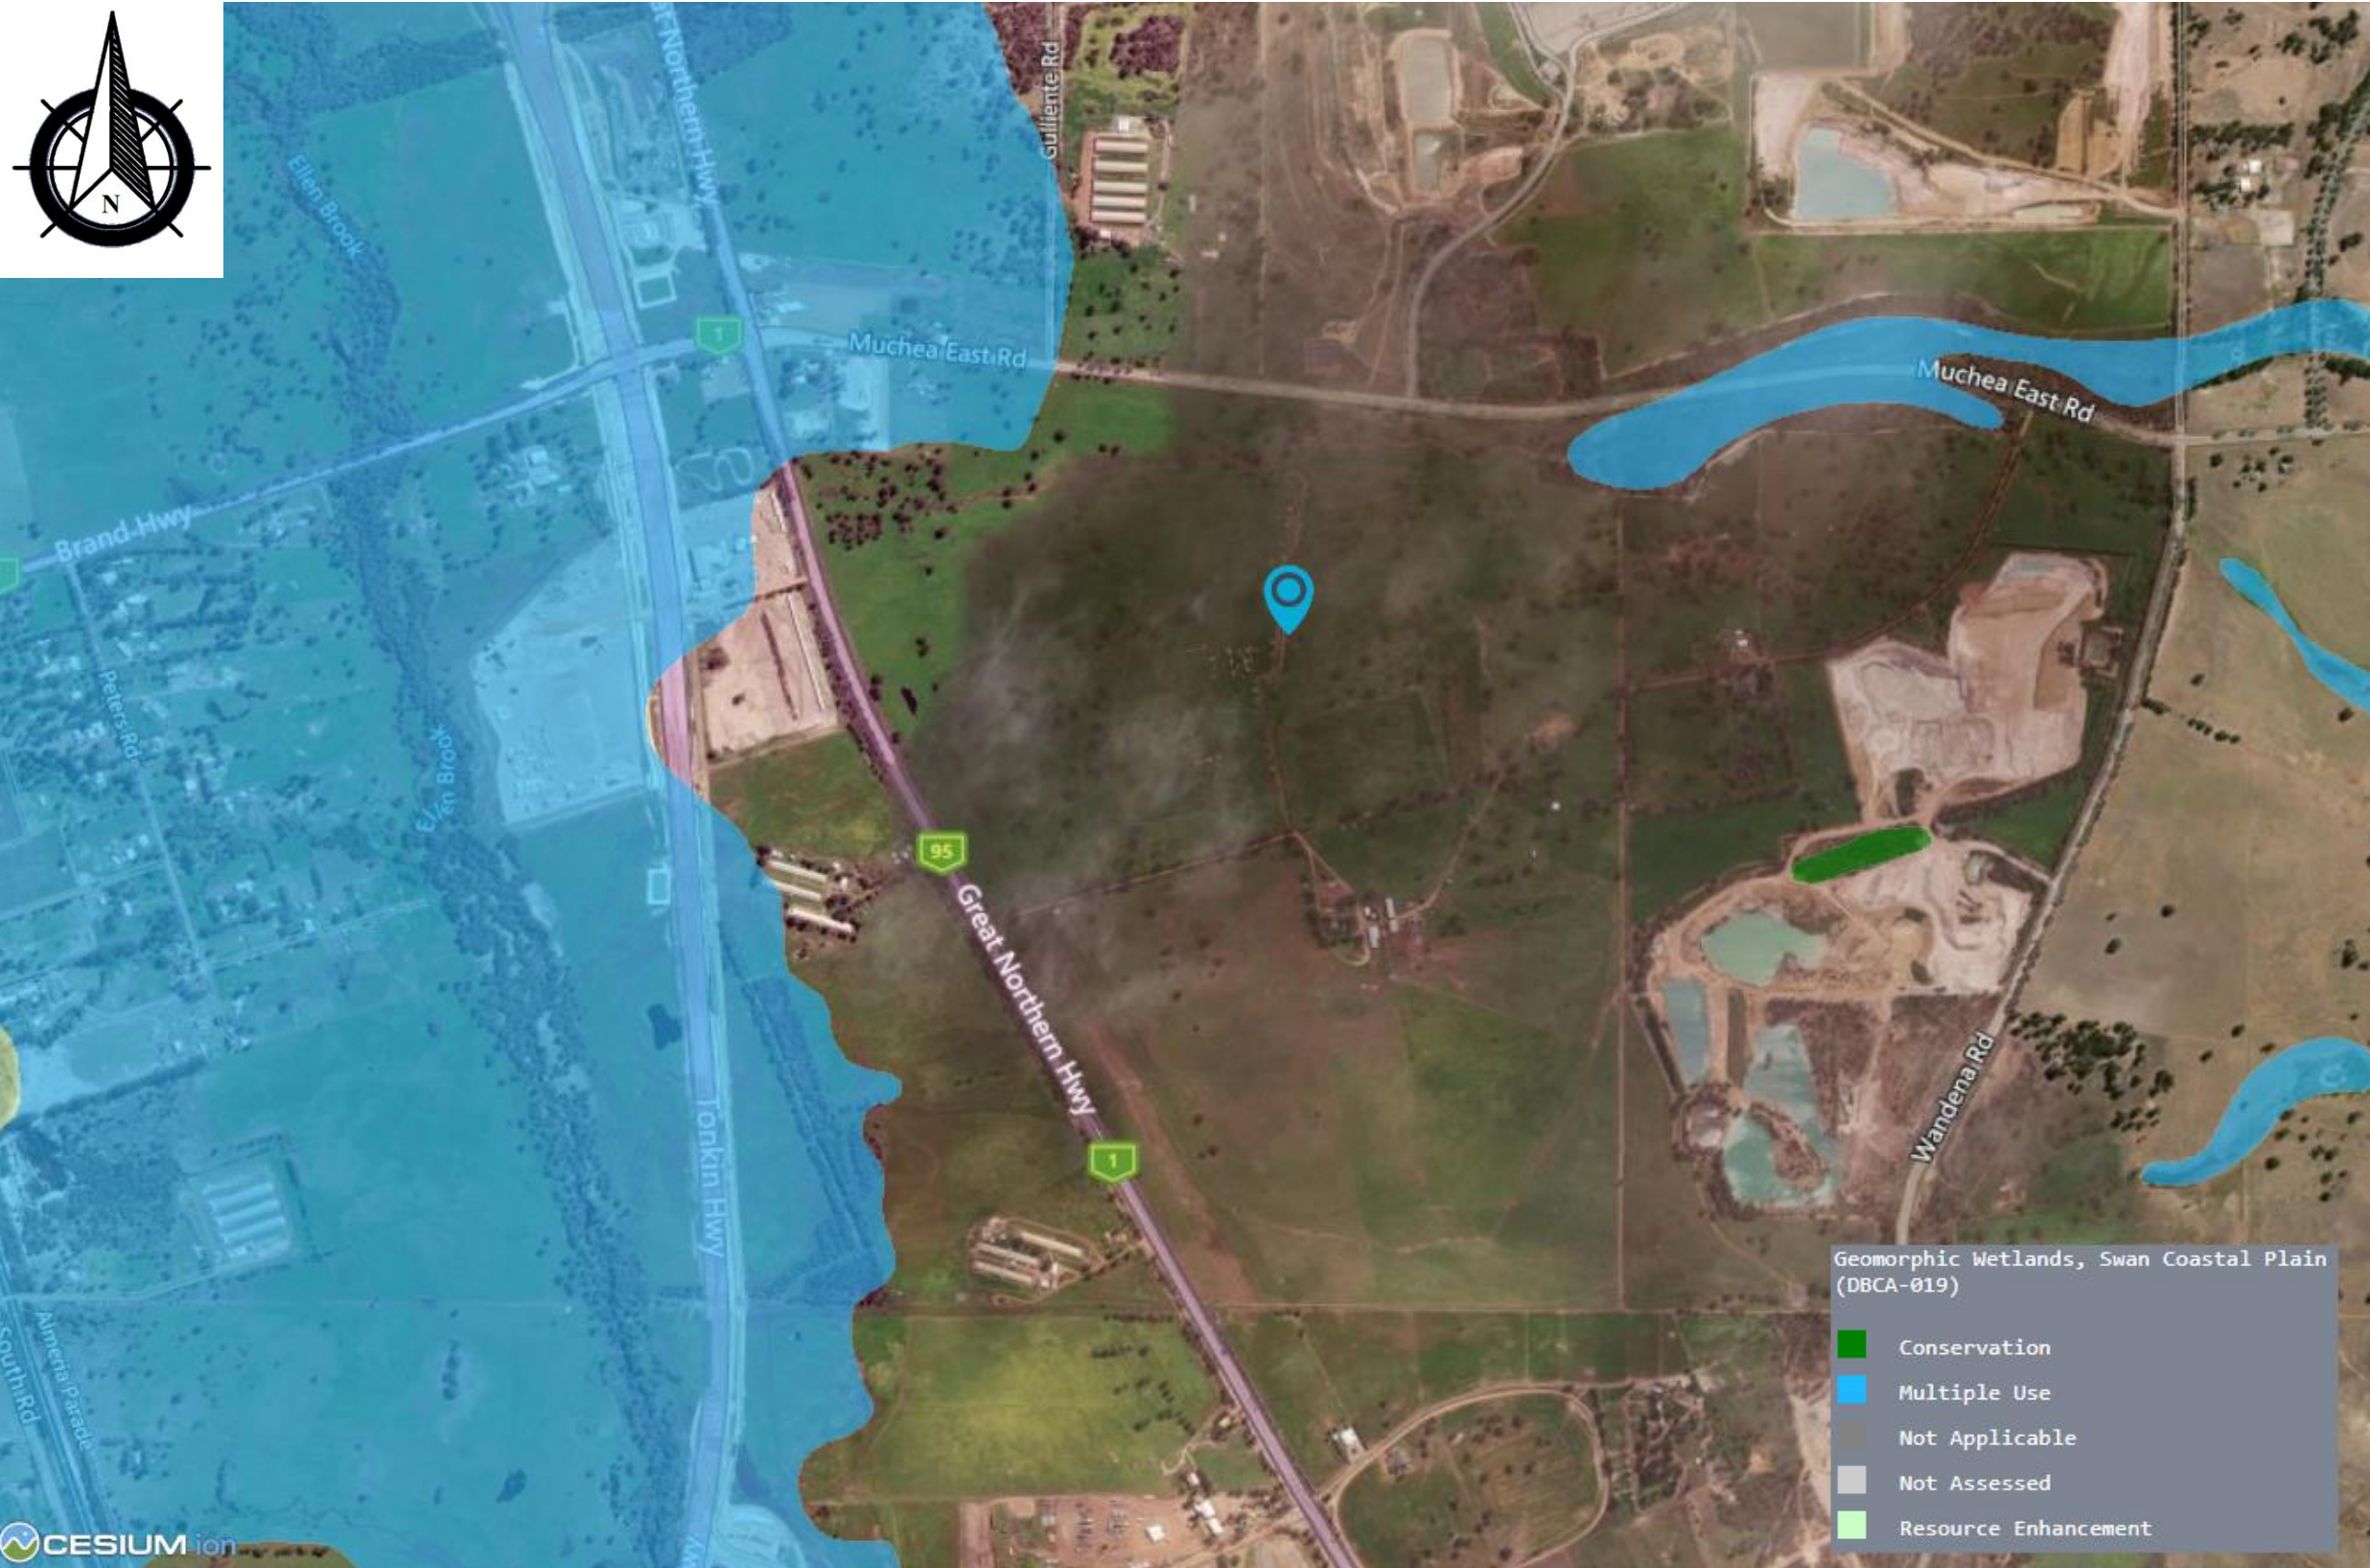
PROJECT	3488 (LOT M1456) & LOT 50 GREAT NORTHERN HIGHWAY	Scale:	N.T.S
CLIENT	IPARKS	Drawn:	HW
LOCATION	3488 (LOT M1456) & LOT 50 GREAT NORTHERN HIGHWAY	Date:	20.10.20
TITLE	GEOMORPHIC WETLAND	Reference:	PC20171.SKT.011
			Rev. A

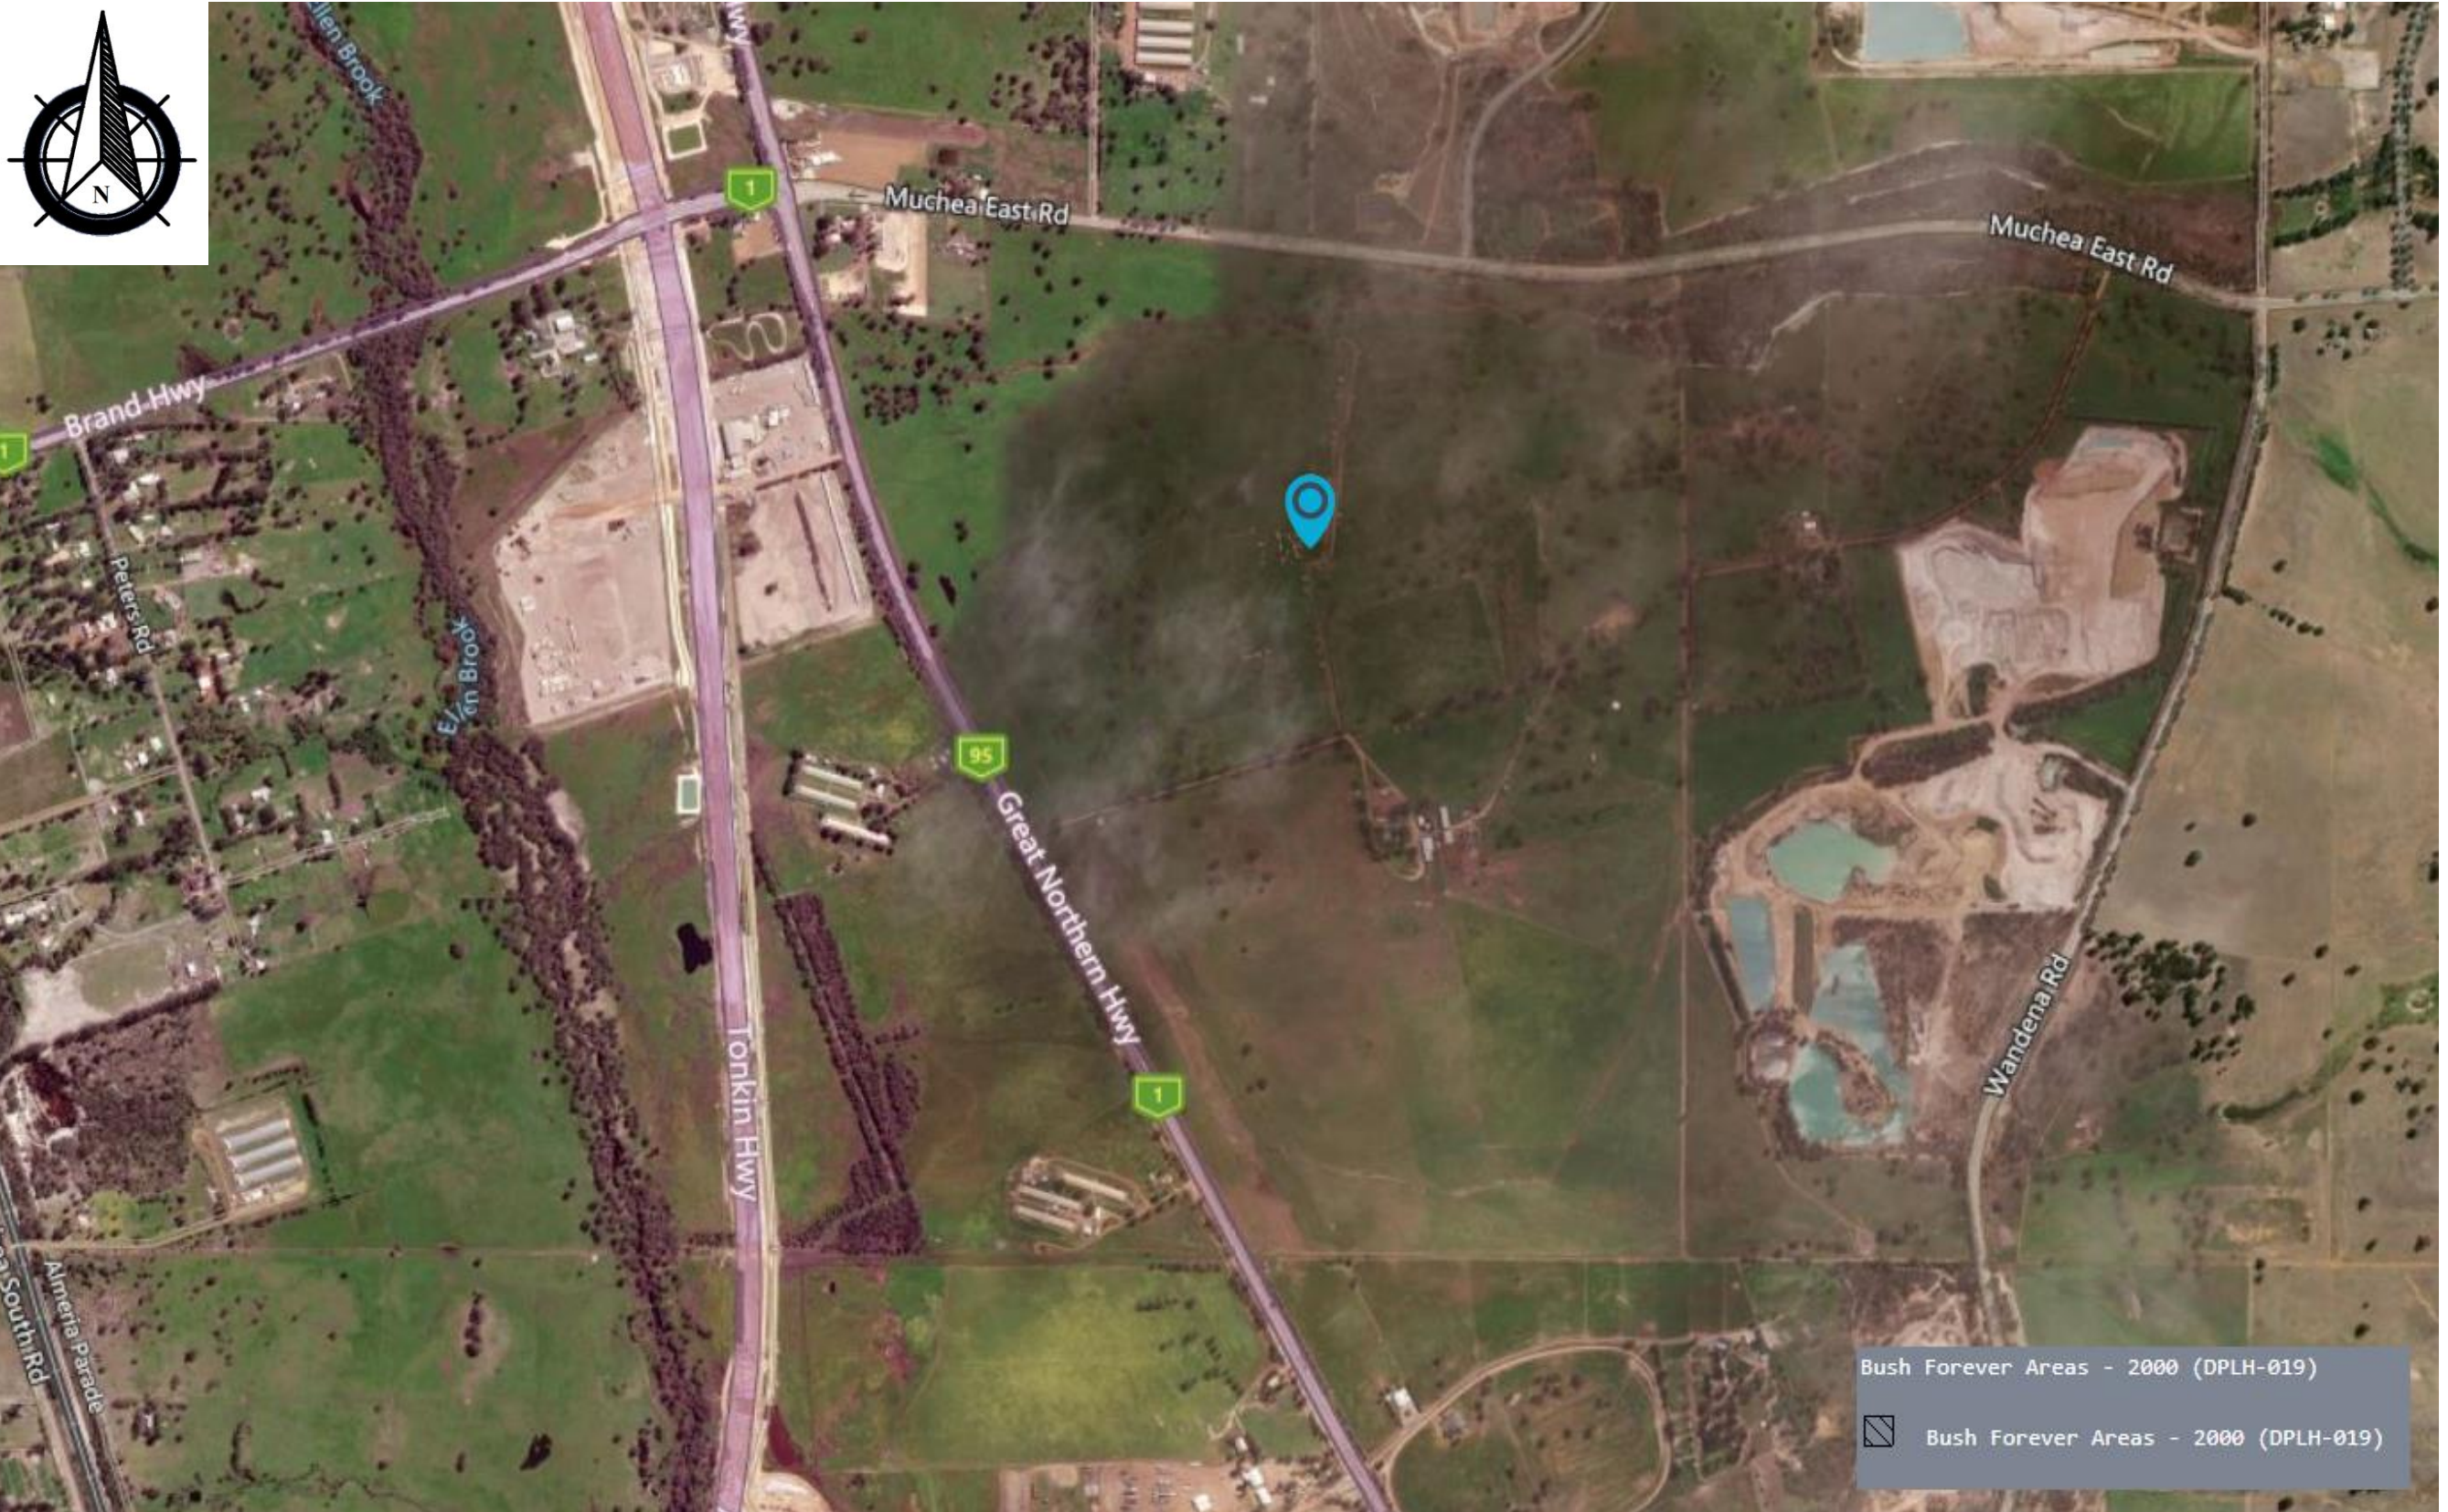
PROJECT	3488 (LOT M1456) & LOT 50 GREAT NORTHERN HIGHWAY	Scale:	N.T.S
CLIENT	IPARKS	Drawn:	HW
LOCATION	3488 (LOT M1456) & LOT 50 GREAT NORTHERN HIGHWAY	Date:	20.10.20
TITLE	BUSH FOREVER	Reference:	PC20171.SKT.012
			Rev. A

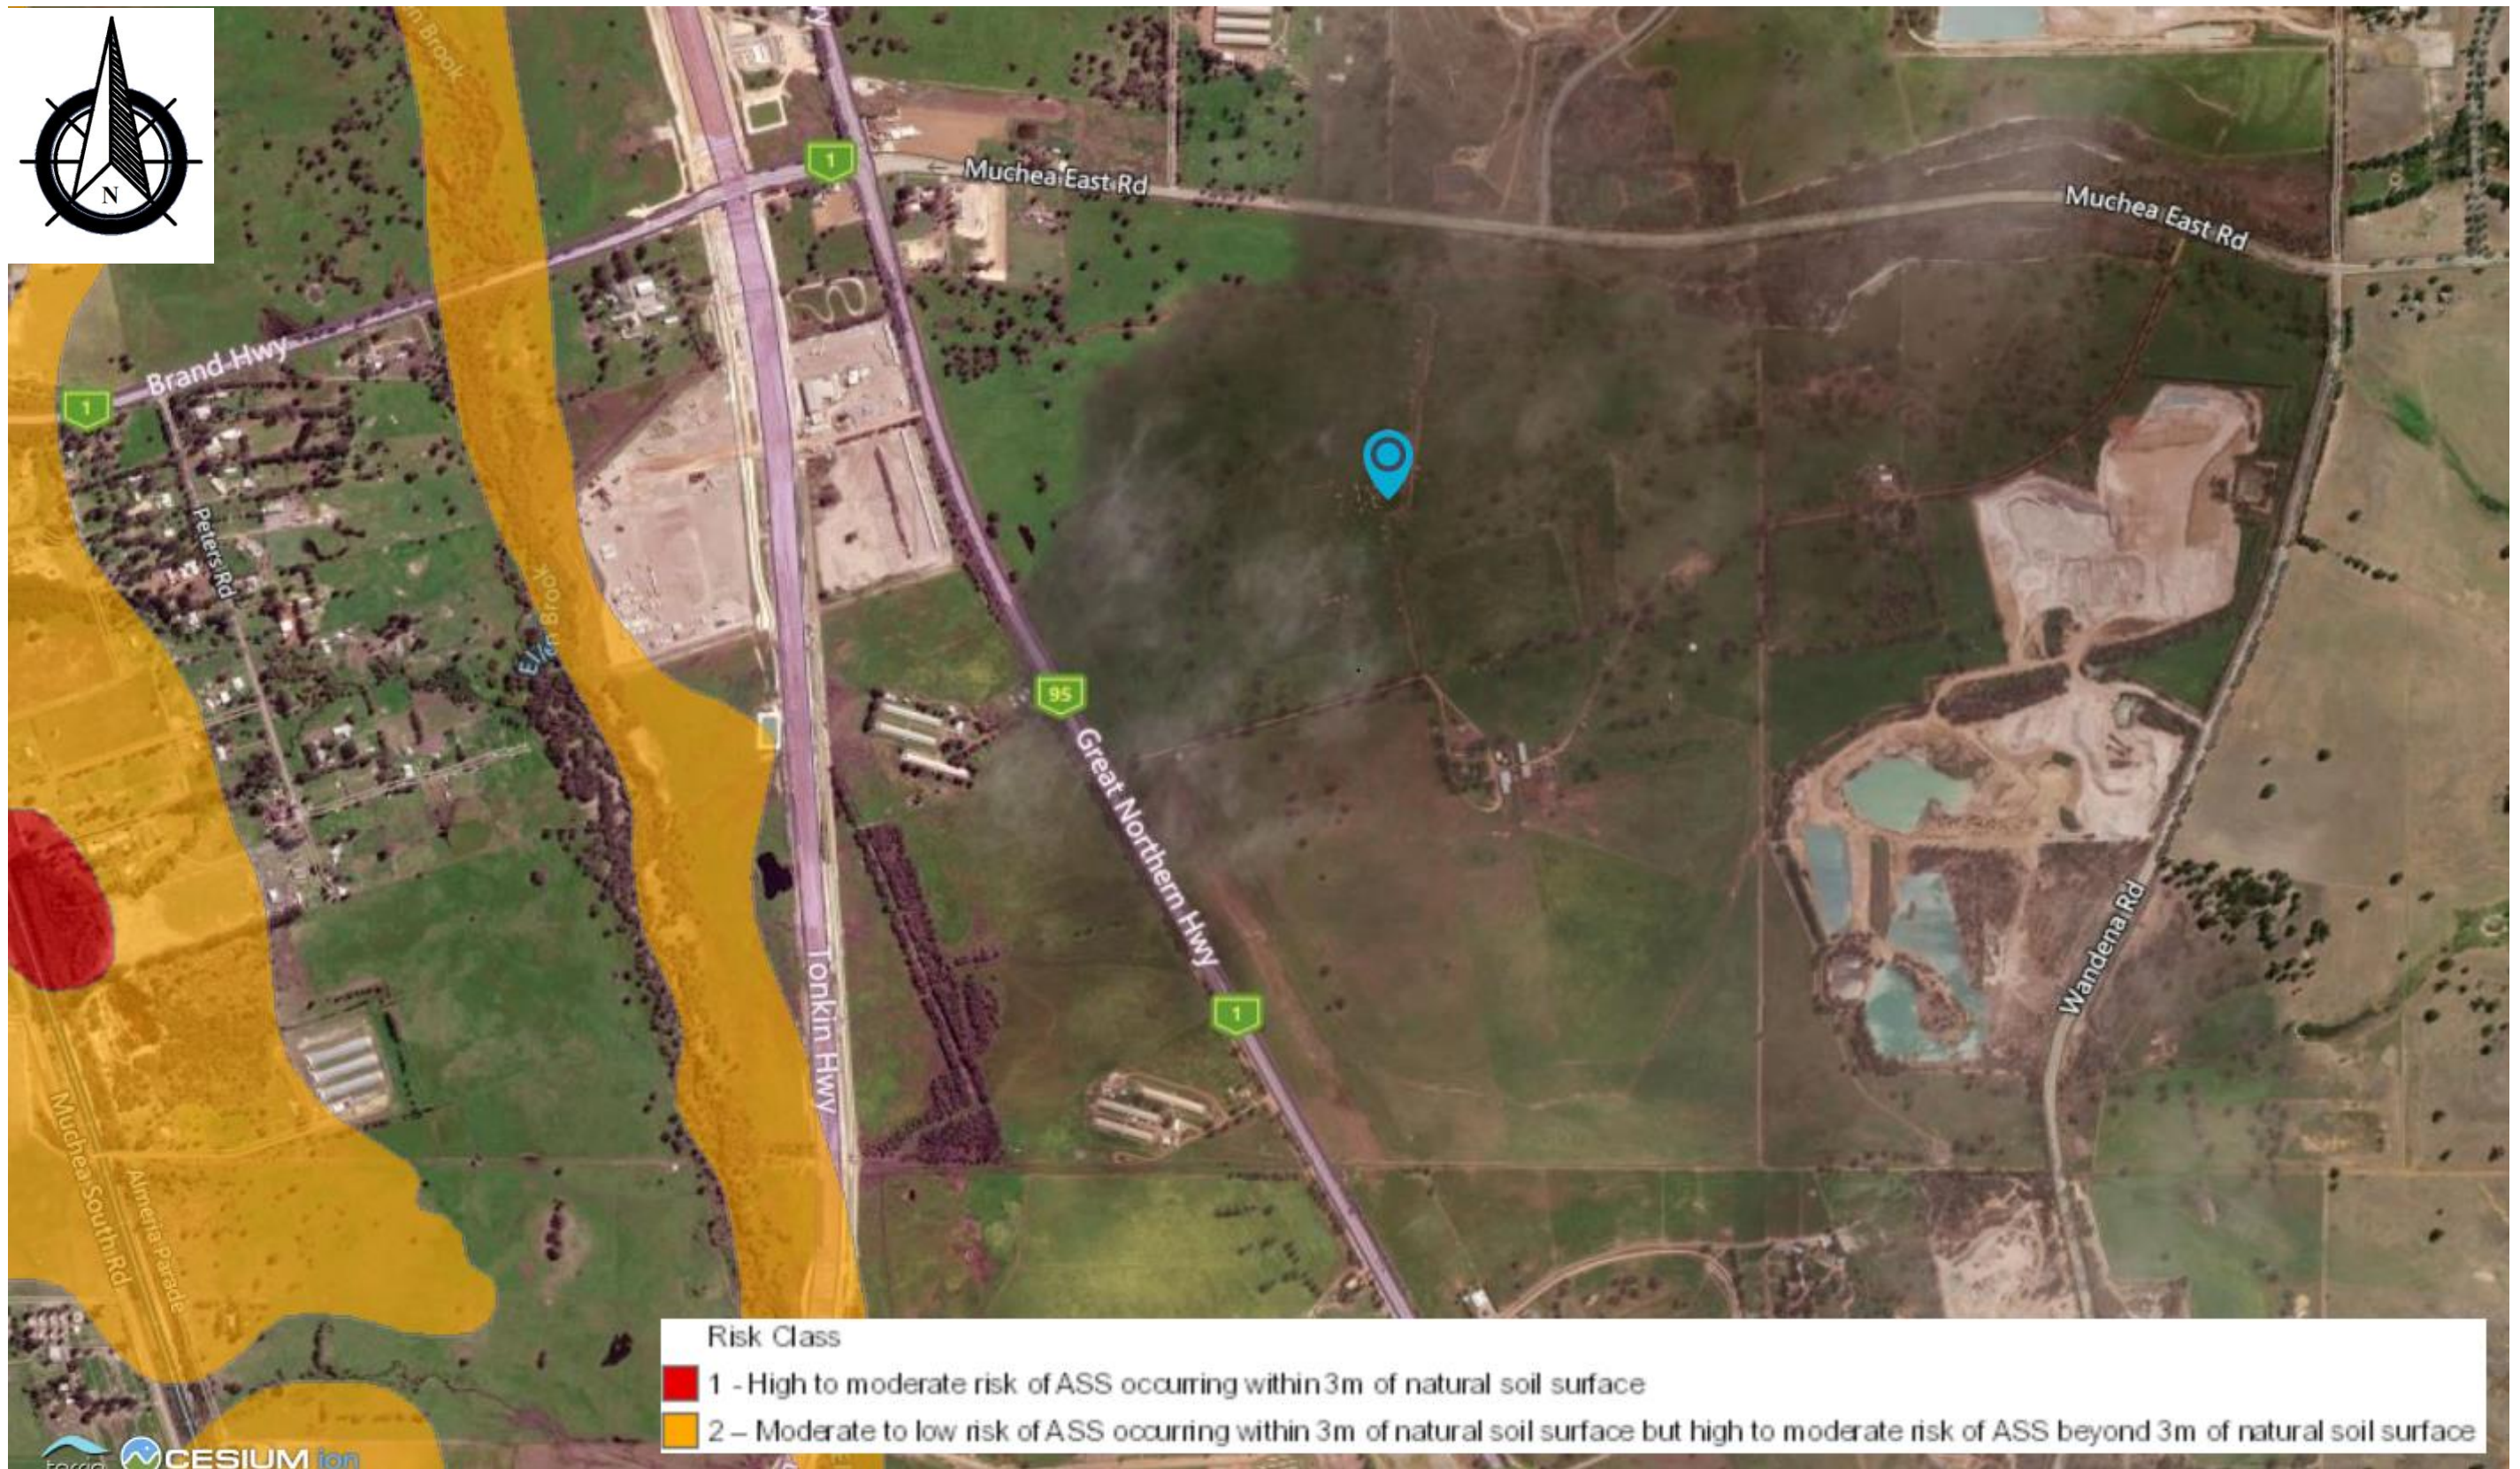
PROJECT	3488 (LOT M1456) & LOT 50 GREAT NORTHERN HIGHWAY	Scale:	N.T.S
CLIENT	IPARKS	Drawn:	HW
LOCATION	3488 (LOT M1456) & LOT 50 GREAT NORTHERN HIGHWAY	Date:	20.10.20
TITLE	ACID SULFATE SOILS	Reference:	PC20171.SKT.013
			Rev. A

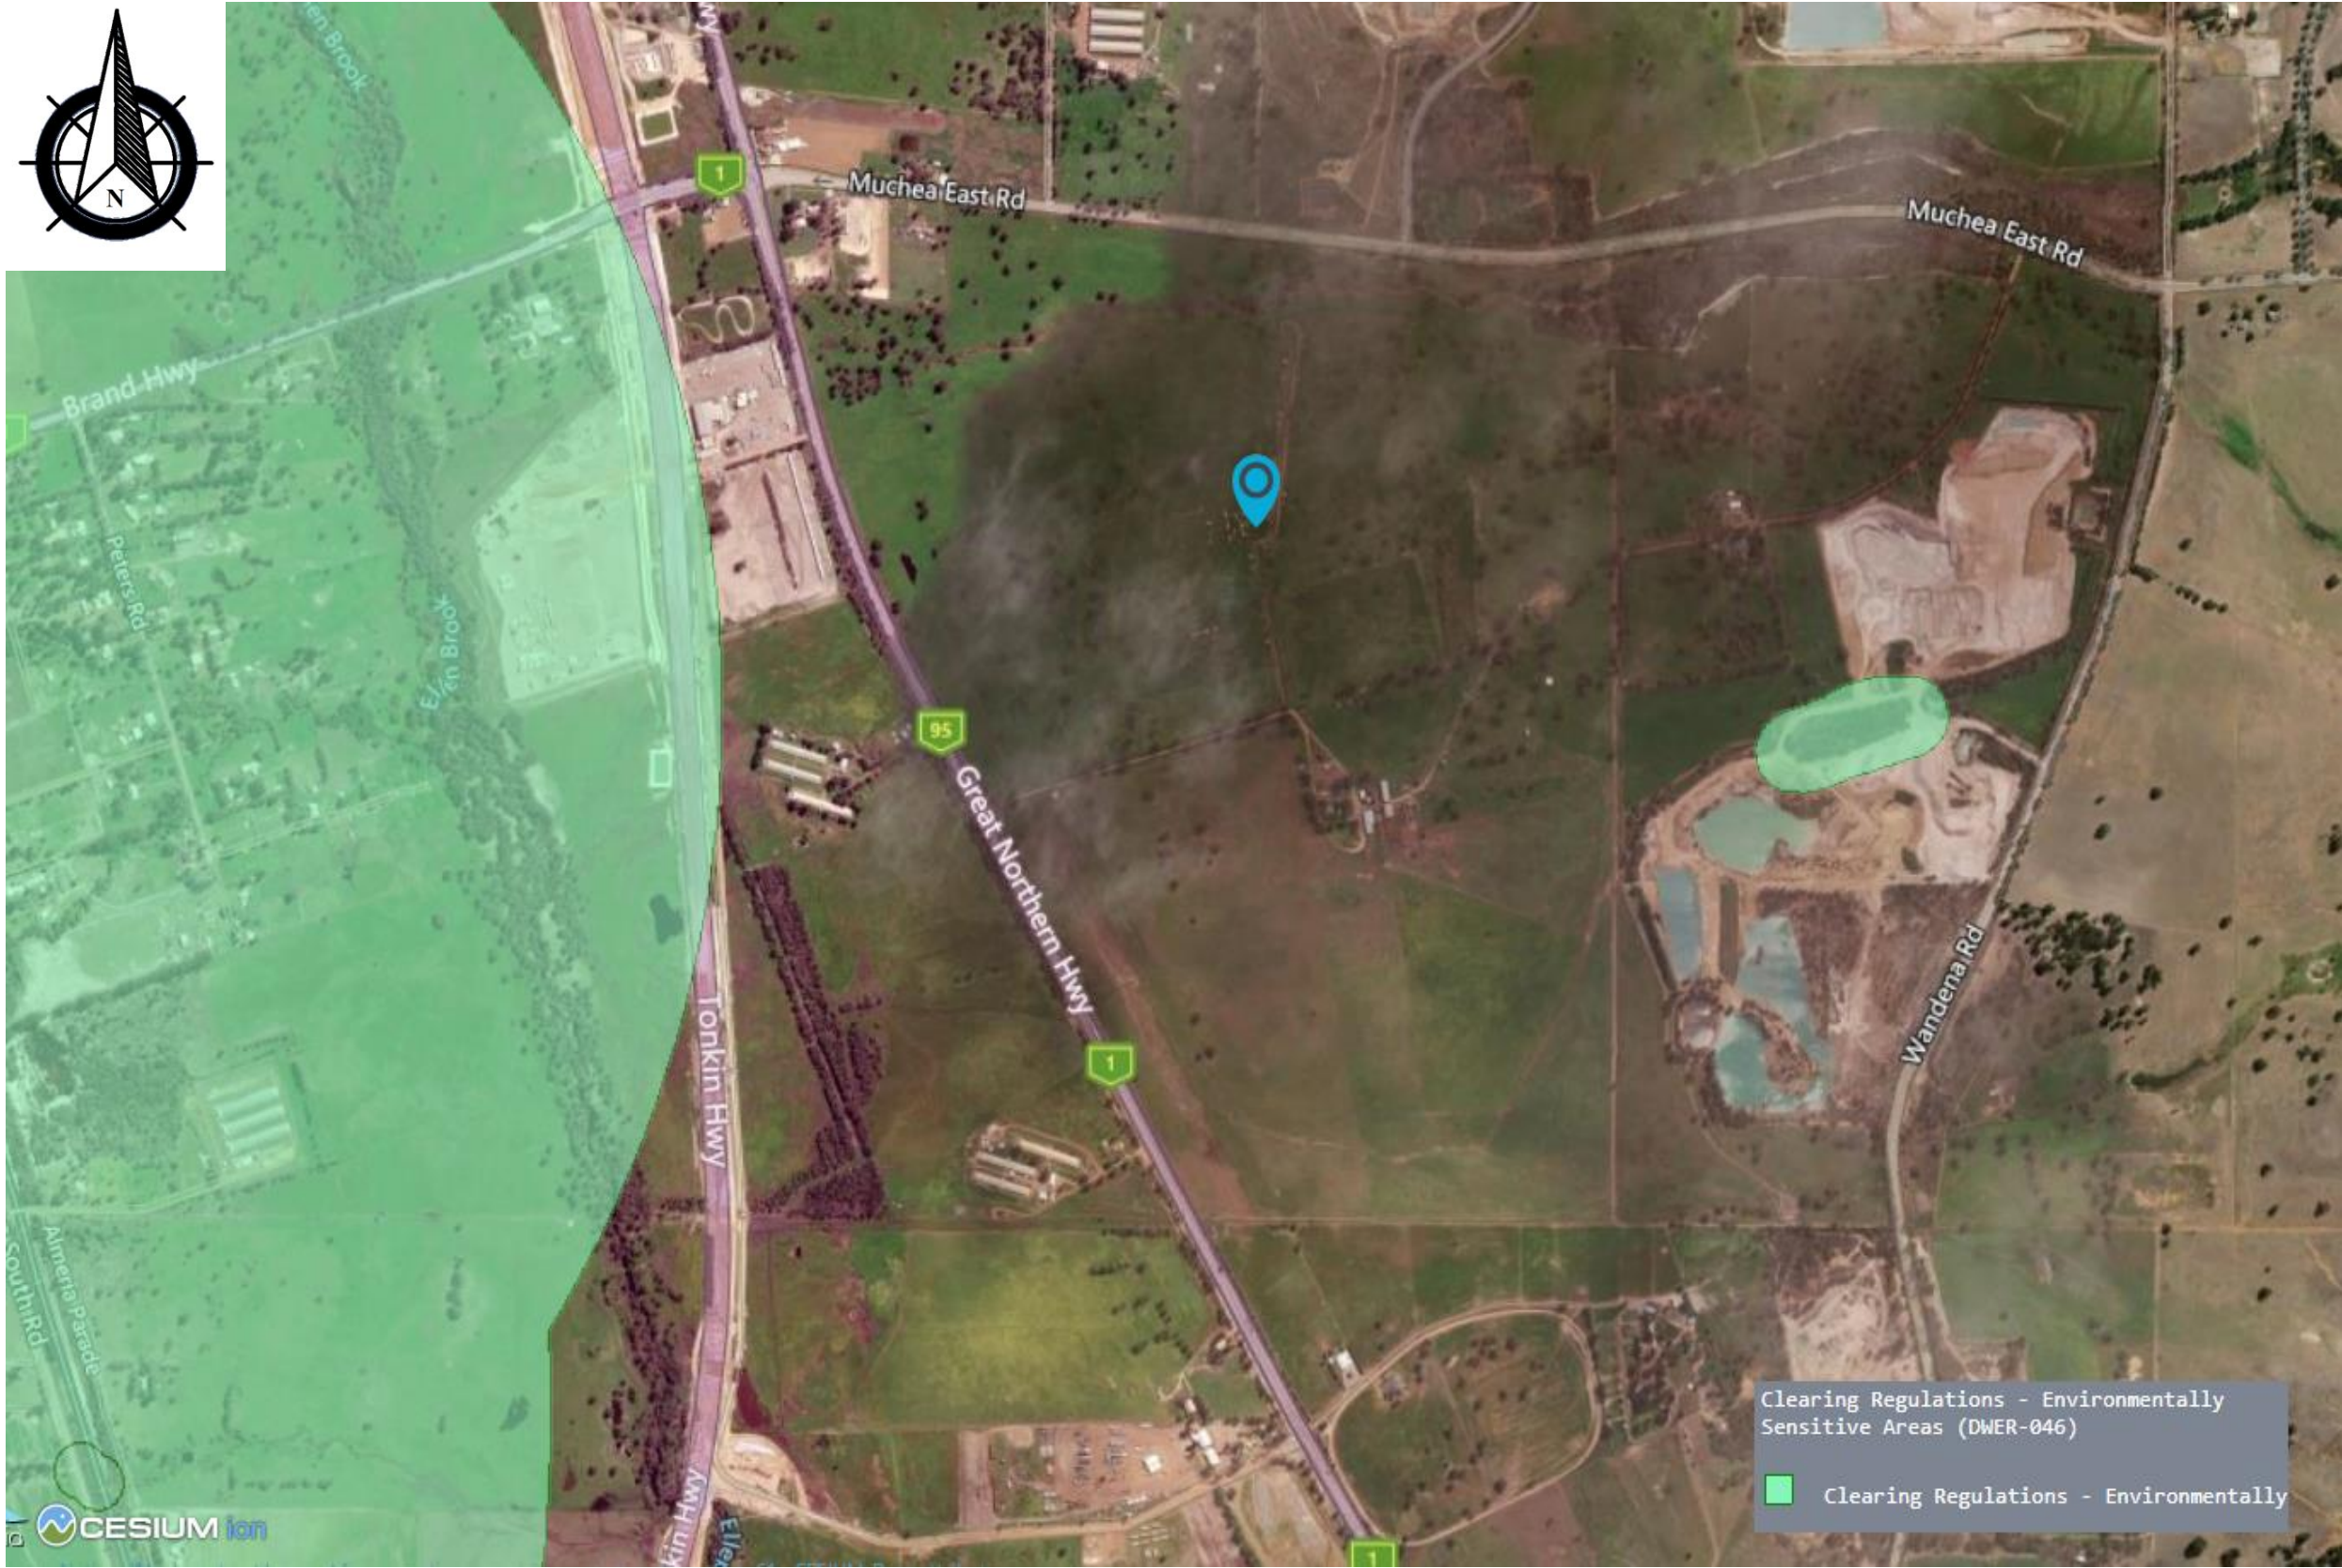
PROJECT	3488 (LOT M1456) & LOT 50 GREAT NORTHERN HIGHWAY	Scale:	N.T.S
CLIENT	IPARKS	Drawn:	HW
LOCATION	3488 (LOT M1456) & LOT 50 GREAT NORTHERN HIGHWAY	Date:	20.10.20
TITLE	CLEARING REGULATIONS	Reference:	PC20171.SKT.014
			Rev. A

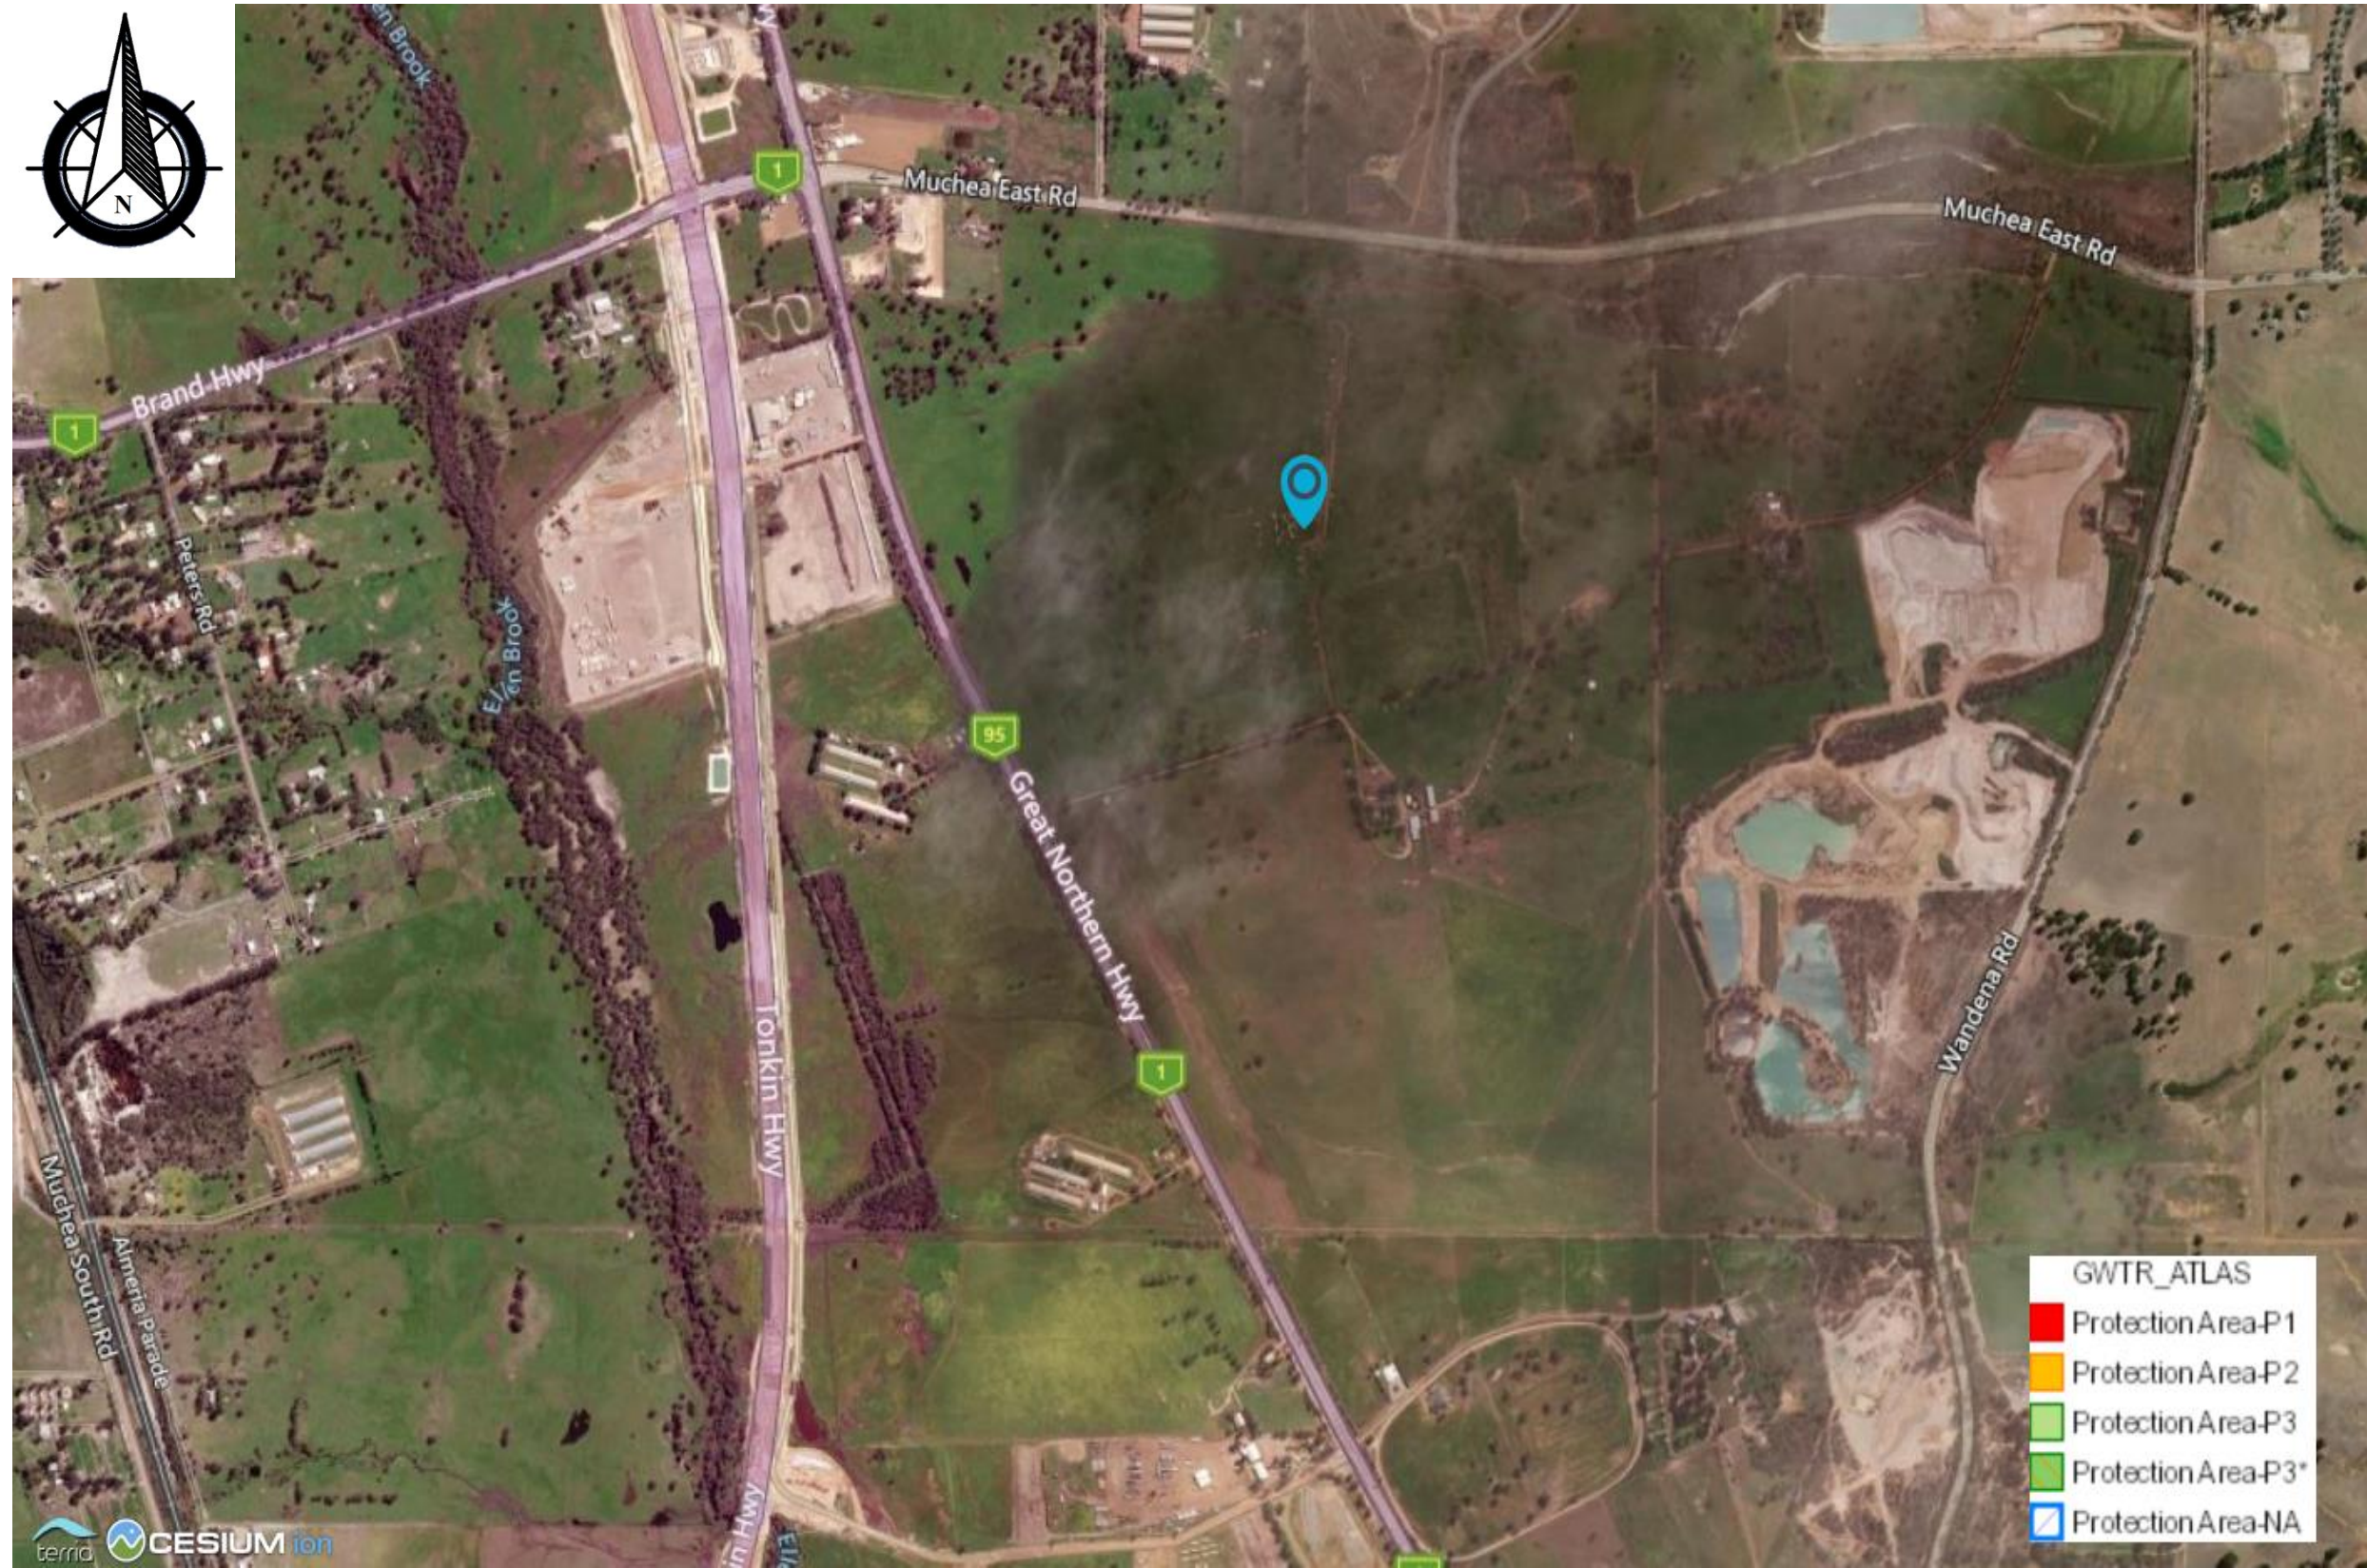
PROJECT	3488 (LOT M1456) & LOT 50 GREAT NORTHERN HIGHWAY	Scale:	N.T.S
CLIENT	IPARKS	Drawn:	HW
LOCATION	3488 (LOT M1456) & LOT 50 GREAT NORTHERN HIGHWAY	Date:	20.10.20
TITLE	PUBLIC DRINKING WATER SOURCE AREAS	Reference:	PC20171.SKT.015
			Rev. A
