**DEVELOPMENT SERVICES ATTACHMENTS
ORDINARY MEETING OF COUNCIL
WEDNESDAY 15 MARCH 2023**

Muchea Industrial Area – Precinct 2A

Request for Amendment to the Shire of Chittering *Local Planning Scheme No. 6*

Taylor Burrell Barnett
Town Planning and Design

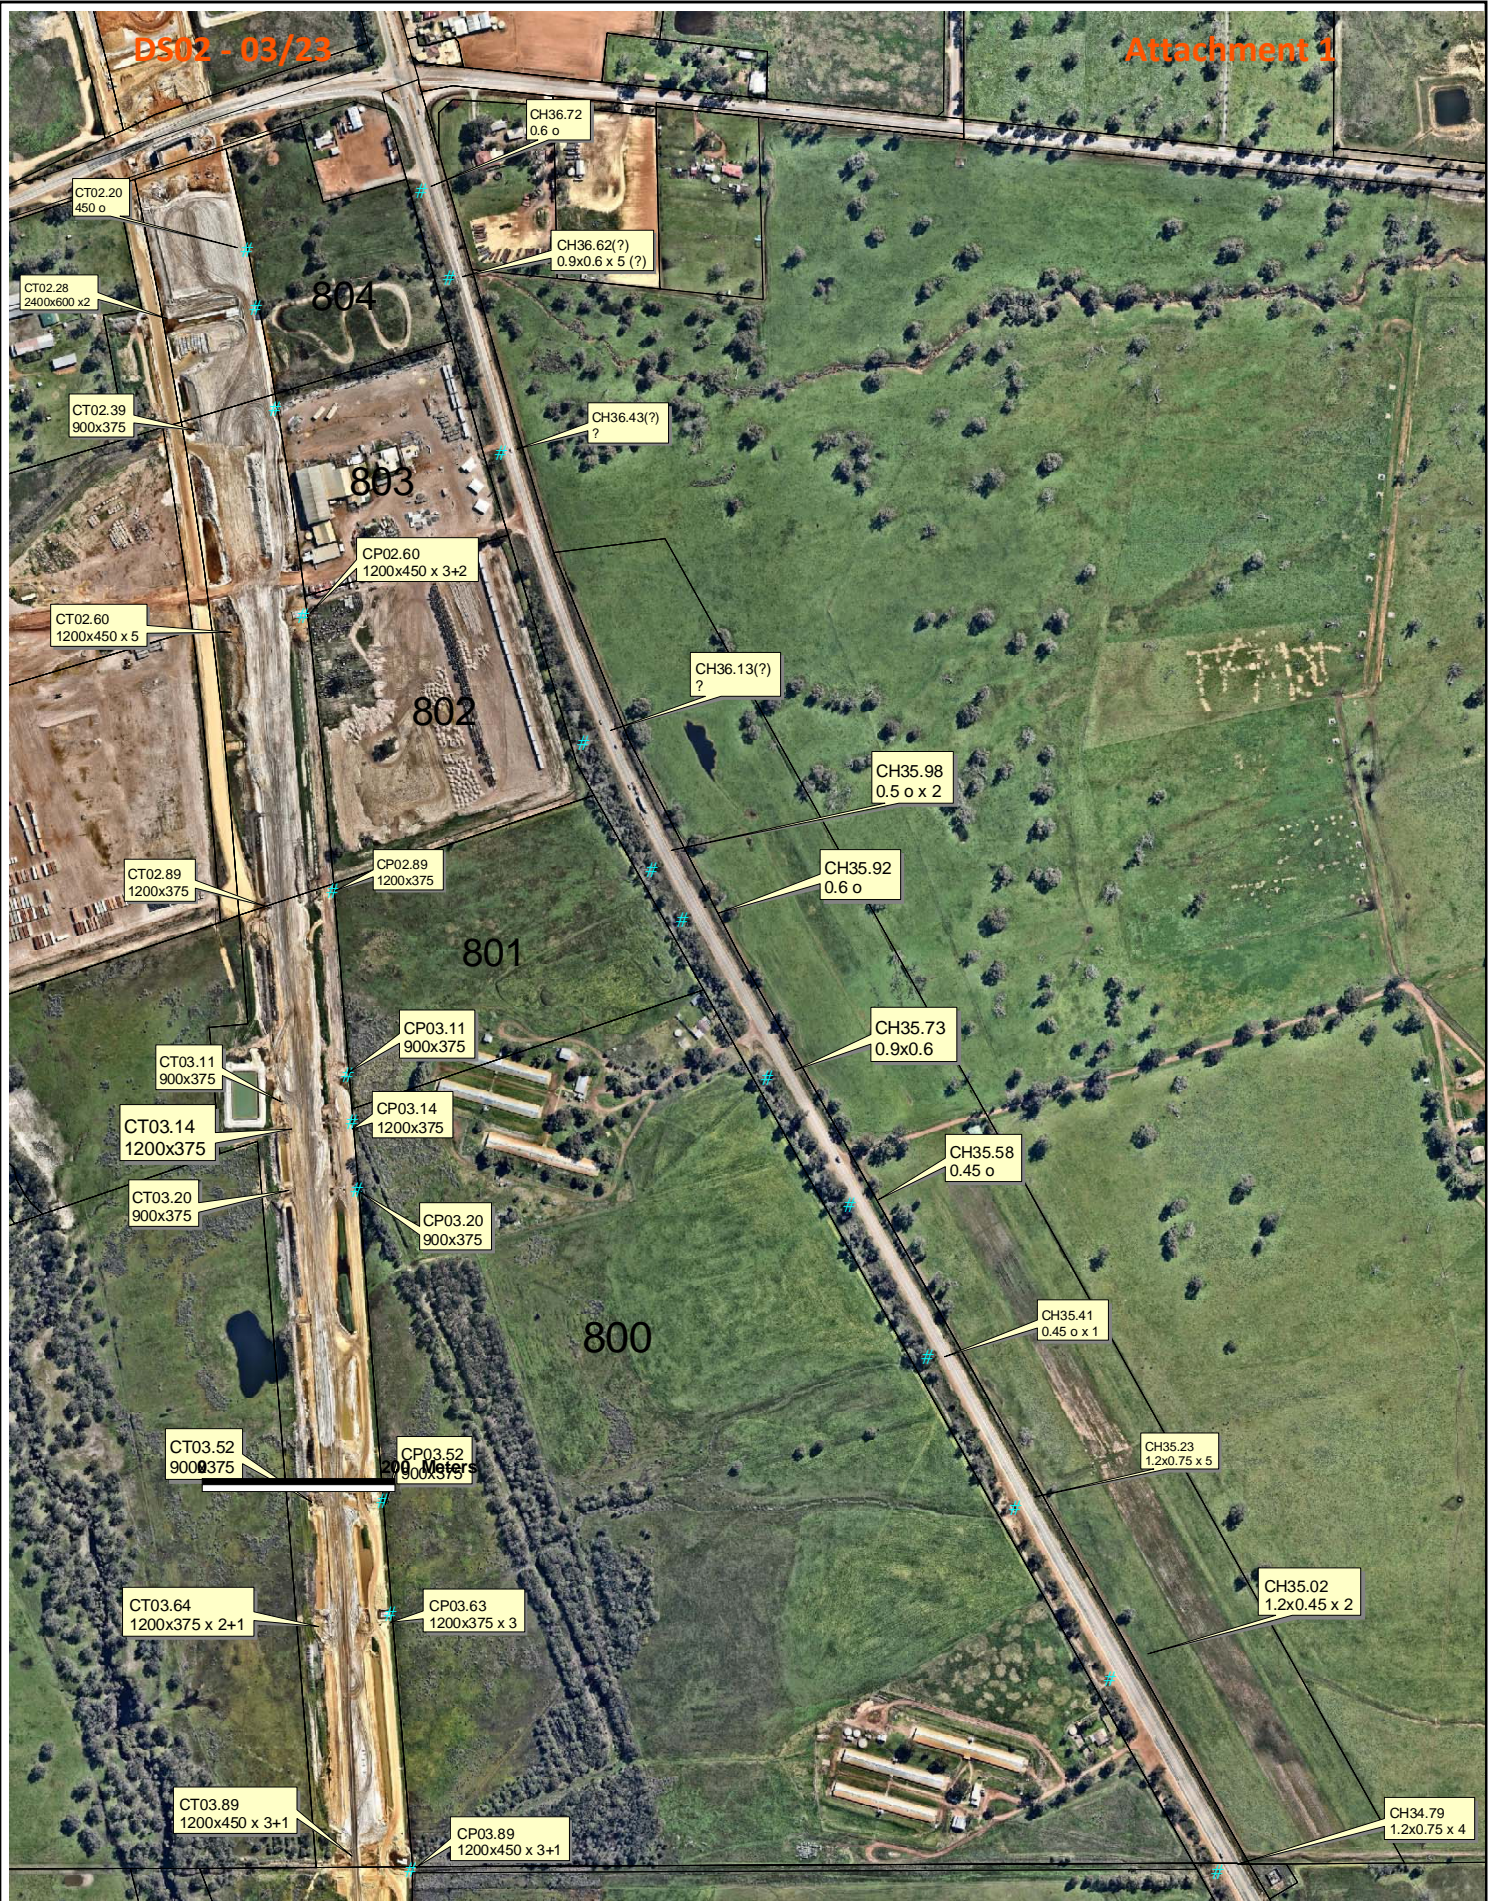
CH	Chainage (MRWA)
1.2x0.45 x 2 (eg)	Rectangular culvert (width x height x no. barrels)
0.5 o x 2 (eg)	Round culvert (diameter x no. barrels)

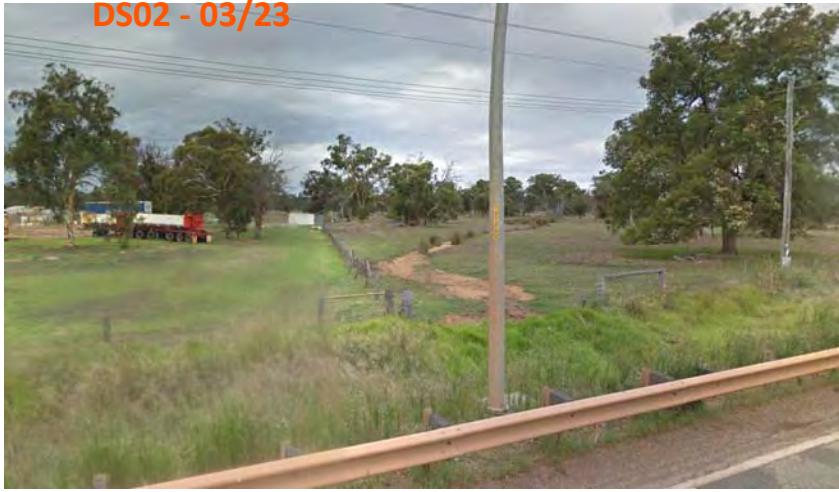
1 Western end of creek at exit from site

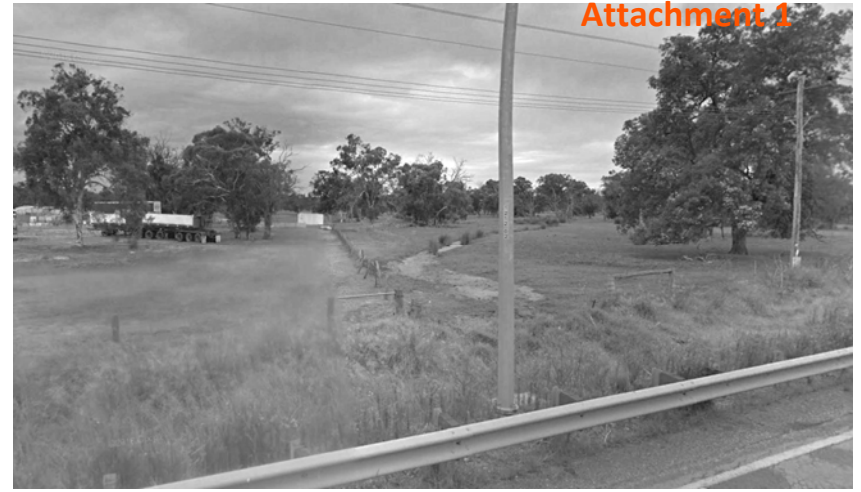
2 Lower middle creekline

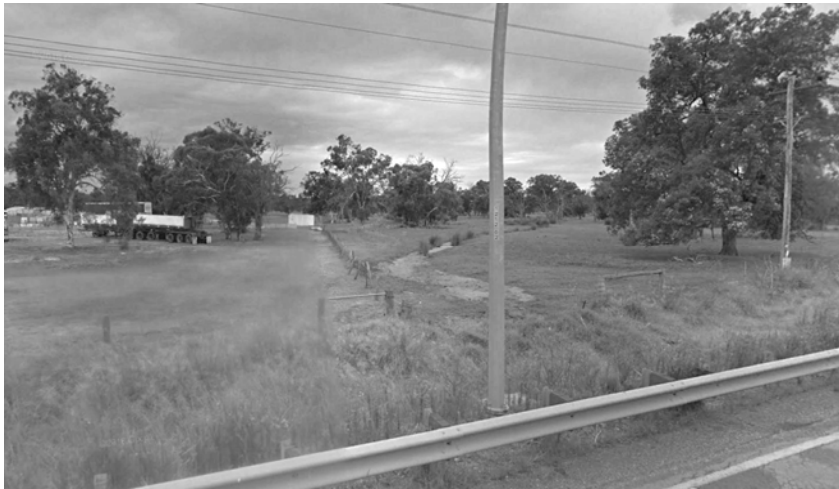
3 Upper middle creekline

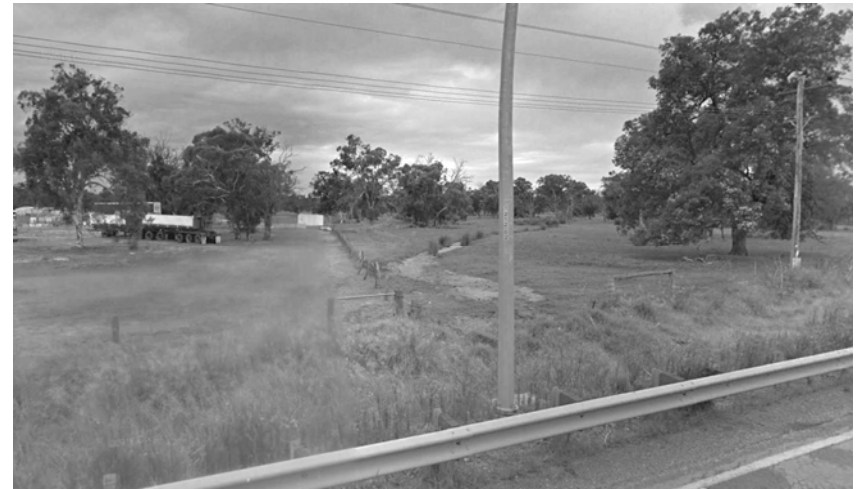
4 Eastern end of creek near entrance to site

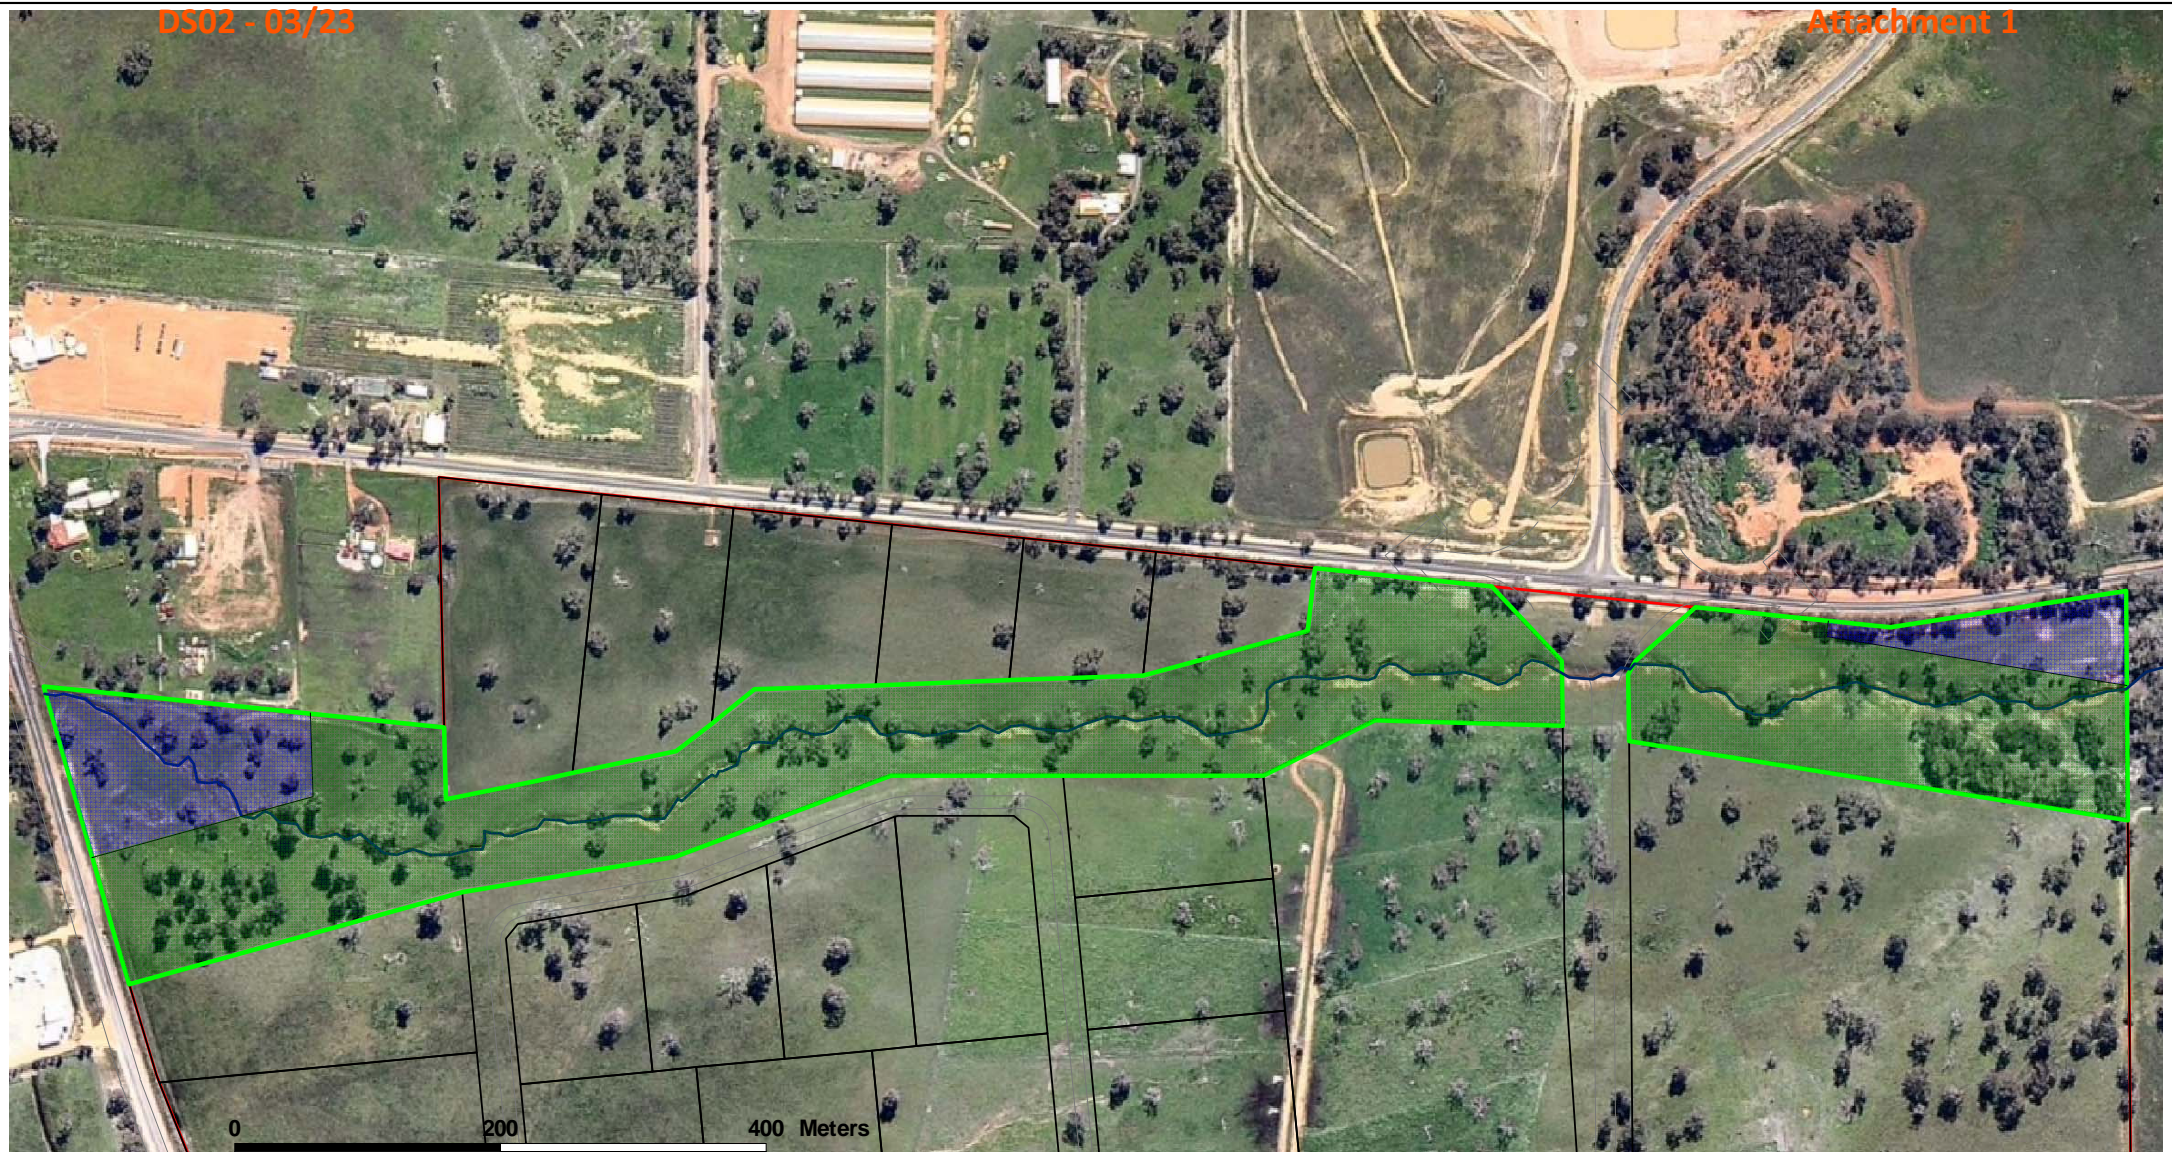
Figure 4

FORESHORE RESERVE
